Investigation report

| Report title Investigation of an incident with personal injury and gas leak when splitting a blind hub on Statfjord B on 22 April 2023 | Activity number 001037074 |

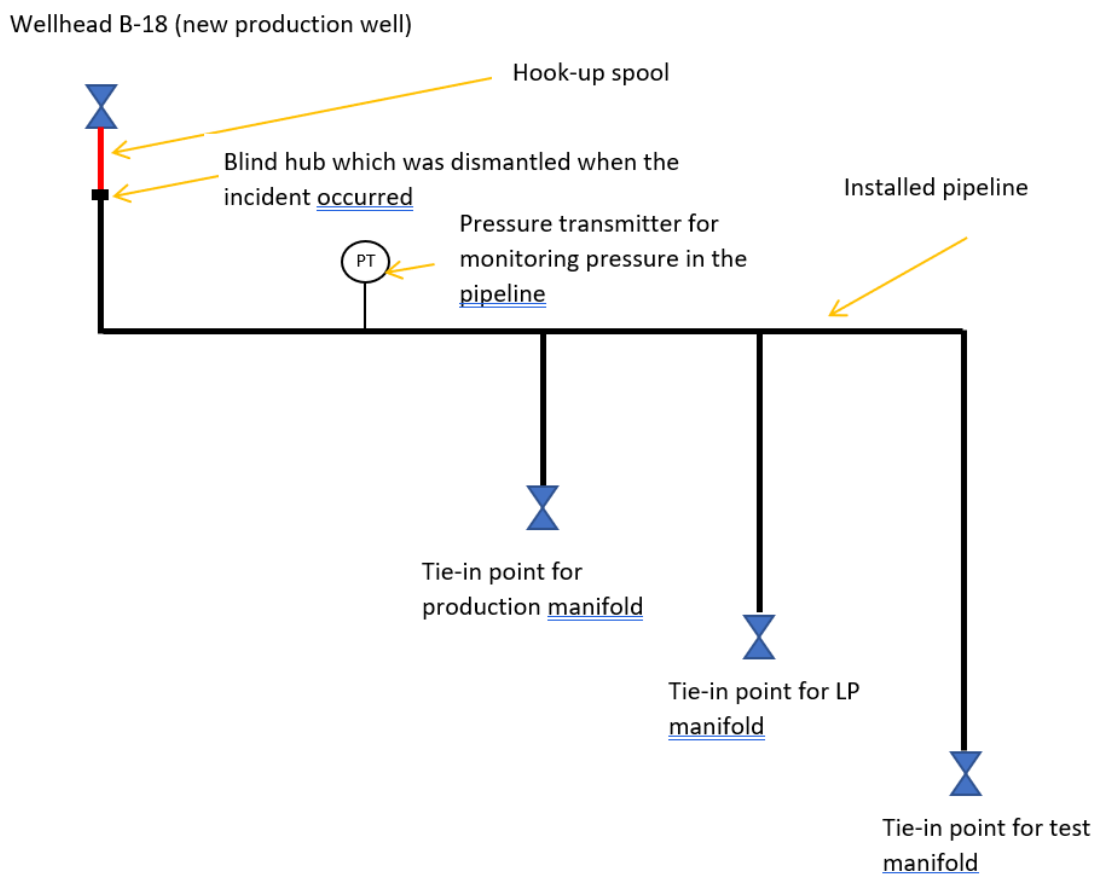
Figure 5 Scope of installation work related to a new production line from the new B-18 wellhead/Xmas tree to the manifolds. The diagram shows the blind hub to be split and the hook-up spool to be installed on the incident day.

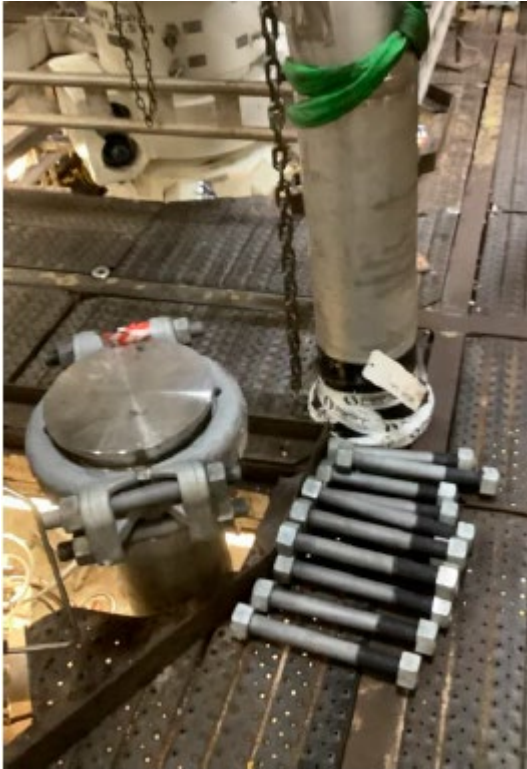
Figure 9 Photograph of the incident site. It was taken before work on splitting the blind hub began on the day of the incident. (Source: Equinor)

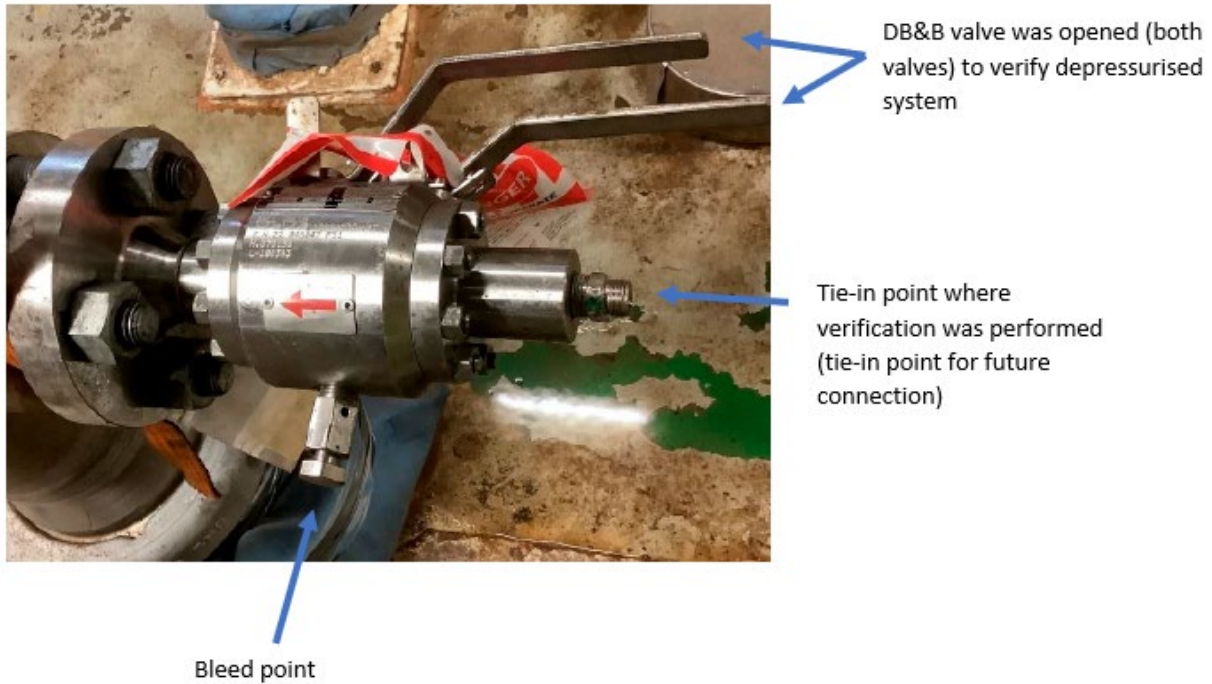
Figure 10 DB&B valve which was opened to verify system depressurisation. (Source: Police)

The isolation plan attached to the WP was not verified in the field.

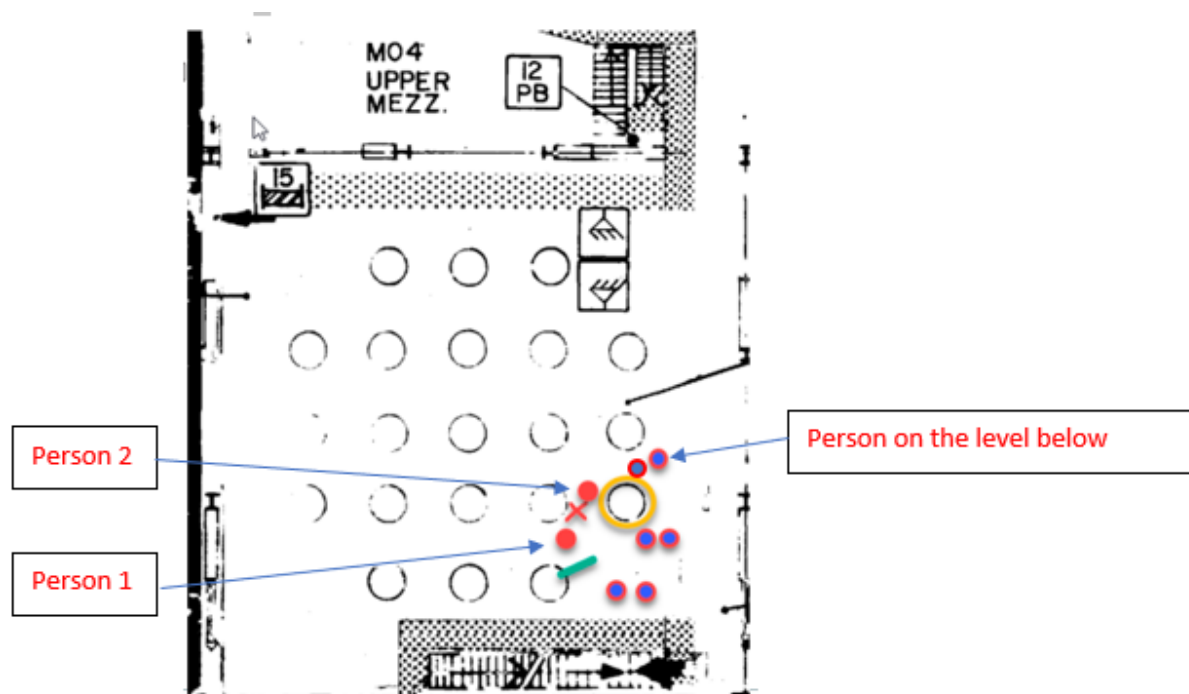
Figure 11 Overview of people in the area where the incident occurred and on the level below. (Source: Equinor)

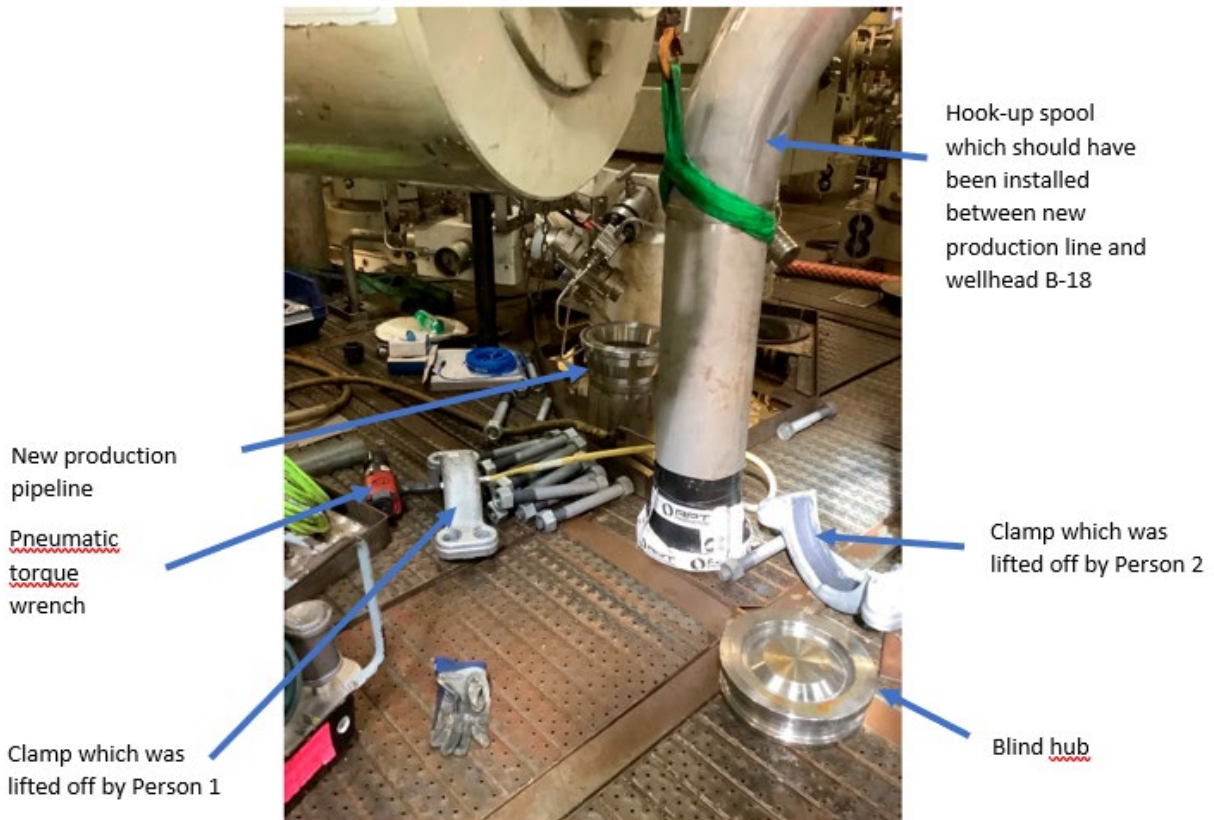
Figure 12 Photo of the workplace after the incident. (Source: Equinor)

The direct cause of the incident was that the hydrocarbon system (production pipeline) was not depressurised when the blind hub was split. Pressure in the production pipeline caused the blind hub to be thrown up by about 1.5 metres and to strike a person on the way down.

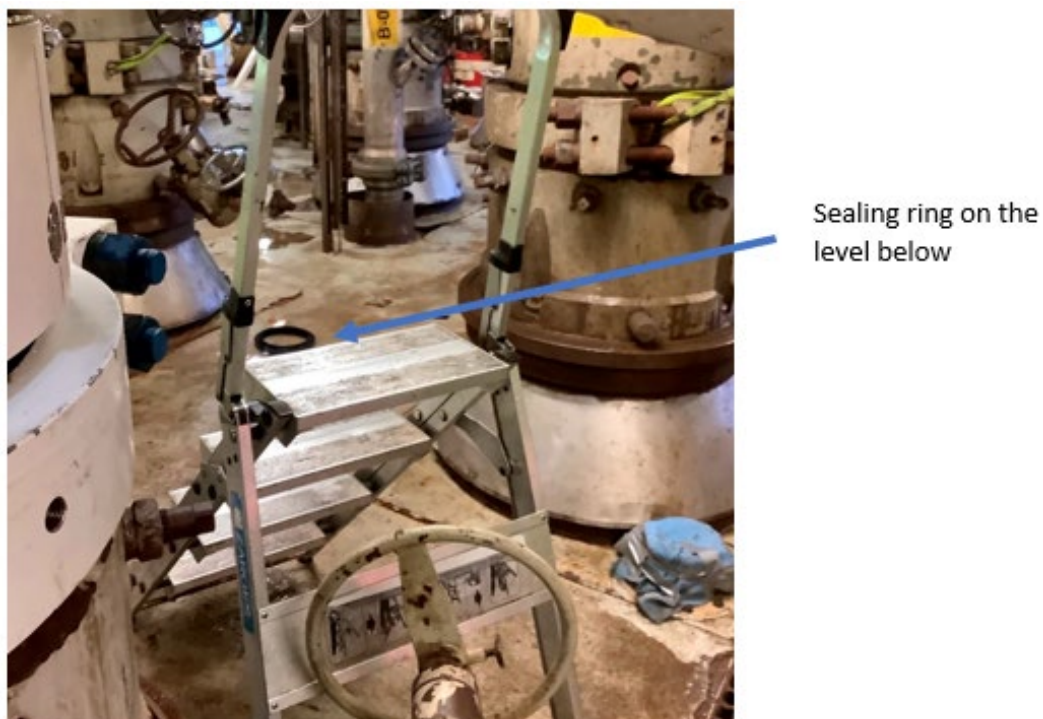
Figure 13 Photo of the sealing ring which hit the person on the deck below the area where the incident occurred. (Source: Equinor)

The 2.15-kg sealing ring hit the arm of another person on the deck below.
