Investigation report

Report title Report from the investigation of the listing of <i>Floatel Superior</i> , 7 November 2012 on the Njord field	Activity number 420001003
---	------------------------------

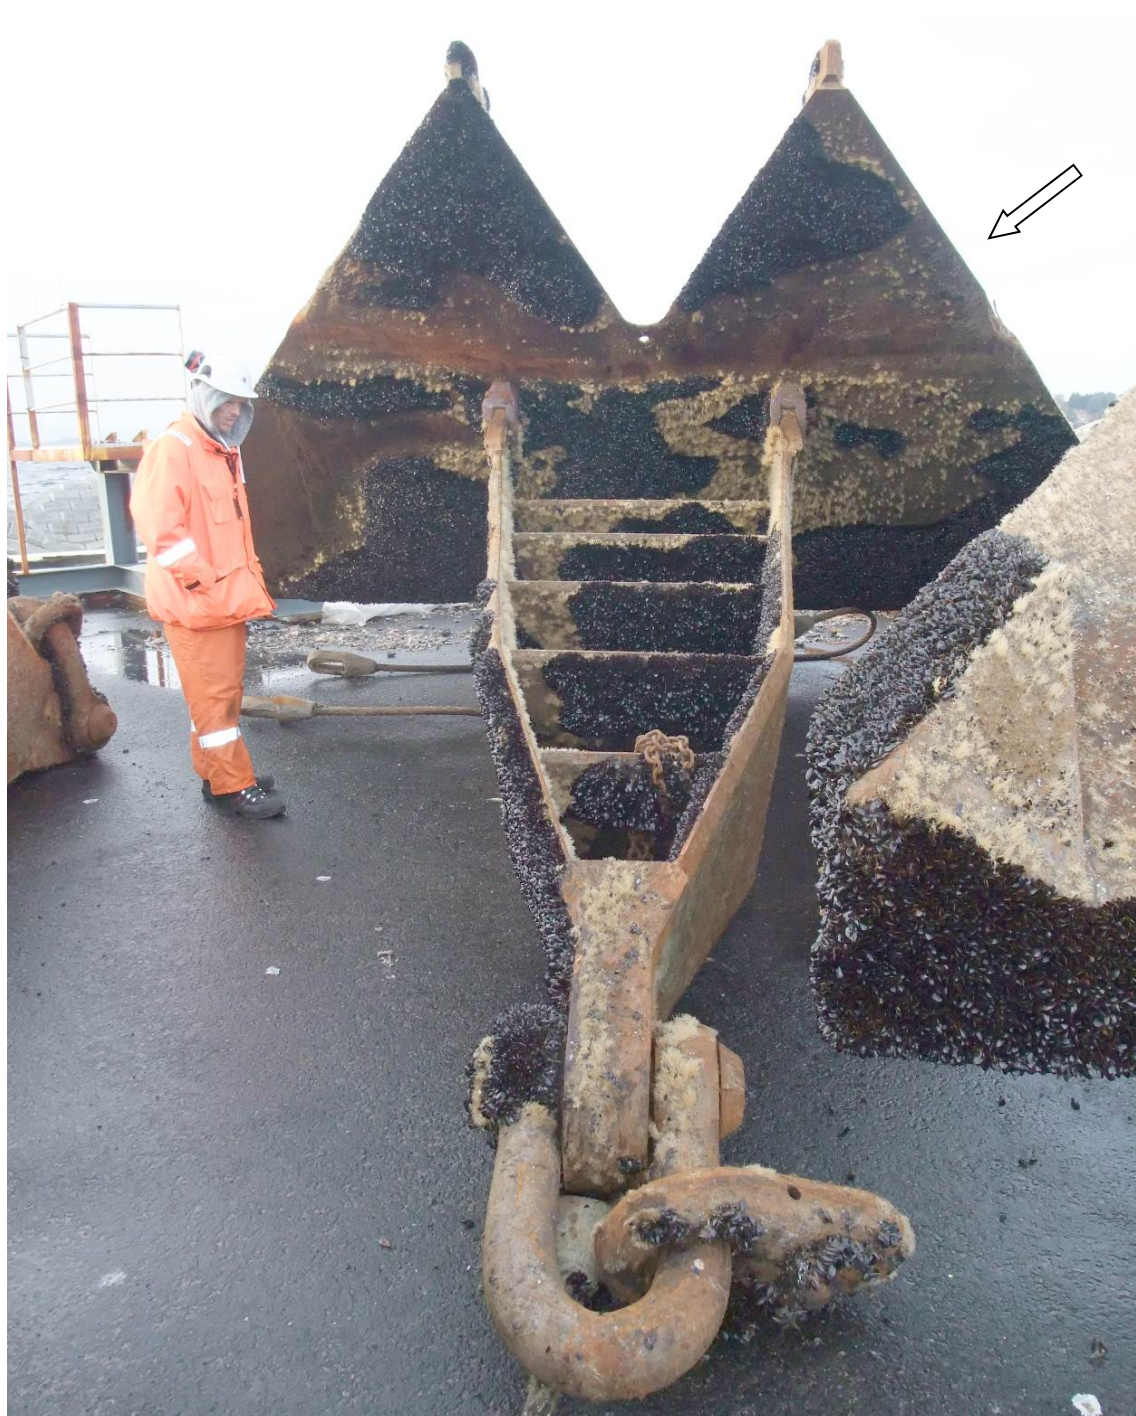
Figure 2: A 12-tonne Bruce anchor from *Floatel Superior*. The photograph shows anchor 1 from the starboard side after removal. The scratch marks where marine fouling (the blue-black colour of the mussels) has been removed show that the anchor has rotated as well as moved from side to side (see the fan shape on the right-hand side of the fluke, arrowed). See also Figure 14, which shows various positions taken by the anchor. The anchor fluke is the large plate topped by two points. The photograph was taken by the PSA on 14 November 2012 in Kristiansund.

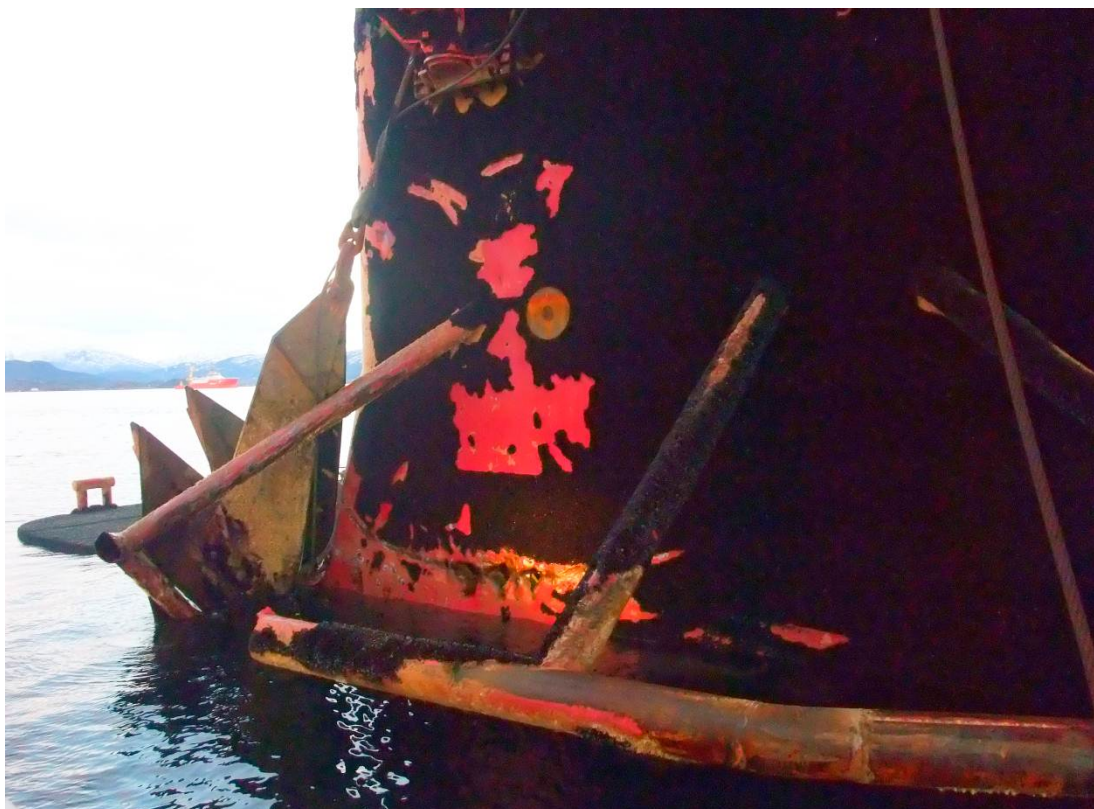
Figure 3: Anchor 8 and the damage above the waterline, here at transit draft. The anchor which caused the damage and the partly destroyed bolster are visible. The photograph was taken by the PSA on 10 November 2012 in Kristiansund.

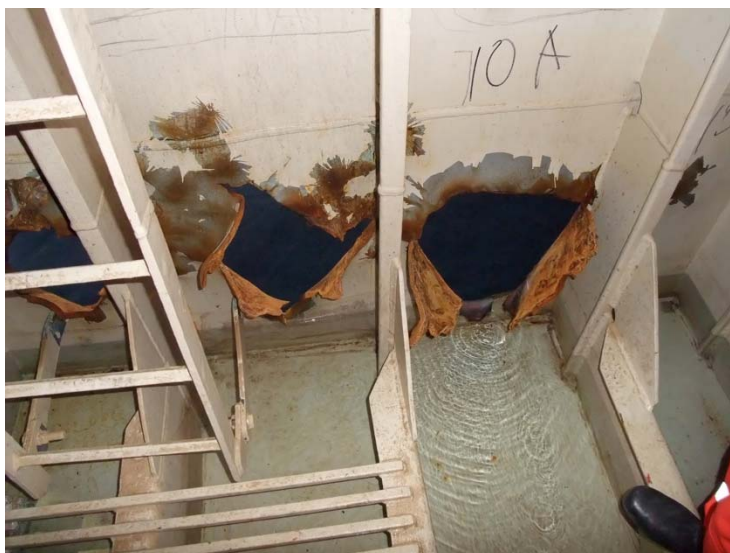
Figure 4: Three of holes in tank 10A viewed from inside. The photograph was taken in Kristiansund during November 2012 by the PSA.

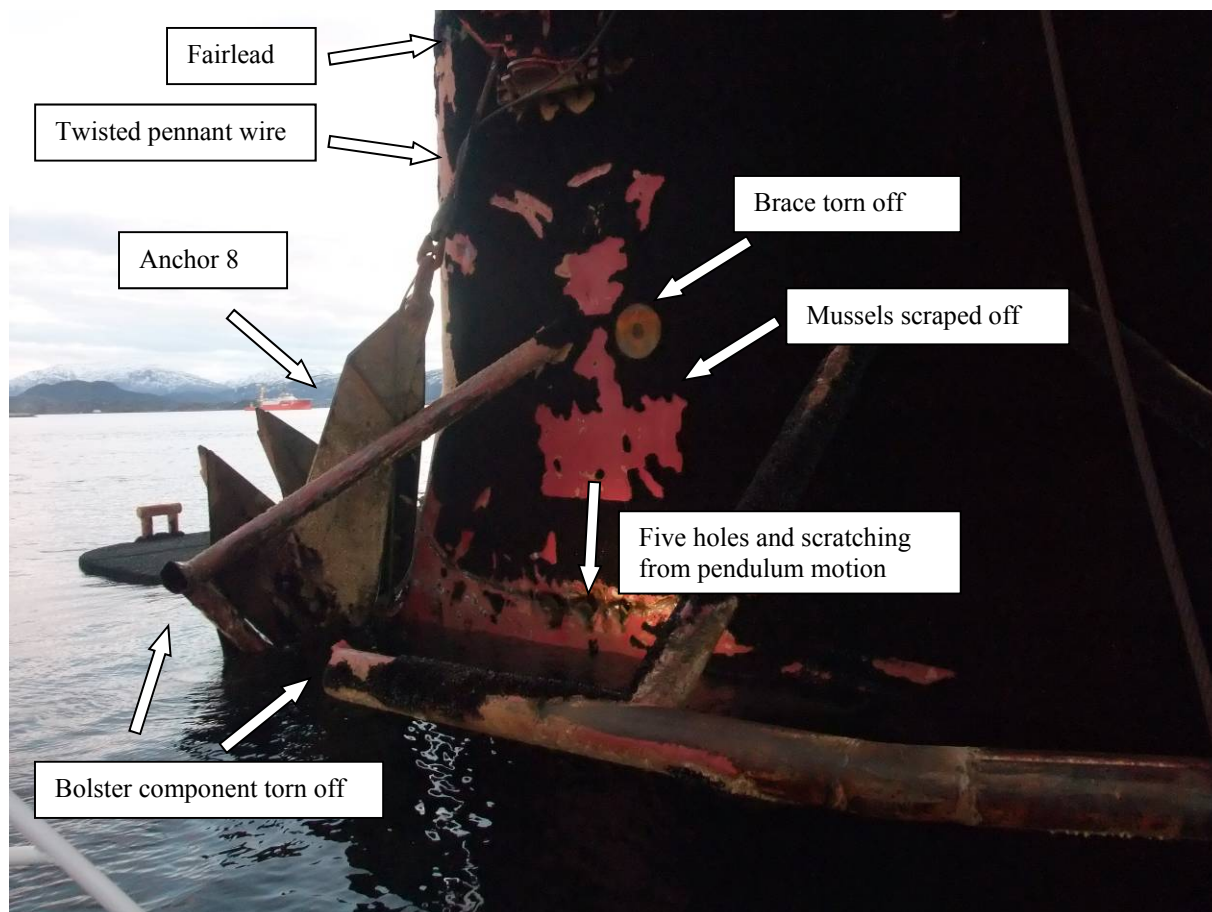
Figure 7: The damage site at anchor 8 after arrival in Kristiansund on 10 November 2012. Anchor 7 has been removed from its place to the right of the picture. Five holes can be seen in the hull just above the waterline (see arrows). The circular mark has been left by the torn-off brace. The black areas are covered with mussels and the hull is painted red. Red areas show where mussels have been peeled off from contact with the anchor and lines. The anchor is rotated, with a twisted pennant wire. The facility is in its transit draft of about 8.5 metres. At survival draft, the mean waterline is at the uppermost fixings of the bolster, to the right at the top of the picture. The photograph has been taken by the PSA.

Crew in the forward port column had heard noises and blows from outside the hull, and continued to investigate what had caused the water intrusion in tank 10. On deck, it was reported at about 03.45 that the railings on the stern side of the operating house for anchor winch 4 had been damaged [1]. From the observation point beside winch 3 (the level below the cabin), the bolster at anchor 8 was seen to be damaged and anchor 8 was not in its usual place (was gone). The sight line from anchor winch 3 to anchor 8 runs along the side of *Floatel Superior*. Anchor 8 was located from the observation point at winch 4 (the level below the operating house for that winch). At that time, the anchor was at rest on the wrong side of the bolster brace, wedged between the forward side of the column, the pontoon deck and the bolster structures²⁰. That location corresponds roughly to what could be observed on arrival in Kristiansund, see Figure 7.

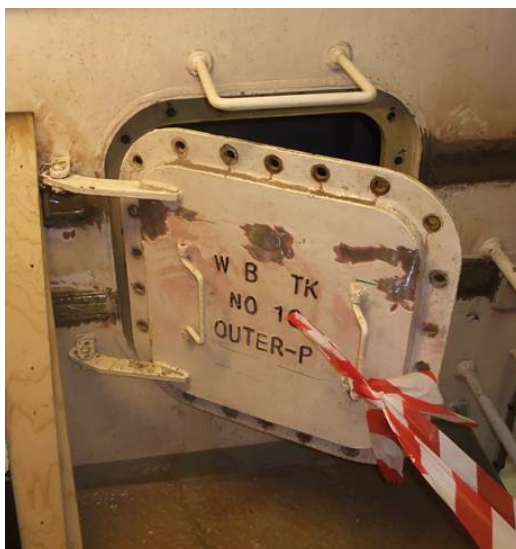
Figure 8: Hatch from the central column to ballast tank WB TK NO 10 OUTER-P. Marks from the reinforcement temporarily welded on during 7 November 2012 are visible where the paint has gone. Seal and bolts are removed. Photograph taken by the PSA in Kristiansund on 12 November 2012

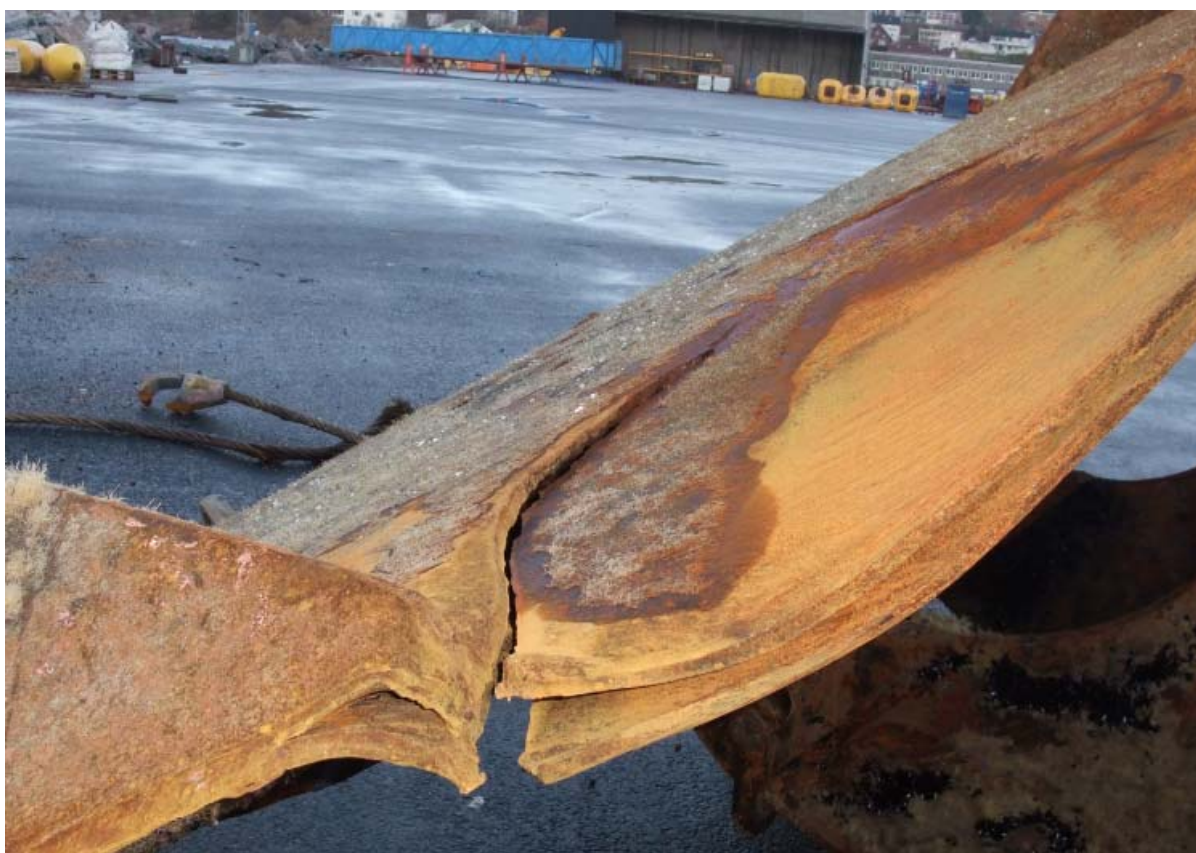
Figure 10: Damage to anchor 8 on *Floatel Superior*, photographed in Kristiansund on 14 November 2012 by the PSA.

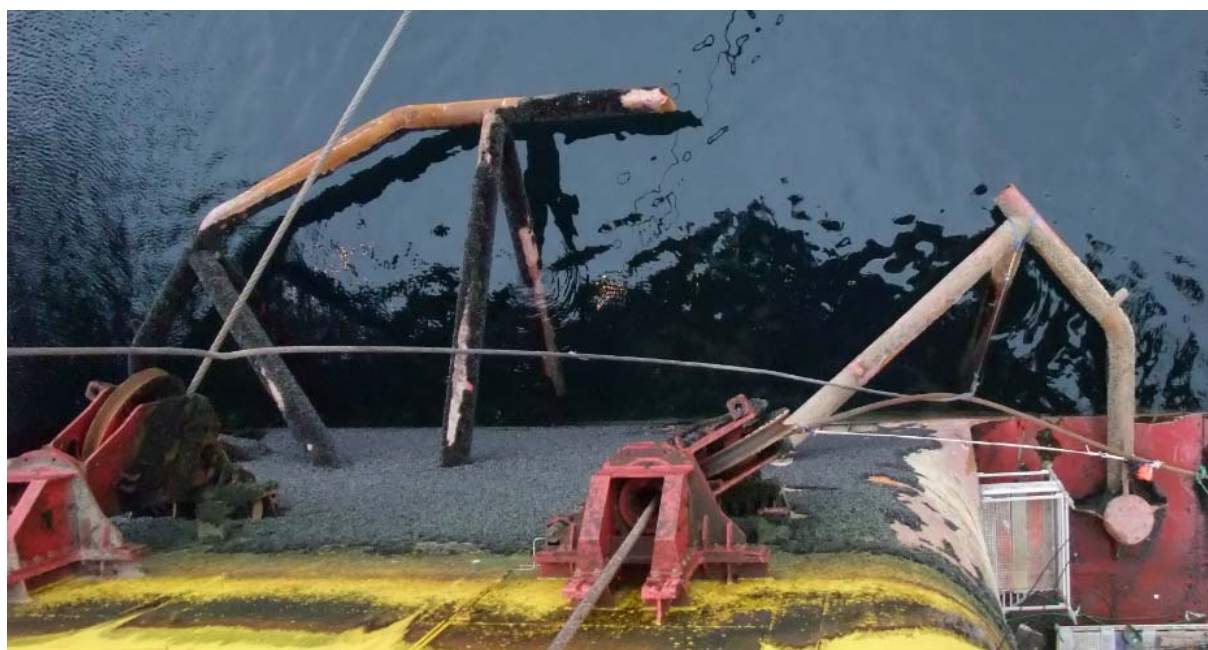
Figure 12: The bolster after the damage. Line 7 is to the left and line 8 on the right. Line 7 has been used here for mooring to land. The line running across the picture is the pennant wire. A comparison with Figure 11 shows which components have fallen off. The photograph was taken in Kristiansund on 13 November 2012 by the PSA.

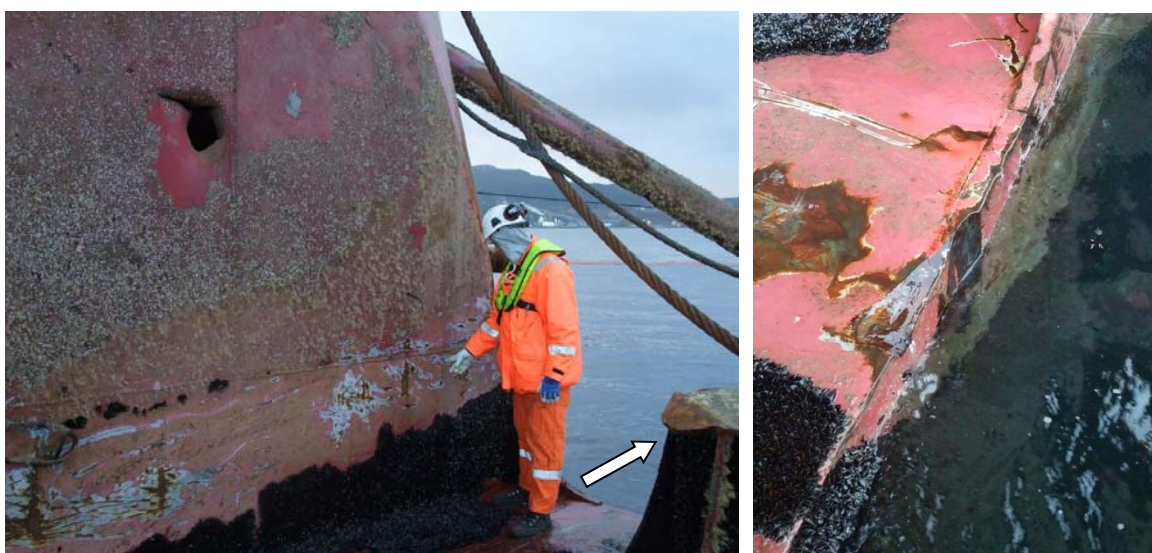
Figure 13: The hull at the front of the column outside tank 10. A simple penetration before the anchor has become wedged between hull and bolster components. Note the bent plate marked with an arrow in the left-hand picture. The picture to the right shows extensive wear on hull plates outside tank 2. The photographs have been taken by the PSA in Kristiansund on 12 November 2012.

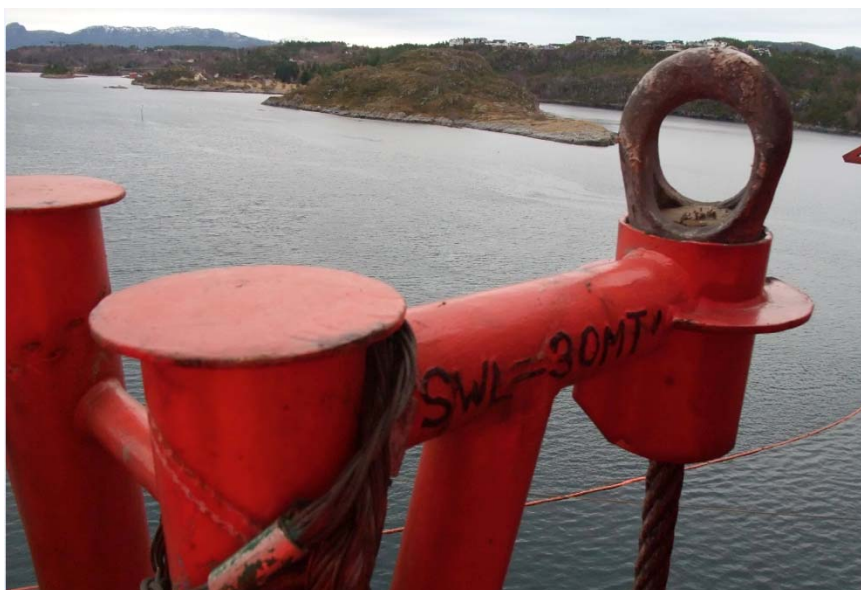
Figure 15: An intact pennant-wire holder on *Floatel Superior*. The wire is freed by lifting the loop away from the hull with a crane. The whole steel structure for wire 8 was ripped off, including holder and railing. The photograph was taken by the PSA in Kristiansund on 13 November 2012.

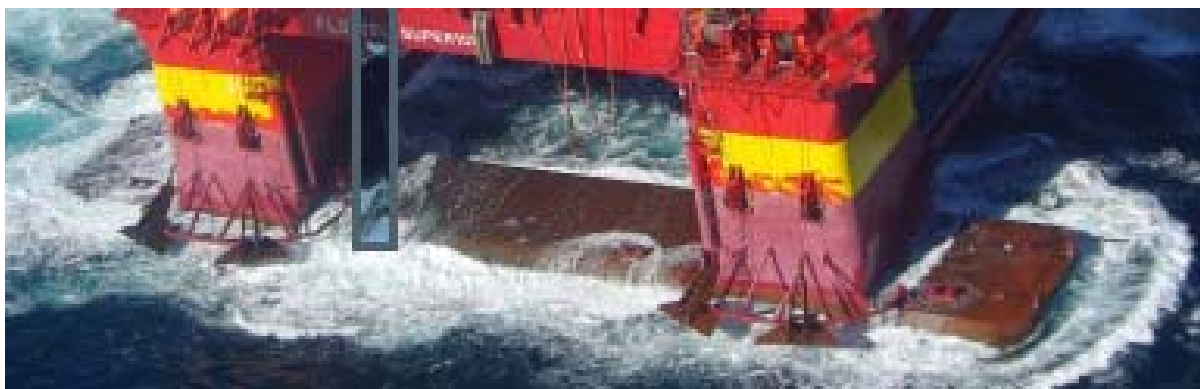
Figure 26: Detail from a photo which shows one anchor (anchor 1 at far right) out of position with its fluke against the lower brace on the bolster while under tow at transit draft on 24 August 2010. Photograph: Floatel International [73].

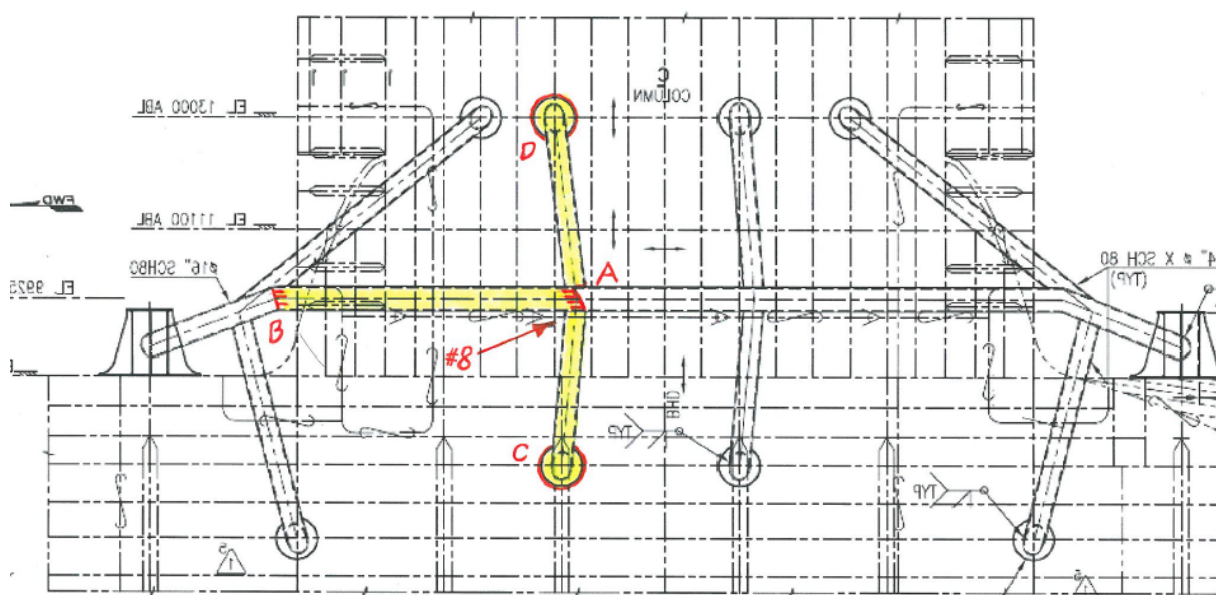
Figure 27: Detail of drawing with the extent of the damage to the bolster at anchor 8 sketched in. Arrow marked #8 indicates the most likely position of the anchor before the damage developed. A, B, C and D show the four fractures in the bolster structure. Yellow indicates which components fell off. From the Keppel FELS design drawing [58] with our notations in yellow and red.

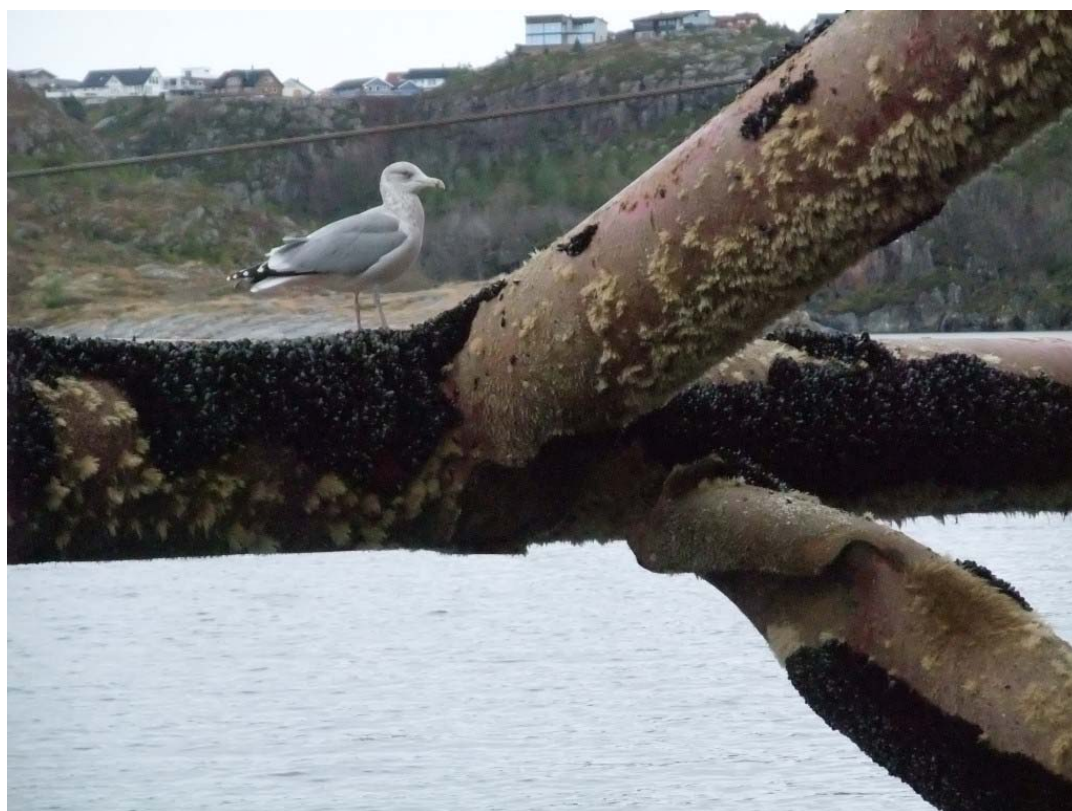
Figure 28: The bolster on the forward port side. Anchor 1 has hit the brace under the bolster bar. Note that the lower brace has been disconnected completely and shifted about one diameter aft (to the right in the photo), and is thereby attached only at a point on the side of tank 3A starboard. The damage is not the outcome of a sudden fracture, but has big deformations from action over a long time. The bolster at anchor 8 (A in Figure 27) has probably suffered similar damage on the evening of 6 November 2012 (all the anchors have damaged bolsters). The photograph was taken in Kristiansund on 13 November 2012 by the PSA.

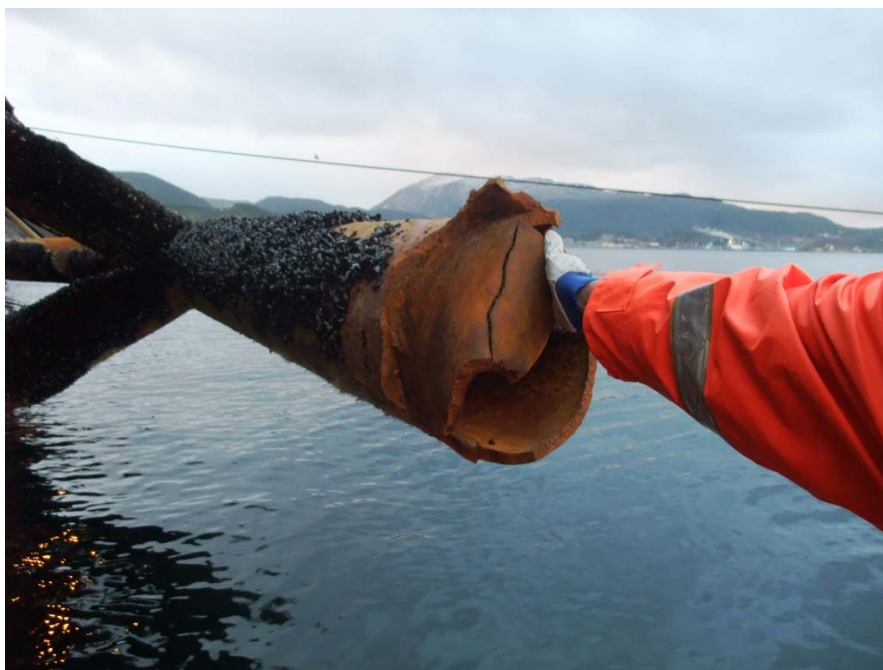
Figure 29: Bolster 4 with damage A (see Figure 27). Three components are missing at this point. The first fracture on the incident night is assumed to have occurred here at 23.40 on 6 November, when overload alarms on the anchor winch ceased. Until then, the anchor could have pulled with a load of 70-80 tonnes in the horizontal bolster bar A-B (see Figure 27). The fracture has developed from the earlier damage, which is thought to have occurred in the lower brace (see Figure 28). This fracture caused a reduction in the anchor load, and allowed the anchor to start moving. The bolster bar between A and B may have remained for a time. After about two hours, the anchor has been able to hit the hull. Before that, the bolster has suffered yet another weld fracture at B and the bar – weighing about 1.5 tonnes – has fallen to the seabed. Both braces have been present until 01.40, with the upper probably still attached to point B (where the hand in the photo is holding a component which was bent after 01.40). The photograph was taken in Kristiansund on 12 November 2012 by the PSA.

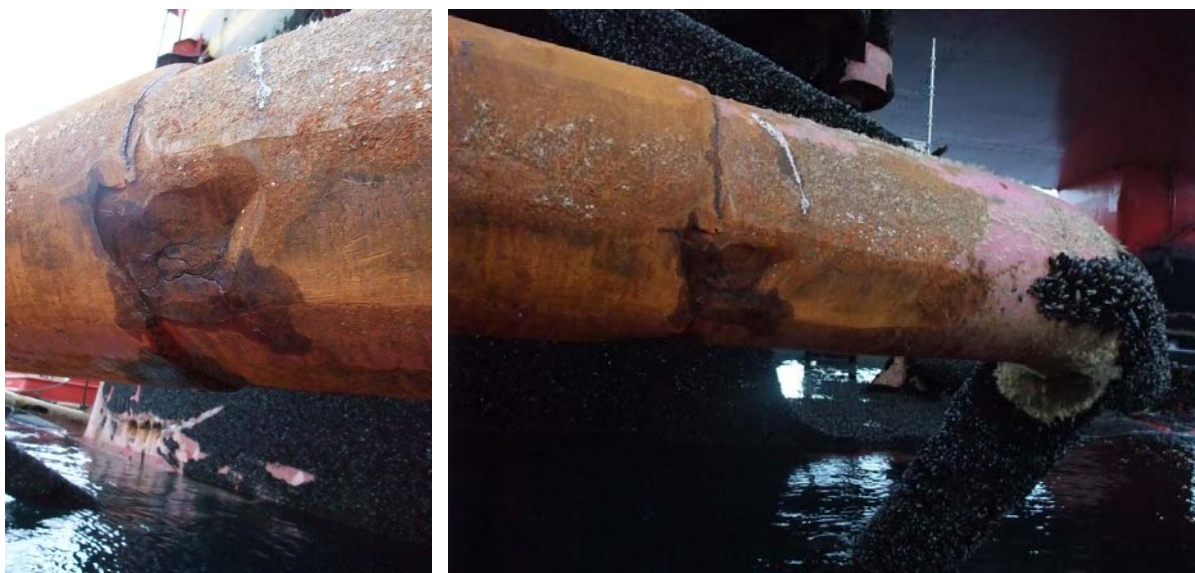
Figure 30: Wear damage where anchor 7 has been wrongly positioned on the bolster (towards the aft of *Floatel Superior*) and worn bolster material and wear surfacing on the edge of the wear surface (left). Note also the surface which has been scraped smooth on the bolster base material to the right. These observations are interpreted to mean that anchor 7 (and other anchors similarly) moved for long periods outside the dedicated position on the bolster's wear surface. In addition, the local wear on the edge of the wear surface is interpreted to show that the anchor has been "locked" in this position and that a high contact pressure has led to extensive local wear. With movements of the anchor from the centre of the wear surface, the geometry of the bolsters causes the wire rope to elongate. This design is intended to

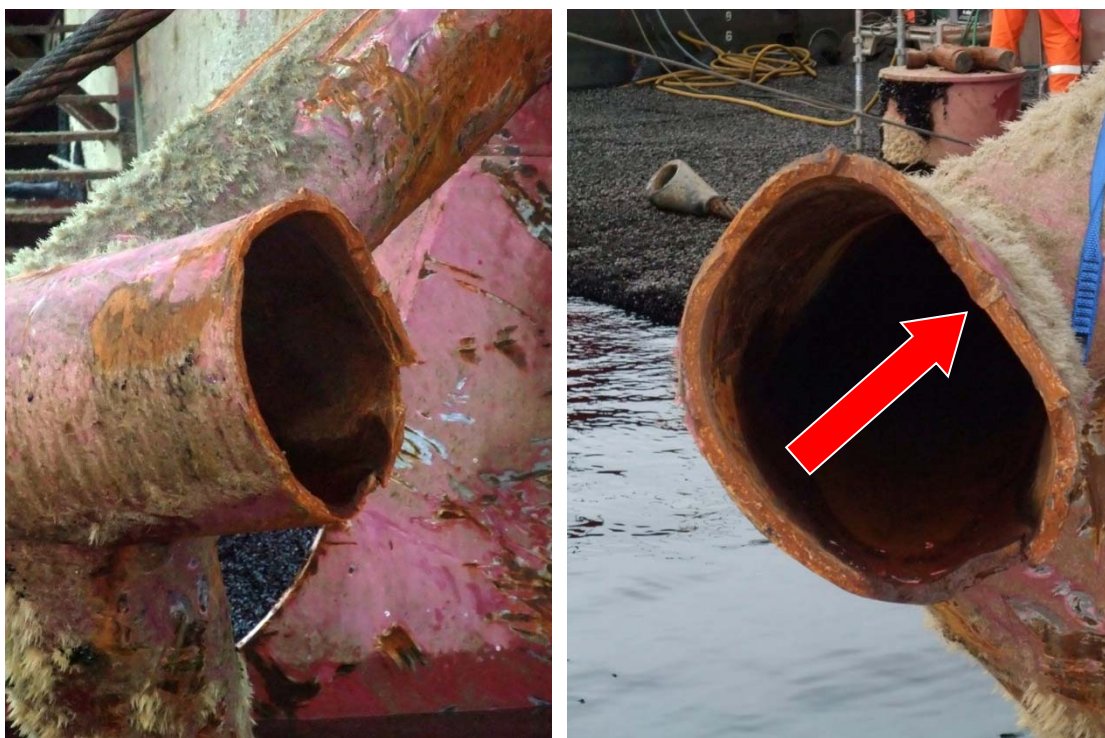
Figure 31: Fracture surface B on the bolster, see Figure 27. The fracture has developed from the circumferential weld at the bend in the bolster geometry. Note that the final stage of the fracture could have developed as a tension fracture from the anchor tension (along the arrow), and the cross section has been deformed to a straight section before this component was torn off and the A-B bolster section fell off shortly before 01.40. The photographs were taken in Kristiansund on 12 November 2012 by the PSA.

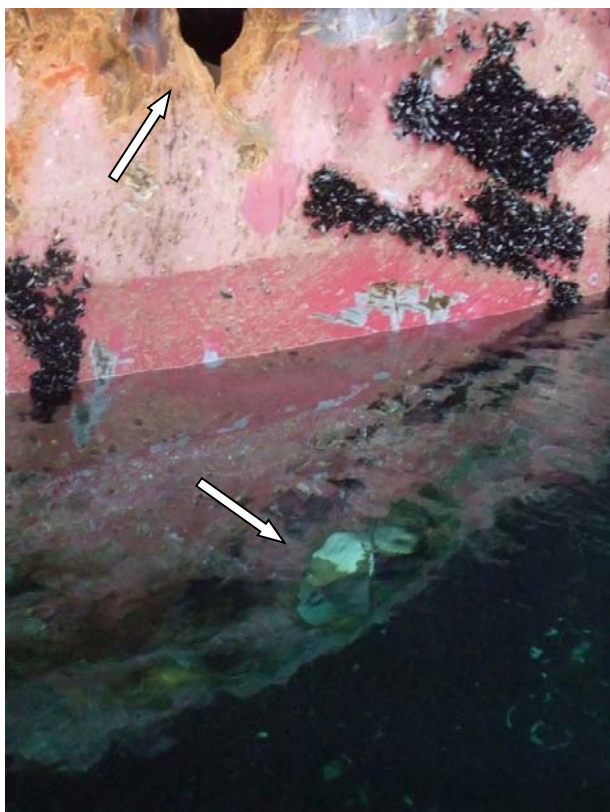
Figure 32: Hole beneath the waterline at bolster damage C (see Figure 27), where the doubling plate has been ripped off, leaving a hole in the hull's outer plating. Note the bottom edge of the anchor penetration at the top of the photo, and the waterline with transit level in the middle. The photograph was taken in Kristiansund on 12 November 2012 by the PSA.

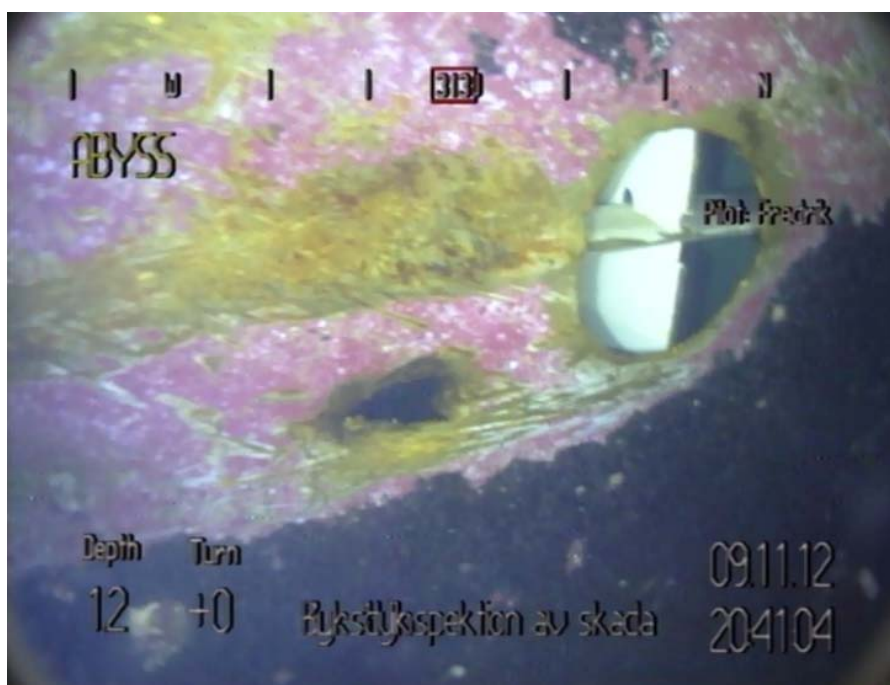
Figure 33: The two holes through the hull into tank 3A. Most clearly visible is the circular hole where the C brace fixing (see Figure 27) has broken off from the hull, with the development of cracks along the weld between doubling plate and hull. Observe that the cross-stiffening with L profiles remains in place on the inside of the hull. The hole diameter is 700 millimetres. To the left can be seen the hole created by the rear part of the fluke of anchor 8 penetrating the hull. The damage is assumed to be the first penetration (about 01.40), and has occurred while the anchor has had its “back” to the brace which was later torn off.

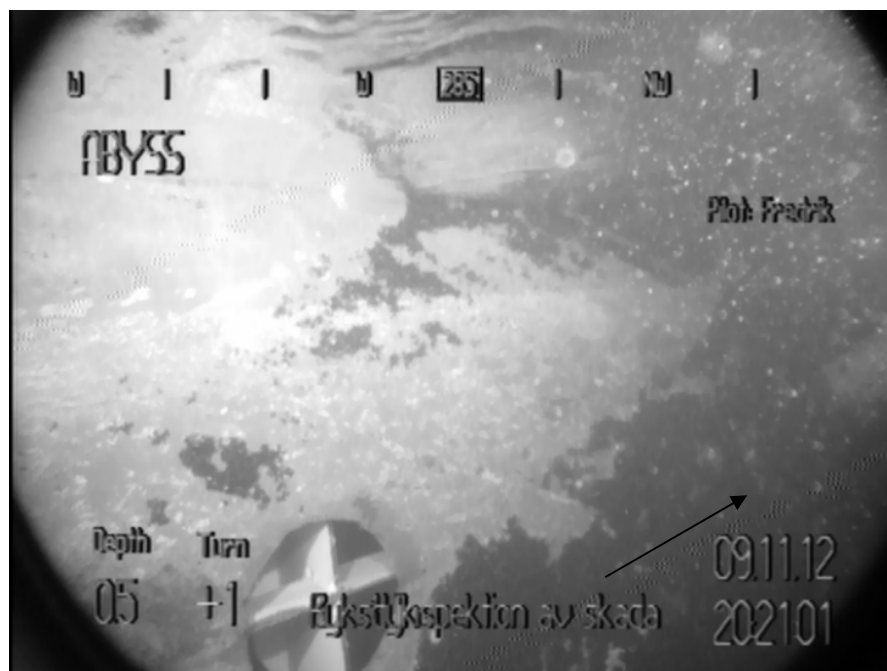
Figure 34: Scrape marks on the hull between anchor positions 8 and 7. Note that the lower brace for the bolster at anchor 7 can be discerned at the far right (see the arrow). The still photograph is from the ROV inspection film taken on 9 November 2012 [148].

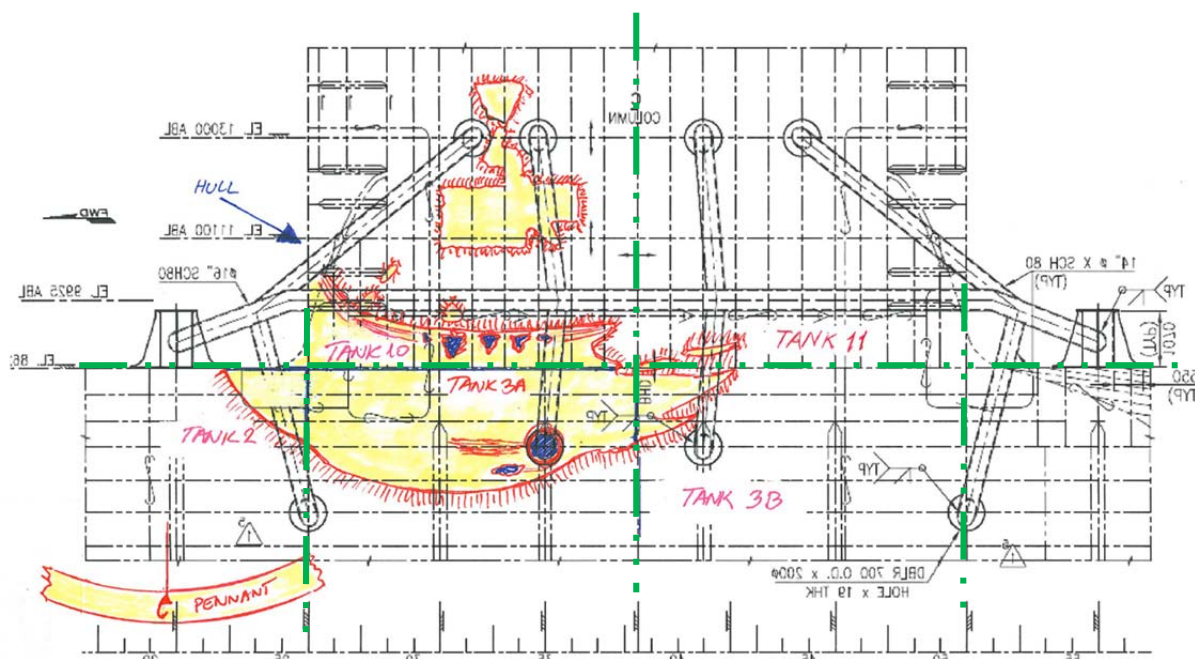
Figure 35: Drawing of part with areas of the hull sketched in where mussels were scraped away by the anchor and the damaged pennant wire holder. These are marked in yellow. Seven of the eight holes in the hull are marked in blue. The eighth was on the front of the column close to the 11 100 millimetre level (see arrow). Note that the drawing has been mirrored from a typical detail design to show the damaged area correctly. Scratch marks are found on the outside of tanks 2, 3A, 3B and 10 and small marks on tank 11. The total ballast weight for these five tanks is 1 500 tonnes. The boundaries between the tanks are shown by dotted green lines. Keppel FELS design drawing [58] with our markings in red, blue, yellow and green.

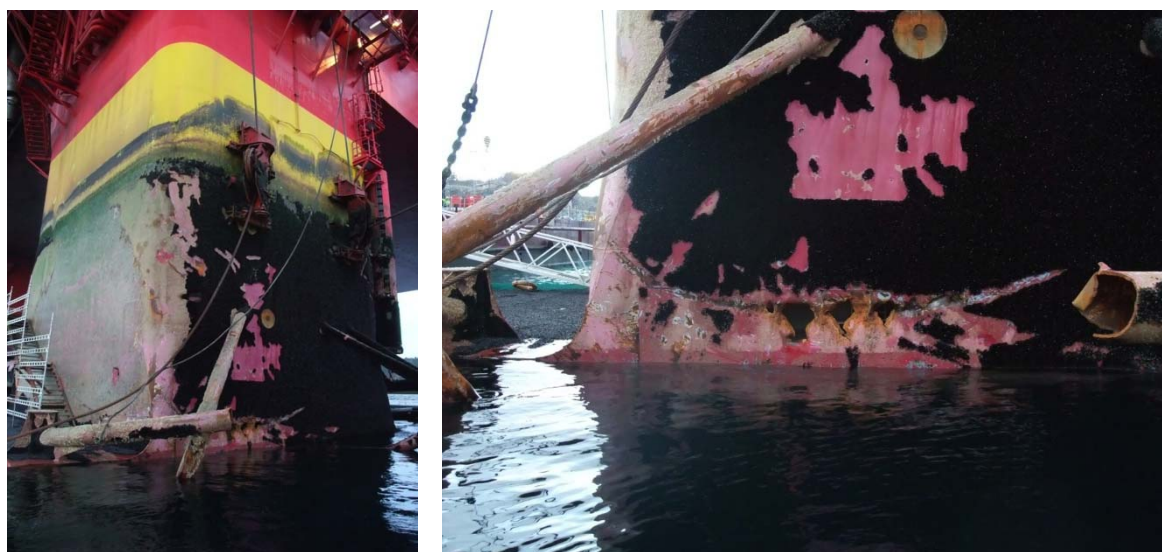
Figure 36: Damage above transit draft, with five holes in the hull side and one on the front of the column. All six were caused by penetration from the anchor fluke's points. Note that the areas where the anchor and the wire rope have moved are clearly delineated (red areas) by scraping away mussels (black area). The photographs were taken in Kristiansund on 12 November 2012 by the PSA.

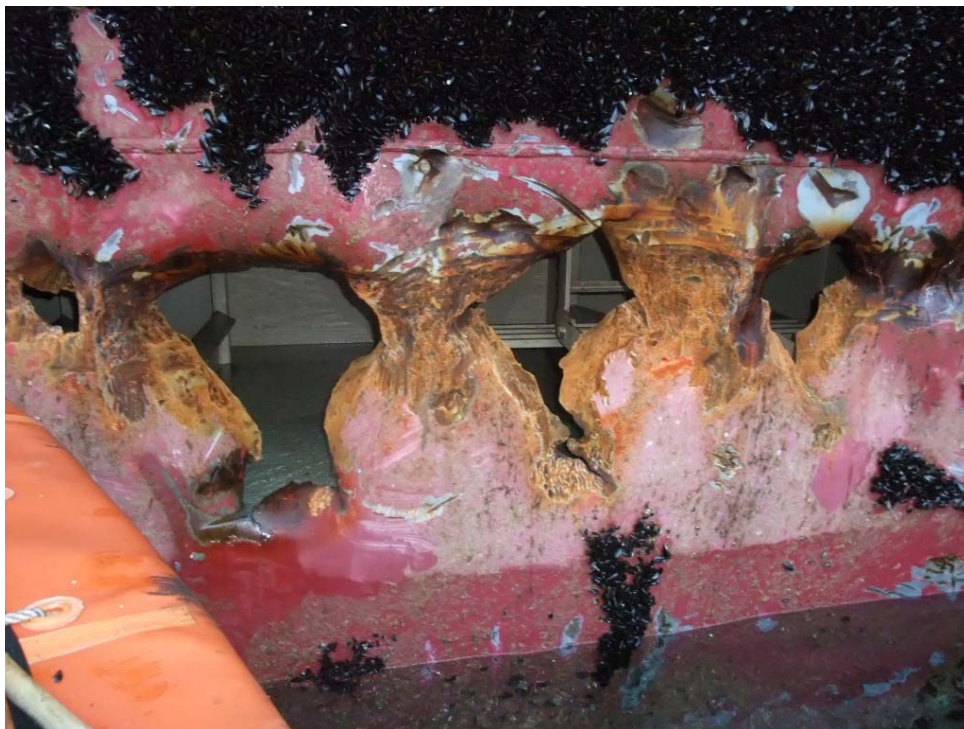
Figure 37: Five holes through the hull into tank 10. Note the clear marks from repeated blows. The hull between the holes is stiffened on the inside of the tank, and these stiffeners (about 0.6 metres apart) have absorbed the anchor's blows and prevented deeper intrusion to the tank's inner bulkhead (1.5 metres in). The photograph was taken in Kristiansund on 12 November 2012 by the PSA..

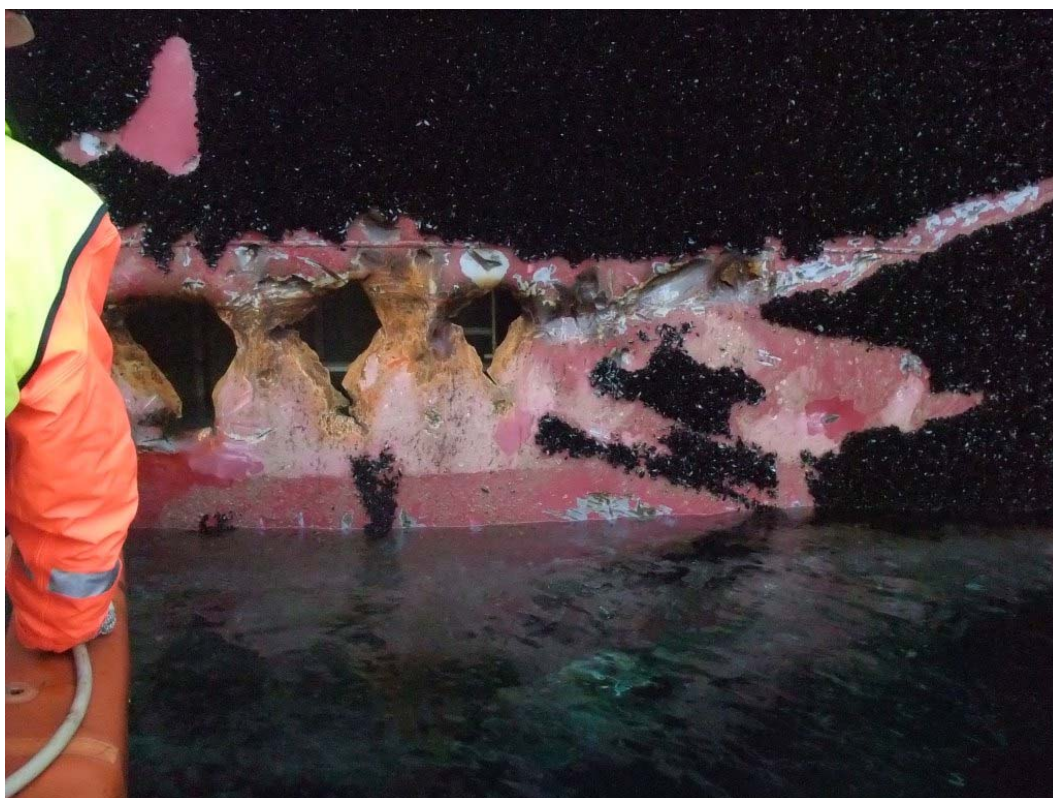
Figure 38: The holes and remaining mussel growth (black). The slanted scratches caused by the flukes towards the upper right provide clear signs of the anchor's pendulum motion. The photograph was taken in Kristiansund on 12 November 2012 by the PSA.

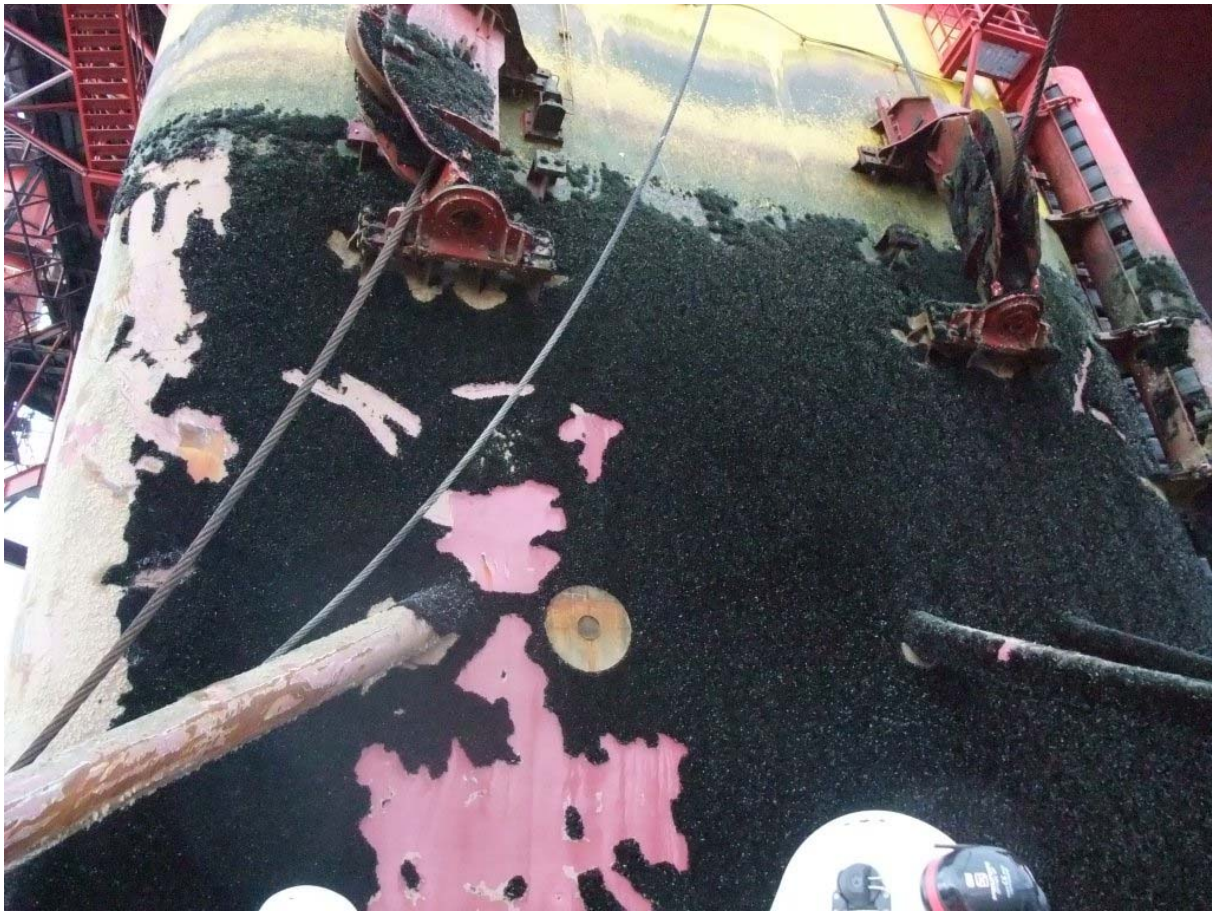
Figure 39: Bolster damage D, see Figure 27. The circular mark in the centre of the picture is where the brace was torn off with the doubling plate welded to the skin of the facility. Note that the doubling plate has been welded both around its exterior and in an inner ring (the plate was doughnut-shaped). The fracture has clearly propagated along the welds, and no noticeable bulging or plastic deformation has occurred on the hull plate, which indicates that this was not a ductile fracture. The internal stiffener cross can be observed, probably because welding heat during fabrication has penetrated the plate. Crack propagation in the doubling plate's weld to the hull rather than in the weld to the brace shows that the plate did not perform its intended role as a structural weak link. The mussels have not been scraped away around the doubling plate after it was ripped off, which is interpreted to mean that the anchor moved forward on the bolster at the same time, or possibly before. See also the scrape marks on the brace to the left of the photo. The photograph was taken in Kristiansund on 12 November 2012 by the PSA.

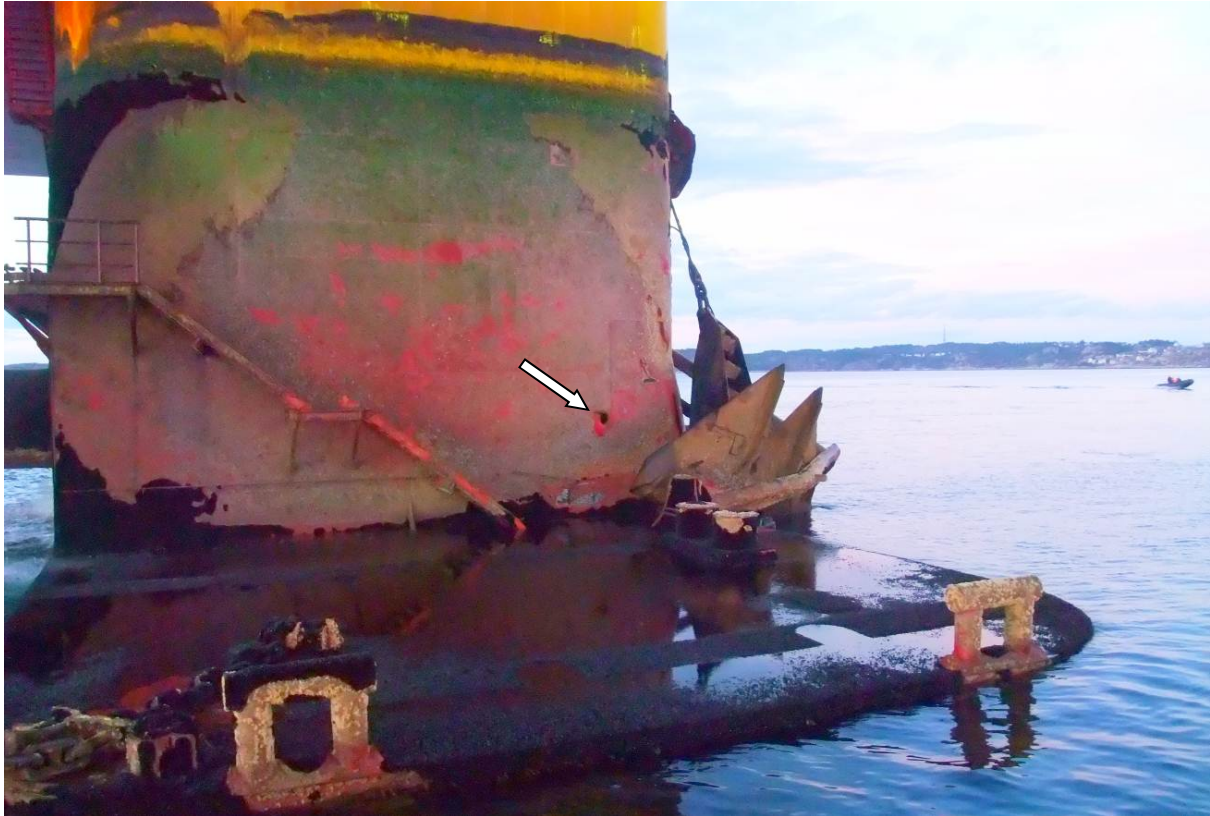
Figure 40: The forward port column on arrival in Kristiansund on 10 November 2012. Anchor 8 is wedged in the bolster and the hole into tank 10 (arrowed) is clearly visible. Some scrape marks at the bottom of the column show that the anchor has moved in the area. The pennant wire twined around the anchor line (above the anchor) shows that the anchor has rotated. The photograph was taken by the PSA.

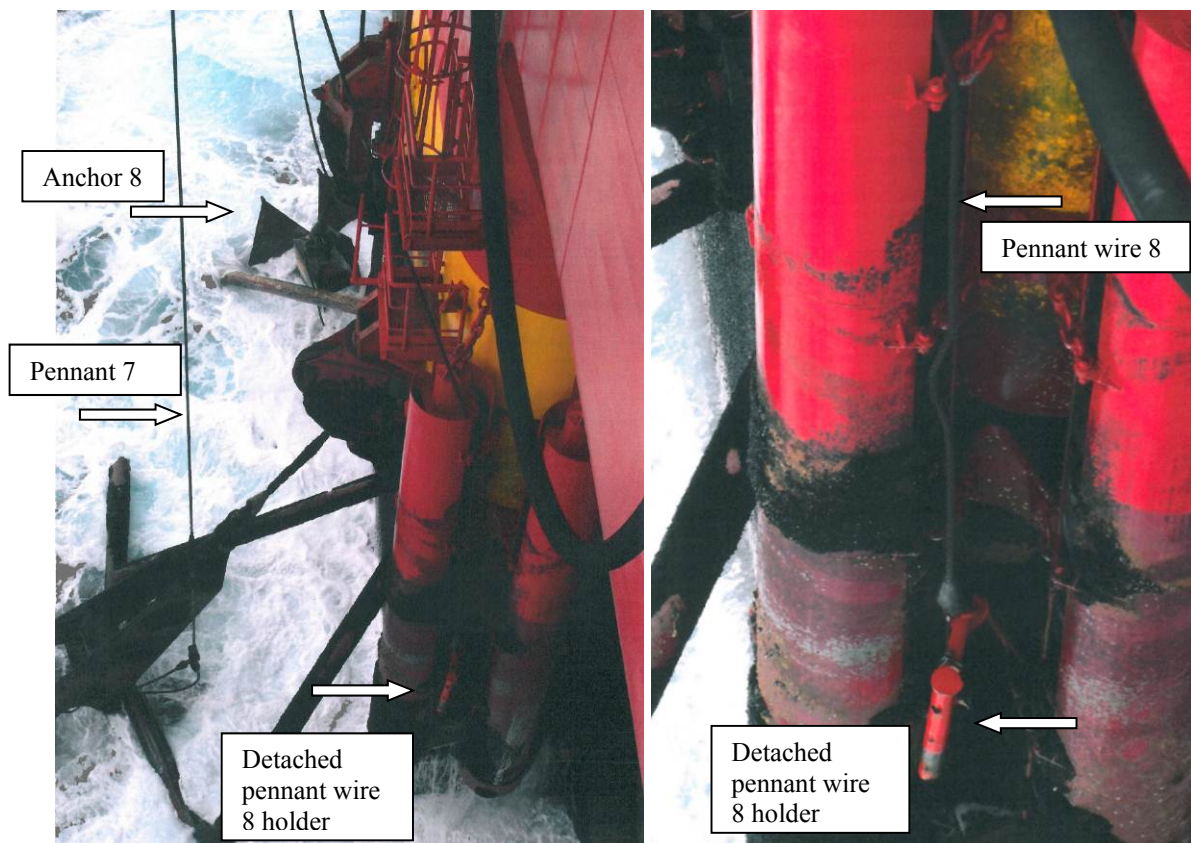
Figure 41: The pennant wire holder for anchor 8 after it had been torn free and damaged the railings and operating house. The overview photo on the left shows that the pennant wire must have become caught up in the railings or something else on a level with the anchor winch and drums (see Figure 42, where the positions are marked). The pennant wire hangs from a position above the top of the photo and down to the anchor, and also down to the damaged holder. The wire has apparently become wedged in the bumper¹¹⁴, and the terminal cable eye has come out of the holder. It appears to hang usually with a security lashing, which the crew reported was normal in order to secure the end of the pennant wire. The photograph was taken by Floatel International personnel on board during the incident day on 7 November.
