Investigation report

Report title Report from the investigation of the listing of <i>Floatel Superior</i> , 7 November 2012 on the Njord field	Activity number 420001003
---	------------------------------

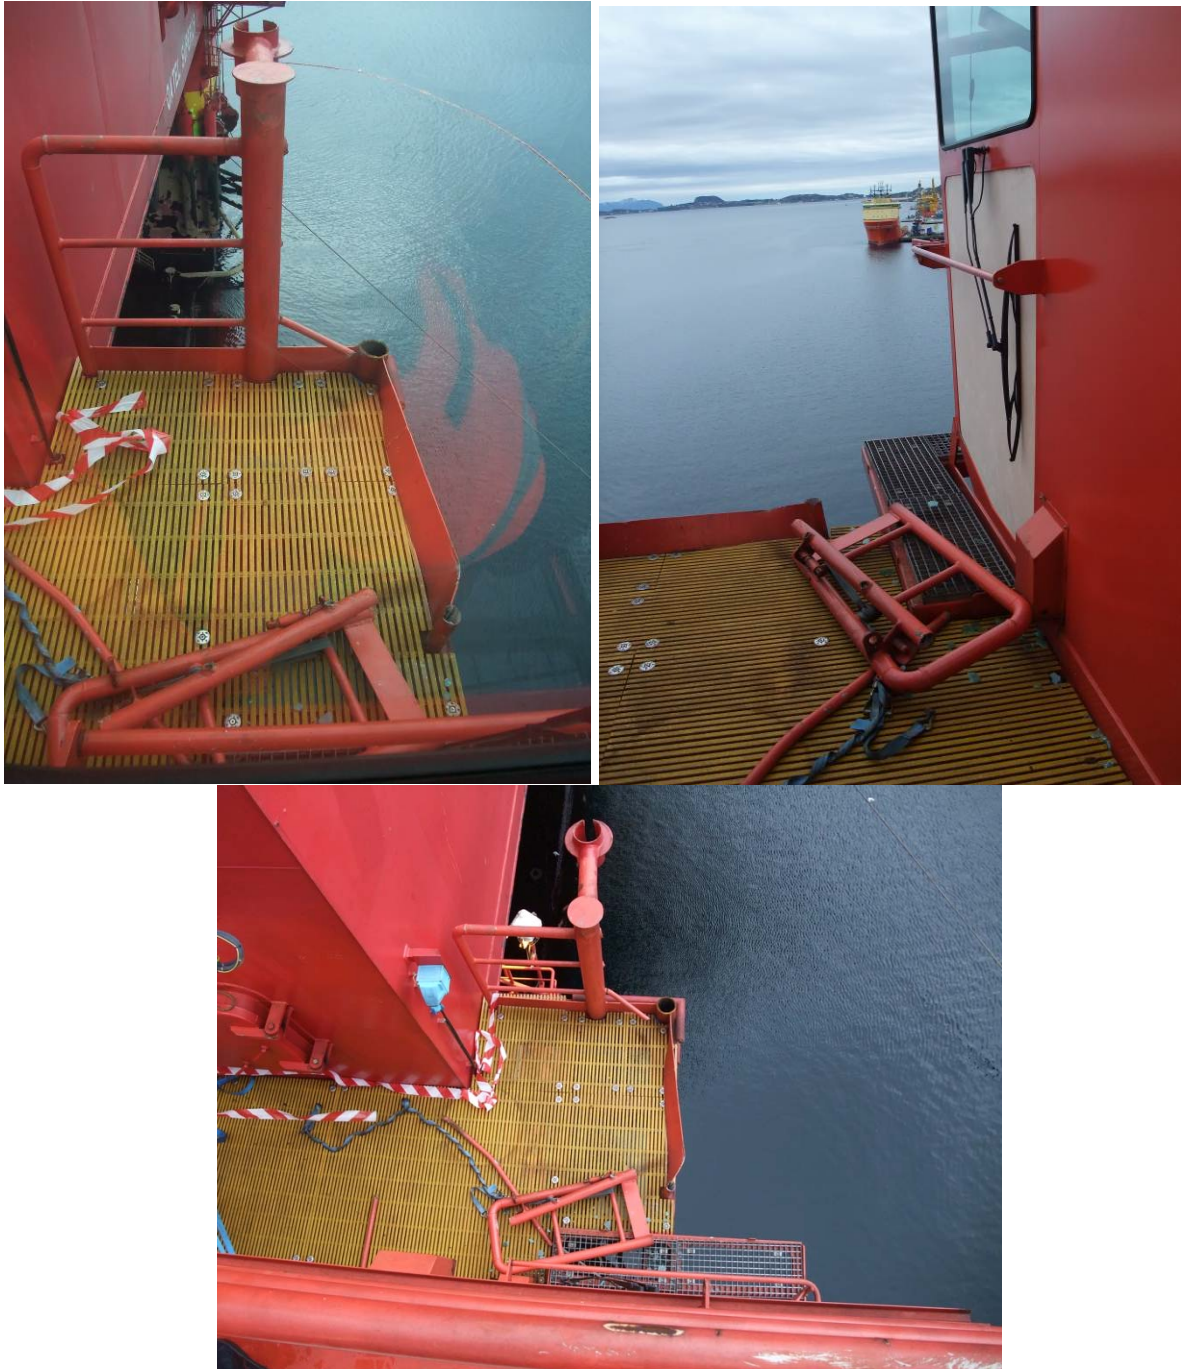
Figure 43: The area by the operating house where the pennant wire destroyed its holder, the railings and the operating house window. The damaged window is covered here with a wooden sheet. The holder for pennant wire 7 remains. The photographs were taken in Kristiansund in November 2012 by the PSA.

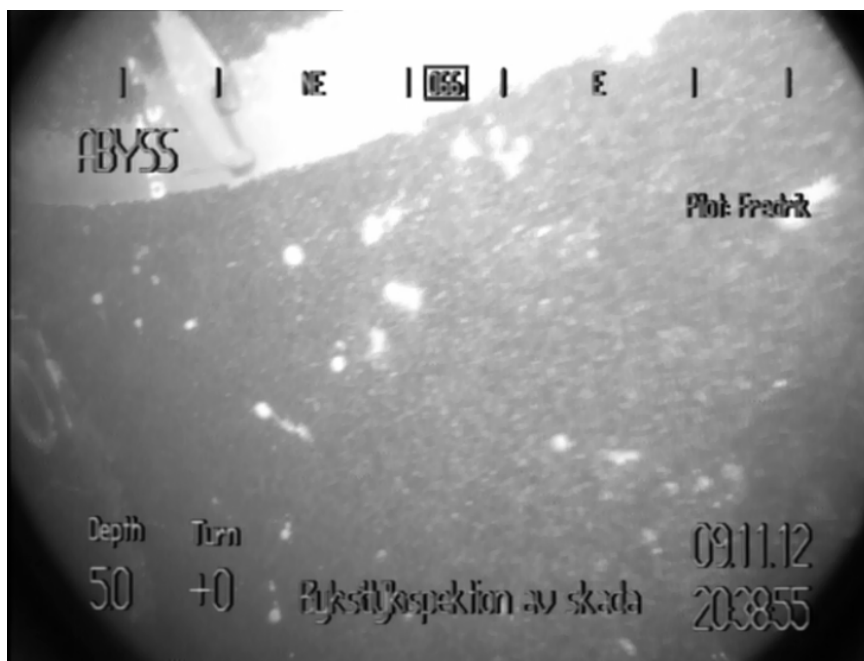
Figure 44: Still from the ROV inspection film of 9 November 2012 [148]. The damaged part of the cock's foot for attaching the pennant wire to anchor 8 can be seen at the top. The cock's foot hung down from anchor 8 after the incident. The cable eye is broken, probably because of a blow or a skewed or twisted load rather than wire tension. See location in Figure 27.

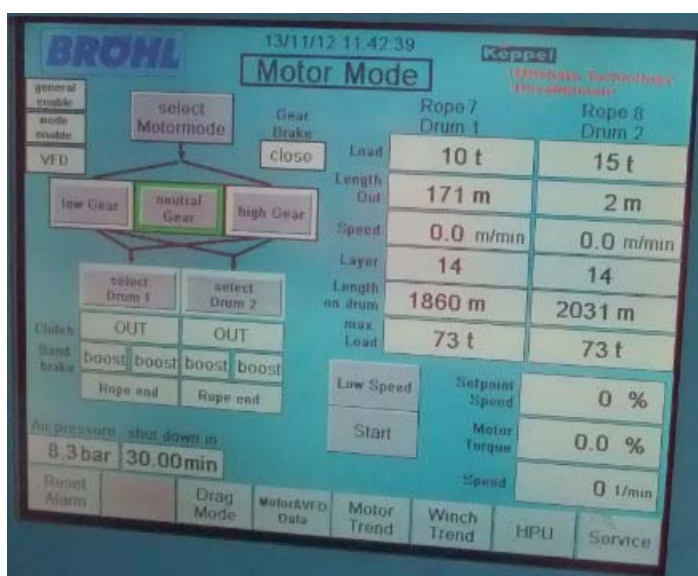
Figure 45: The control panel showing line tension on winch 4. Line 8 had 15 tonnes of tension after the anchor was taken off, which shows that the tension was erroneous. Line 7 was moored to land when the photograph was taken by the PSA in Kristiansund on 13 November 2012.

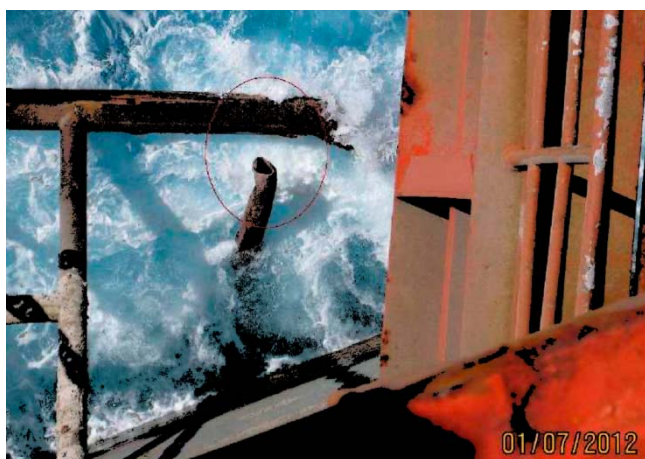
Figure 46: Brace cut off on the bolster on *West Hercules* 1 July 2012. Photograph: Seadrill [128].
