Investigation report

Report	
Report title Investigation of a fire in high-voltage transformer 13ET006 on Åsgard B	Activity number 001094045
Security grading	
<input checked="" type="checkbox"/> Public	<input type="checkbox"/> Restricted
<input type="checkbox"/> Not publicly available	<input type="checkbox"/> Confidential
<input type="checkbox"/> Strictly confidential	
Involved	
Team T-1	Approved by/date Kjell M Auflem/12 May 2023
Members of the investigation team [REDACTED]	Investigation leader [REDACTED]

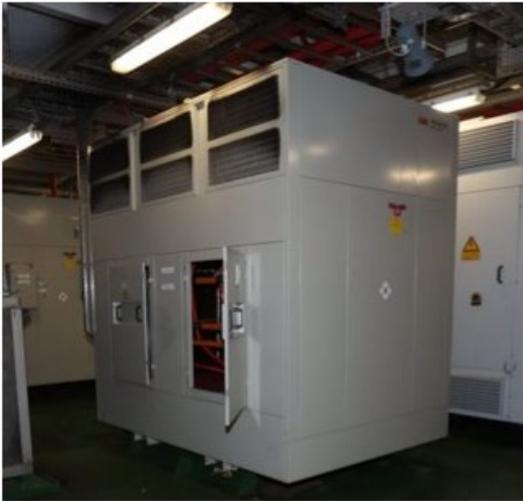
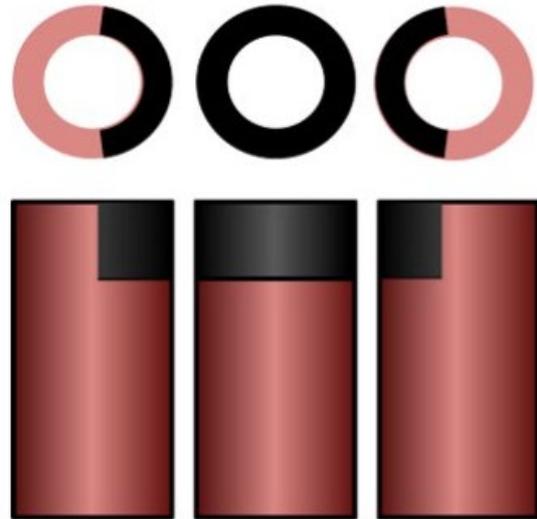
The direct cause of the fire in the transformation is a short circuit/arc flash resulting from impairments to and/or degradation in the winding insulation over time.

Figure 10: Transformer 13ET006 (left) and an illustration (right) which shows that the incident began at the top of middle spool. Sources: Equinor and Sintef

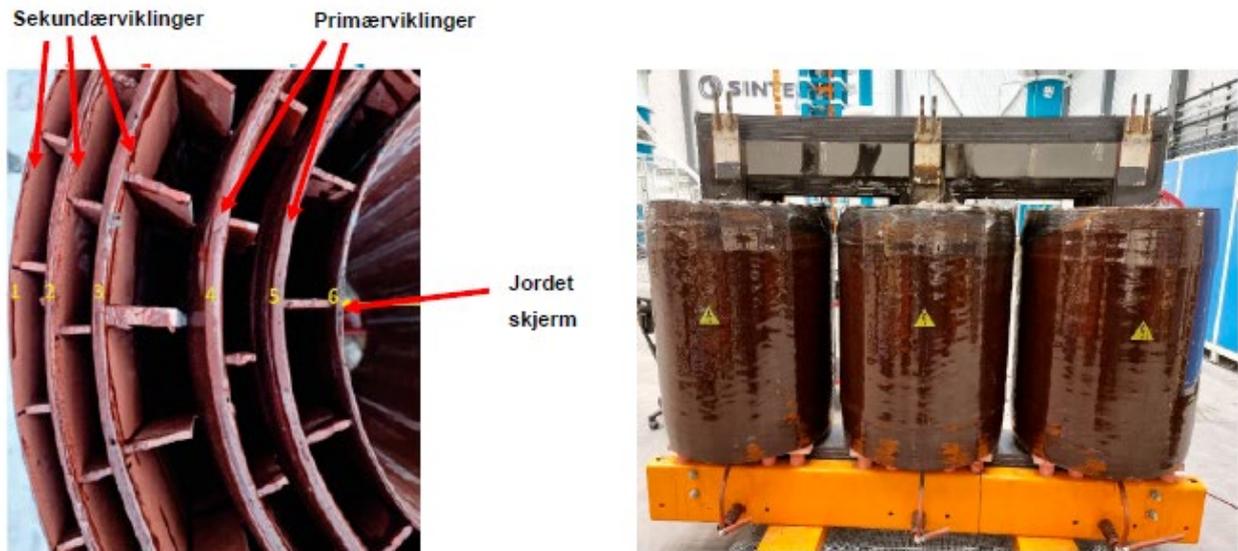
Figure 12: Images of the transformer with windings and core. Source: Sintef
 Key: Secondary windings Primary windings Earthing screen

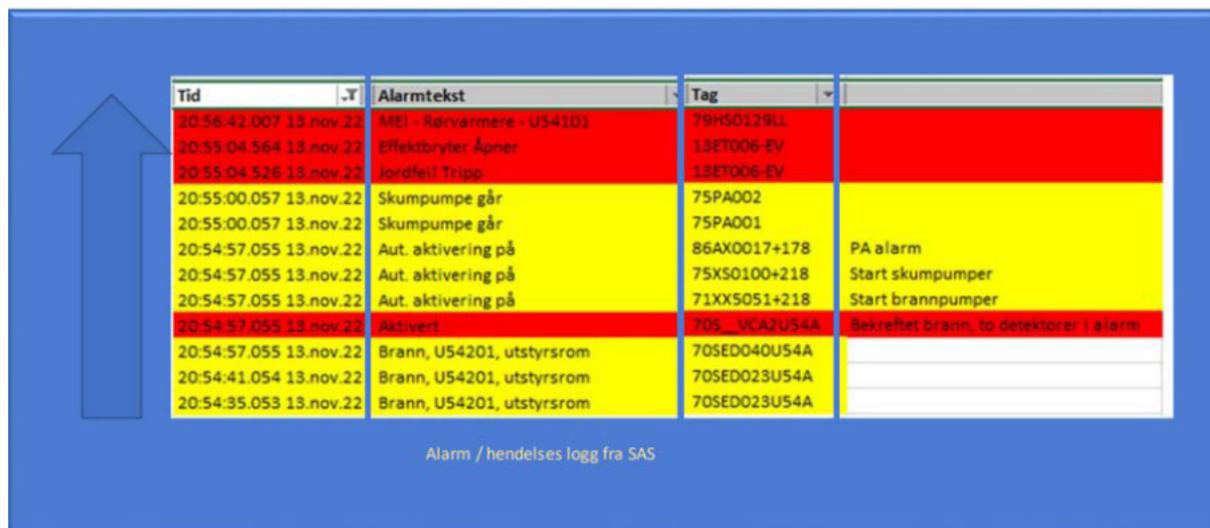
Alarm / hendelses logg fra SAS

At 20.54.34 on Sunday 13 November 2022, the CCR received a pre-alarm from smoke detector 70SED023U54A at level 2 in transformer room U54 on Åsgard B. An alarm was received from the same detector six seconds later. At 20.54.47, an alarm also arrived from neighbouring detector 70SED040U54A. Detector voting 2ooN in alarm gives confirmed fire, automatic start-up of fire pumps and mustering alarm on Åsgard B.

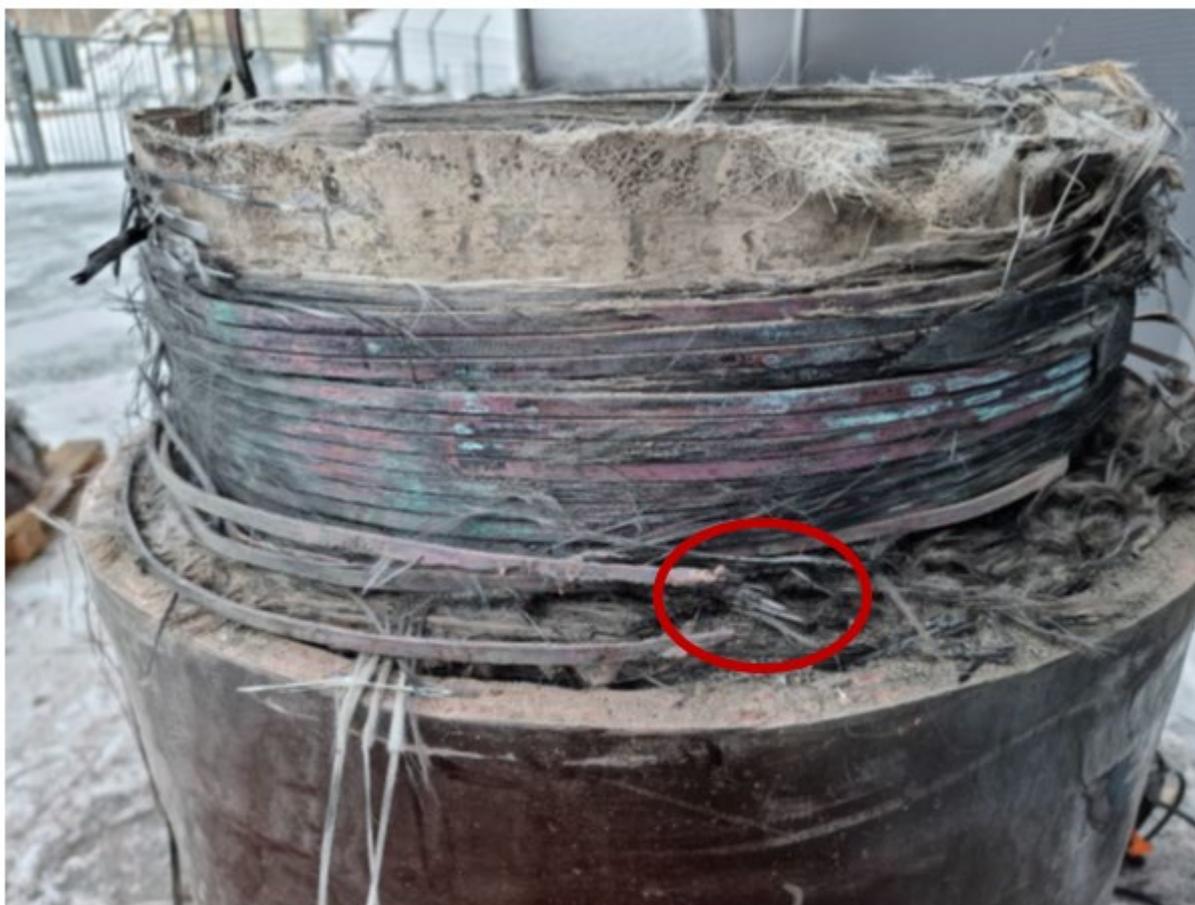
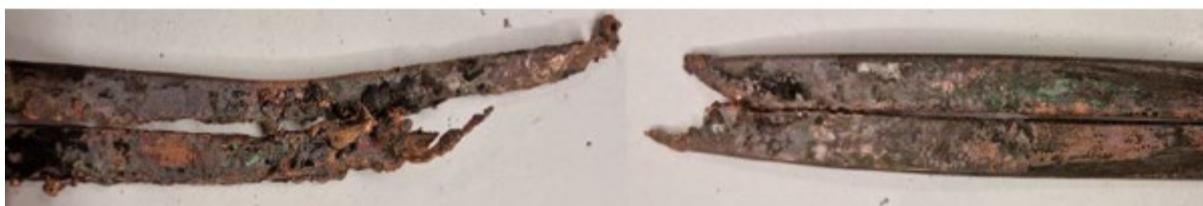
The most probable direct cause of the fire in the transformer is a short circuit/arc flash caused by impairment and/or degradation of the insulation between the copper windings over time.

Figure 14: Defective/melted copper winding on the secondary side located at the top of the middle coil.

- Accelerated degradation of winding insulation at the fault site because of hot spots which exceed the transformer's thermal insulation class.
- Degradation of the insulation material on internal windings caused by local partial discharges owing to transient surges on activating the breaker in the 11 kV board. Since no earthing screen is in place between the primary and secondary windings, such surges can be transferred/connected directly to the secondary side.

- Inadequate cooling which causes overheating in the transformer is the most prominent cause of degradation in the insulation material and causes breakdown over time. A rise in operating temperature of just 10°C over the recommended level can reduce working life by up to 50 per cent.
- Inadequate cleaning, with the accumulation of dust and dirt on cooling surfaces, can reduce the cooling effect and cause a gradual temperature rise over time.
- Surges in the transformer's high-voltage internal winding when operating the breaker.

- in order to detect degradation or degradation mechanisms before equipment faults arise, the maintenance concept for dry-type transformers needs to be updated and the quality of documentation for their condition over time in SAP improved.
