## Investigation report

| Report | |
|---|---|
| Report title<br>Investigation of incident involving fire in tank CD2101 (first stage separator) on Statfjord A, 17.04.2024 | Activity number<br>001037079 |

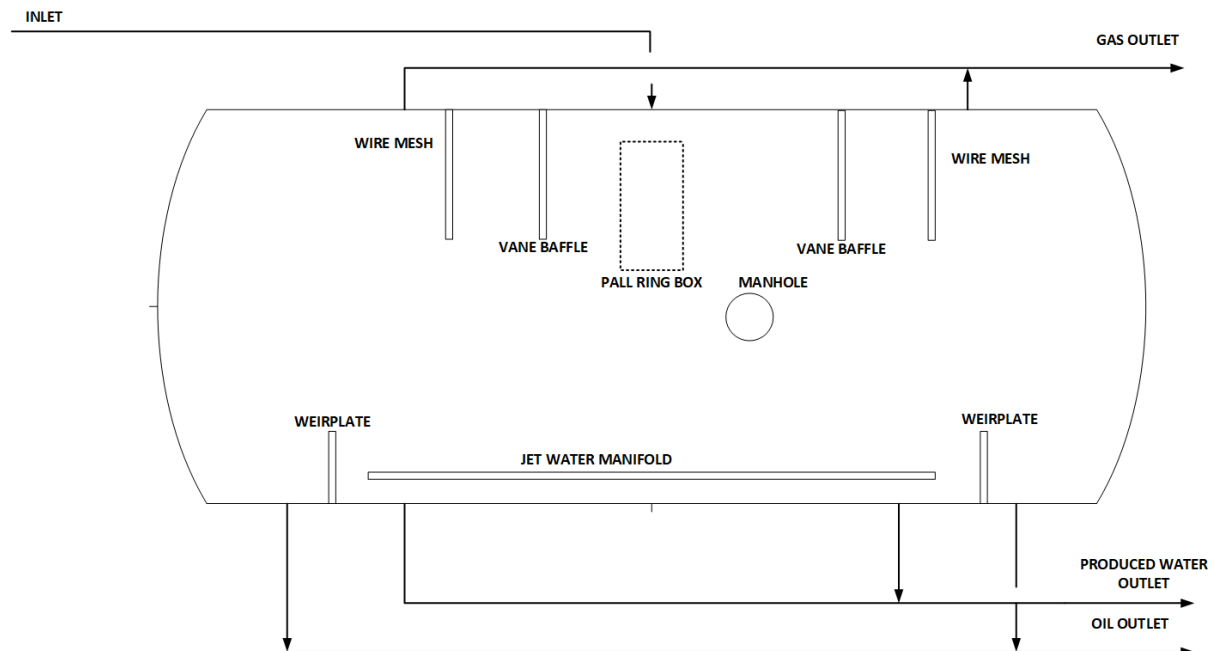
*Figure 4 Simplified sketch of separator*

Dense smoke made visibility inside the tank poor, and this made it difficult to visually identify the exact location of the flames. The individual that observed the fire described it as being located on a grid structure at normal working height. It may have been on the pall ring box or on the wire mesh.

| Year | Estimated quantity of deposits | Status/work on jet water system |
|---|---|---|
| 2024 | 7 m <sup>3</sup> | Defective brackets/clamping ring were identified on the inside of the flushing pipes inside the tank at both ends. Improved during turnaround.<br>Jet water extraction system cleaned.<br>The box containing the pall rings was damaged and parts of the pall rings were lying on the bottom of the tank. |

When the manhole was opened, deposits were observed in the manhole. Sludge pumping was therefore carried out from the manhole prior to entry of the tank. Upon entry, it was discovered that the box containing the pall rings was damaged, and that there were pall rings lying on the bottom of the tank. These had to be removed manually before sludge pumping could commence.
