Investigation report

Report	
Report title Investigation of hydrocarbon leak on Gudrun of 18 February 2015	Activity number 001025017

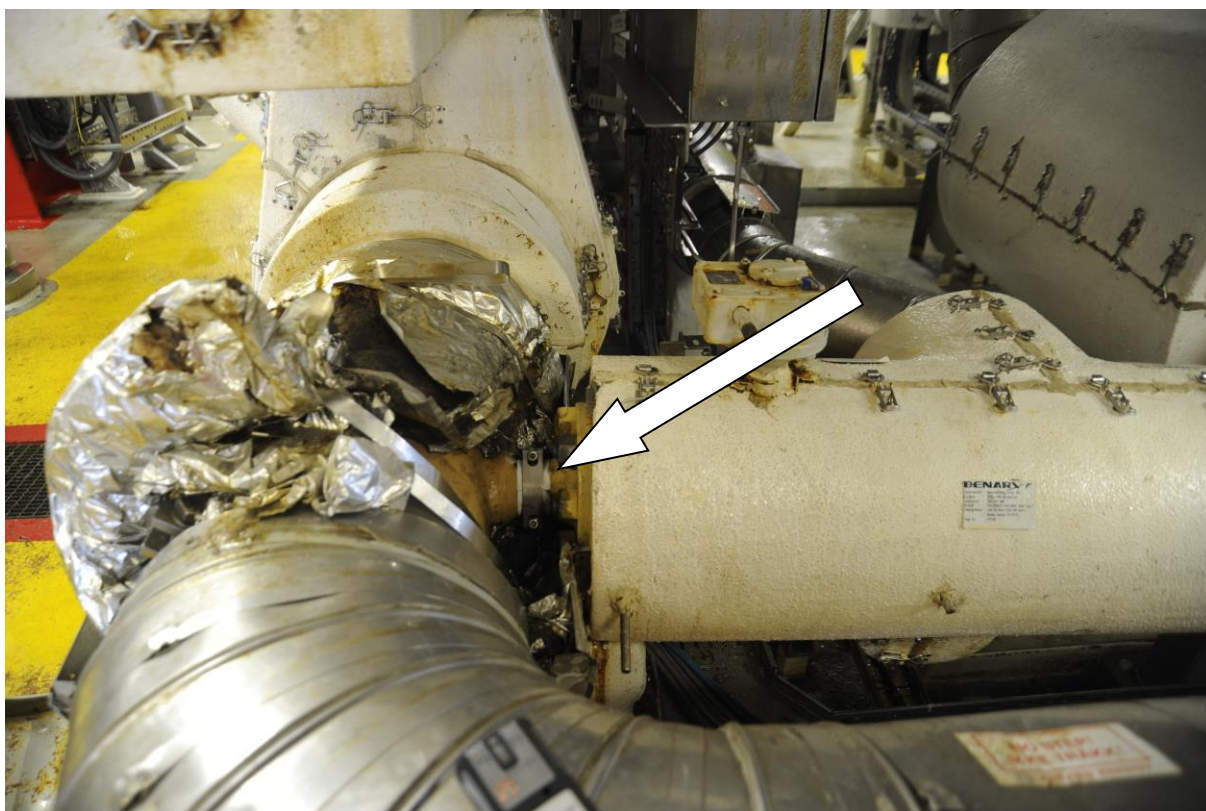
The plant was confirmed depressurised after 35 minutes and the area was free of gas within an hour. It was then established that the leak came from a rupture in a two-inch pipe in the bypass line downstream of the first-stage separator. This was temporarily repaired to prevent further leakage.

Figure 2: The damage site. The rupture site (arrowed) has been sealed with a rubber seal and clamps. Insulation was blown away as a result of the leak. (Photo: police)

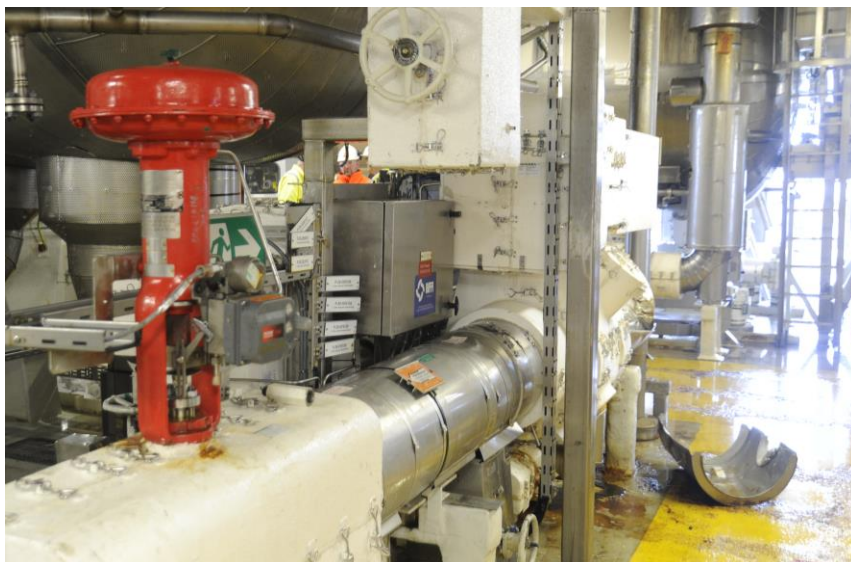
Figure 3: 20-LV0114 control valve (red). The cover below right was bent upwards by the leak and was removed to give access for sealing the leak site. (Photo: police)

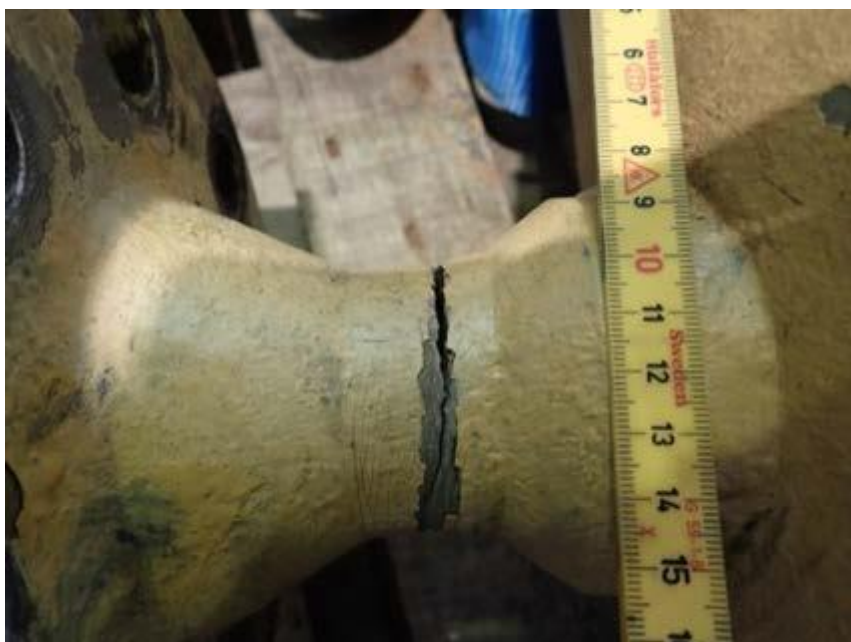
The actual leak was caused by a rupture in a two-inch pipe in the bypass line for the ESD valve on the liquid outlet from the first-stage separator as a result of powerful vibration in the liquid piping system downstream of this separator. The vibration was a result of weaknesses in the 20-LV0114 control valve, which regulates the level of liquid in the separator. This four-inch control valve sits in a 10-inch pipeline and reduces pressure from 124 to 19 bar, or by about 100 bar. The specific valve was chosen following an assessment of results obtained from software developed by the valve manufacturer.

Figure 4: The rupture (photograph from Statoil's material technology investigation).

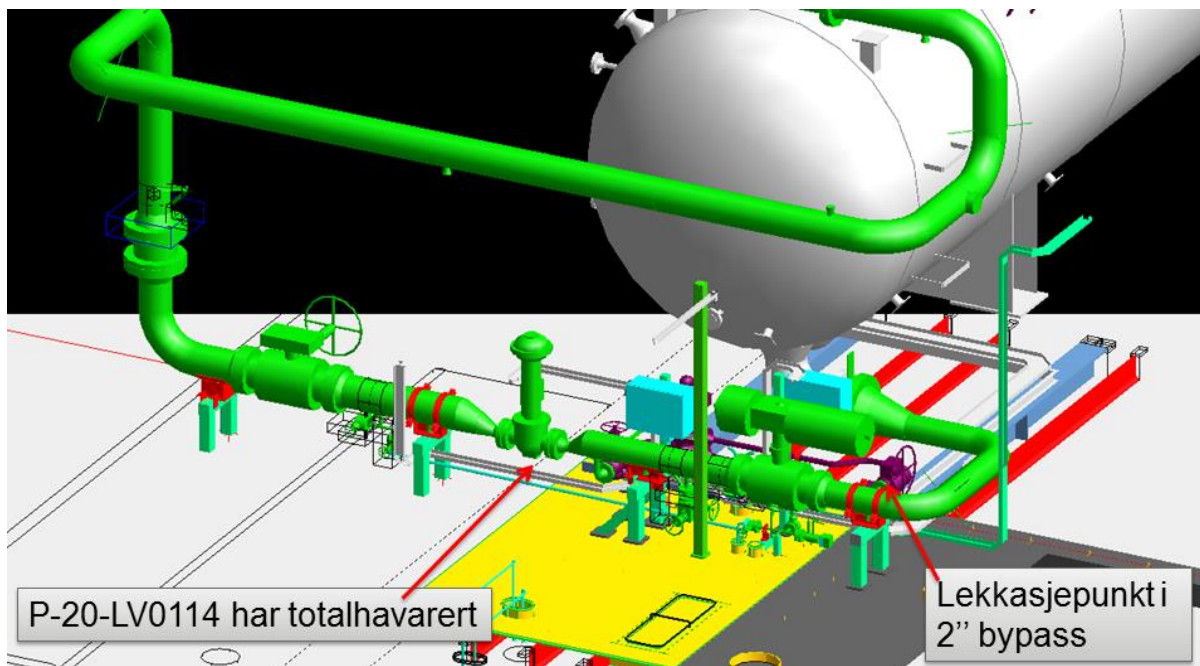
Figure 6: Piping downstream of first-stage separator. (Illustration: Aibel 3D-model)

Key: P-20-LV0114 totally destroyed Leak site in two-inch bypass

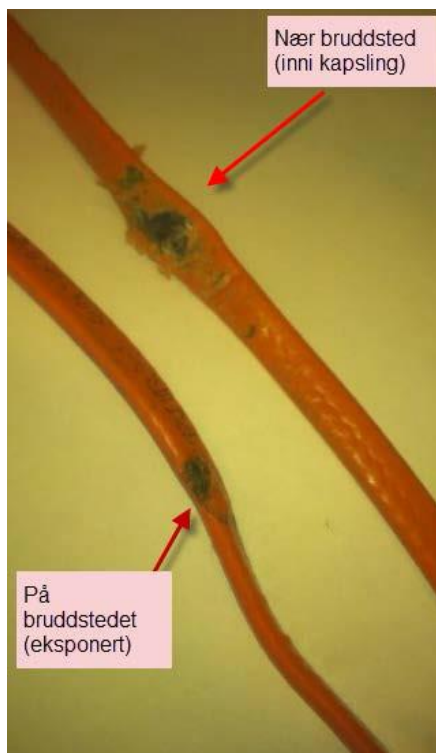
The heating cable has earth fault protection. The damage it suffered led to an earth fault, and the earth fault relay disconnected the cable automatically. That occurred about 90 seconds

before the leak, and coincides with the first video observations of vibration. This could equally well have happened when the vibration resumed, presenting some risk of a spark capable of causing ignition while gas is present.

Figure 9: Damage to heating cable. (From Statoil’s investigation report)

Key: Near rupture site (within insulation) At the rupture site (exposed)
