Investigation report

Report	
Report title Investigation of loss of gangway between Oseberg H and service operation vessel	Activity number 001053076 412000007
Classification	
<input checked="" type="checkbox"/> Unclassified	<input type="checkbox"/> Exempt from publication
Parties involved	
Team A-1 / A-3	Approved by / date Elin S. Witsø / 29.04.2026 Ingvil Håland
Investigation group participants [REDACTED]	Investigation leader [REDACTED]

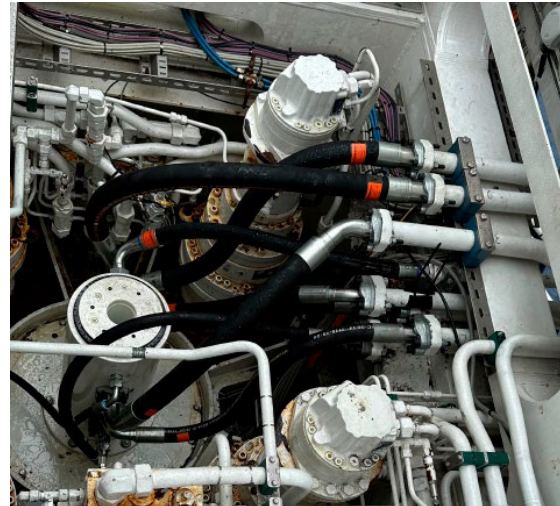
Photo 6: Swivel with temporary hydraulic hoses (Source: Equinor/Island Offshore)

The gangway's swivel mechanism failed on 14 May. Repairs were completed on 22 May. A new swivel was installed, but this one had a different design. The steel pipes originally mounted on the top of the swivel did not fit the new swivel and were replaced with hydraulic hoses as a temporary solution.

The swivel broke on 14 May and was replaced with a new swivel of a different design. The steel pipes originally mounted on the top of the swivel did not fit the new swivel and were replaced with hydraulic hoses as a temporary solution.

It was one of these hoses that caused the incident on 30 May due to a failure in a press coupling. A material examination conducted by Equinor showed that the press coupling likely had a material defect deriving from the sleeve's fabrication.

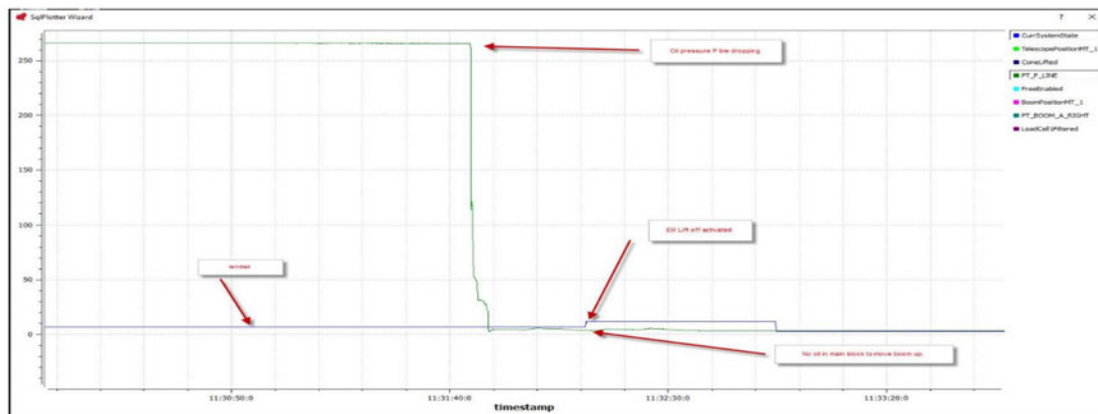
Figure 3: Hydraulic oil pressure (Source: Uptime)

The figure shows a rapid drop (less than 5 seconds) in hydraulic oil pressure (green line) to 0 bar. The leak reduced the oil level in the HPU tank to a critically low level.

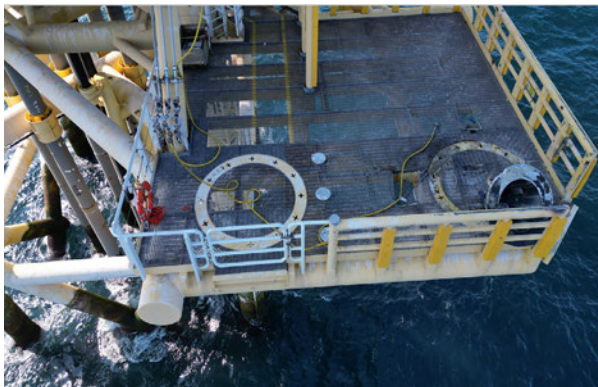
The movement of the gangway caused physical damage to the deck grating and railings in the landing area. The cone came loose from the gangway, and the end of the gangway was damaged.

Photo 6: Landing platform with damaged deck grating and Equinor/Island Offshore) detached cone (Source: Equinor/Island Offshore)

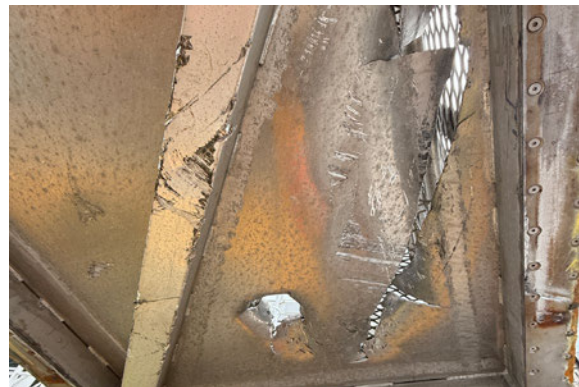
Photo 7: Damage to the gangway (Source: Equinor/Island Offshore)

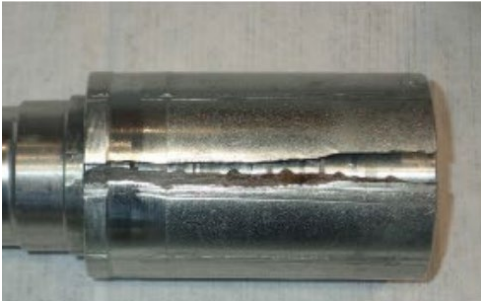
The press coupling and hydraulic hose have undergone materials testing at Equinor's materials laboratory. The report from this examination indicates that a material defect in the outer sleeve of the press coupling was likely introduced during the sleeve's fabrication.

The material defect, combined with the pressing of the sleeve during fitting, is believed to have caused the fracture. When the press coupling failed, one of the four supply hoses in the swivel ruptured. This resulted in a loss of hydraulic oil and pressure, and a consequent loss of control over the gangway's functions. The

The damaged press coupling and hydraulic hose were examined at Equinor's materials laboratory. The examinations revealed that the sleeve in the press coupling had an axial fracture along its entire length. The end of the hose that had been torn out or detached from the sleeve had a frayed end (steel reinforcement) and a partial tear in the rubber.

Photo 7: Sleeve with an axial fracture (Source: Equinor)

Furthermore, the examinations revealed that the sleeve had a material defect at its open end (the narrow end). The material defect appears as a relatively large piece of slag or oxide, originating from the steel production process. Equinor states that the material defect will reduce the load-bearing cross-section of the sleeve locally, and since the pressing of the sleeve generates high compressive stresses on it, it seems likely that a partial axial fracture or crack occurred. If the sleeve was already cracked, the fracture may have occurred during normal operation as a result of a further reduction in the load-bearing cross-section, combined with a certain notch effect caused by the existing crack. As a result, the hose eventually tore, causing a leak.

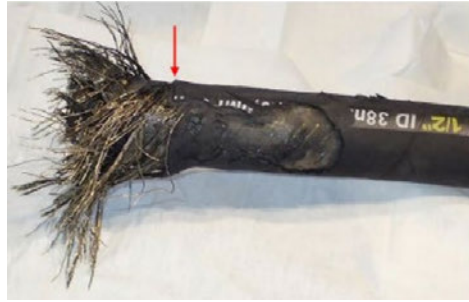
Photo 8: Torn hose end (Source: Equinor)

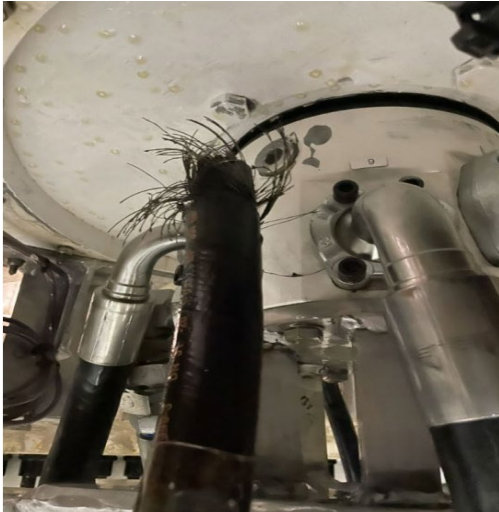
During an inspection on 28 June, damage was observed to three hydraulic hoses beneath the swivel. The damage was caused by friction between the hoses and electrical cables, due to the electrical cables being installed incorrectly relative to the positioning of the hoses. Replacement hoses were ordered and delivered, but two of the couplings used were the wrong type, as the correct couplings were not in stock. The use of the wrong type of coupling, combined with insufficient pressure during fitting, caused the hose end to be detached from the coupling. An examination shows that there was no internal crimp in the insert. A rupture in one of the supply hoses in the hydraulic system led to a loss of pressure and a subsequent failure of the gangway function.

Photo 9: Hydraulic hose (Source: Equinor/Island Offshore)

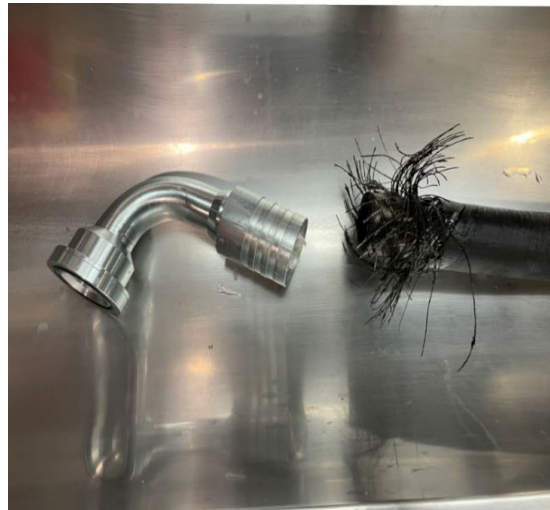
longer hold time than usual. The supplier's own report indicates that the coupling was inadequately pressed and, combined with the incorrect choice of coupling, this was likely the cause of the failure.

Photo 10: Press coupling with the end of the hydraulic hose (Source: Equinor/Island Offshore)

The hose supplier's root cause analysis indicates that two out of three replacement hoses were delivered with the wrong type of coupling, as the correct coupling was not available in stock. Pressure testing was performed with an extended hold time, and a final visual inspection was performed. When the hoses were handed over, the recipient was not informed that the wrong type of coupling had been used. The analysis shows that the insert lacked an internal crimp, which indicates insufficient pressure being applied. In combination with the wrong type of coupling, this is considered the likely cause of the hydraulic hose being detached from the coupling.
