Investigation report

Report title Gas leak at Statoil Mongstad on 25 October 2016	Activity number 001902037
---	------------------------------

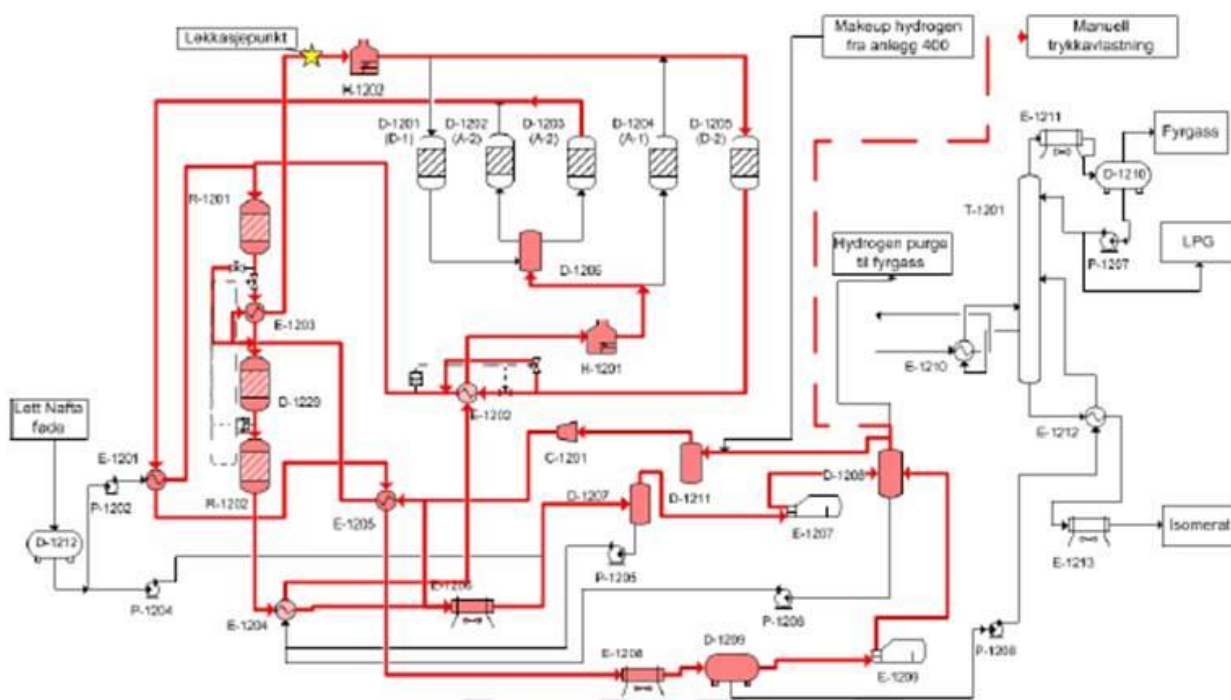
Figure 3 presents a simplified process diagram of A-1200. The leak occurred at a low-point drainage pipe on the recirculation line with hydrogen-rich gas in the reactor part of the plant, on the line into furnace H-1202. The leak point is marked with a star in the figure.

Figure 3: Simplified diagram of the A-1200 process. The leak point is marked by a star at top left.

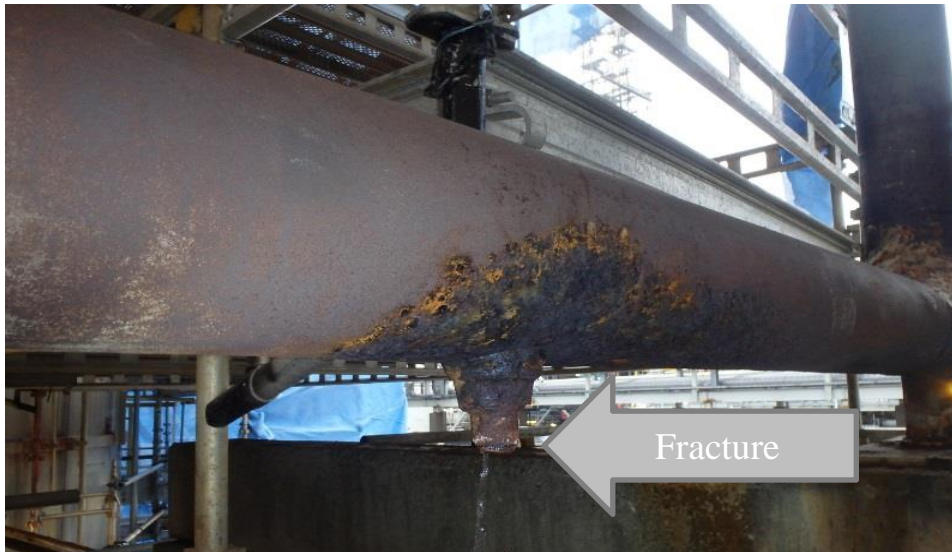
Material technology investigations were carried out by Statoil's materials department in Trondheim (Statoil, 2016), which concluded that the leak and fracture were caused by CUI. The pipe had suffered substantial external corrosion, reducing its wall thickness to zero in parts of the circumference. Internal corrosion was insignificant. Figures 6 and Figure 7 show the main pipe and the pipe end with the fracture to illustrate the configuration. They also gives an impression of the extent of the corrosion. All the photographs in this section are from Statoil.

Figure 6: Main pipe with pipe end where the fracture occurred. The pipe end was later removed for material technology investigations. The scale of external CUI can be seen.

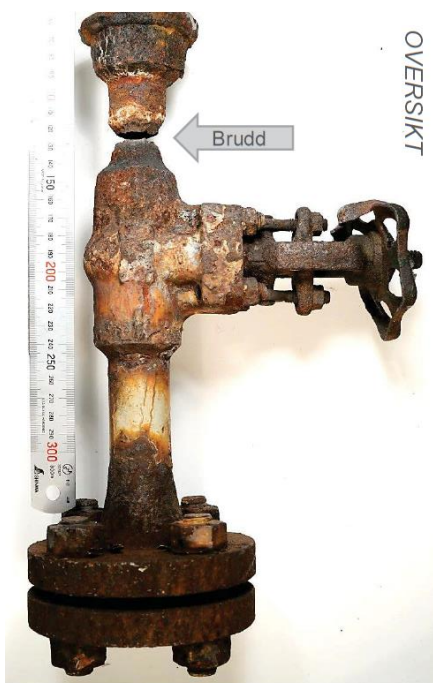
Figure 7: Configuration of the branch pipe with the end to the main pipe on top, the packing box valve and the blind flange. The arrow points to the fracture site. Scale in millimetres.

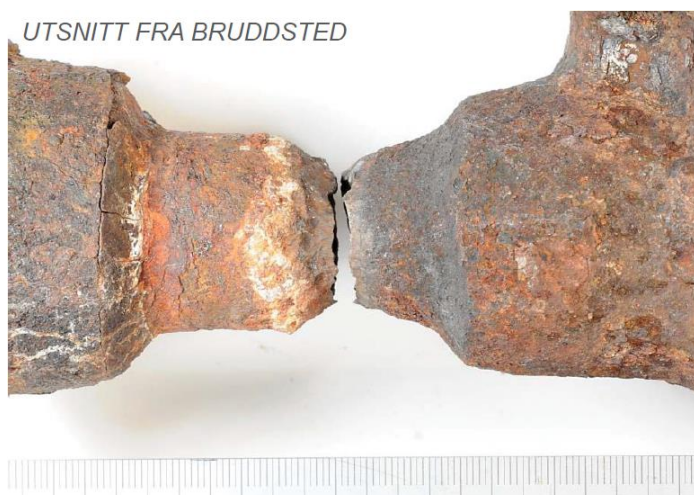
Figure 8: Section of the fracture site. Scale in millimetres.

Visual and macrofractographic investigations (Statoil, 2016) showed that the wall thickness had thinned almost to zero around roughly half the pipe circumference in the fracture area. The fracture site appeared to have corroded right through before the incident. See Figure 9. The remainder of the circumference showed a morphology compatible with a pure overload fracture. Internally, the pipe components had a thick oxidised layer but were not significantly corroded. The original wall thickness is unknown, and corrosion rates have not been calculated.

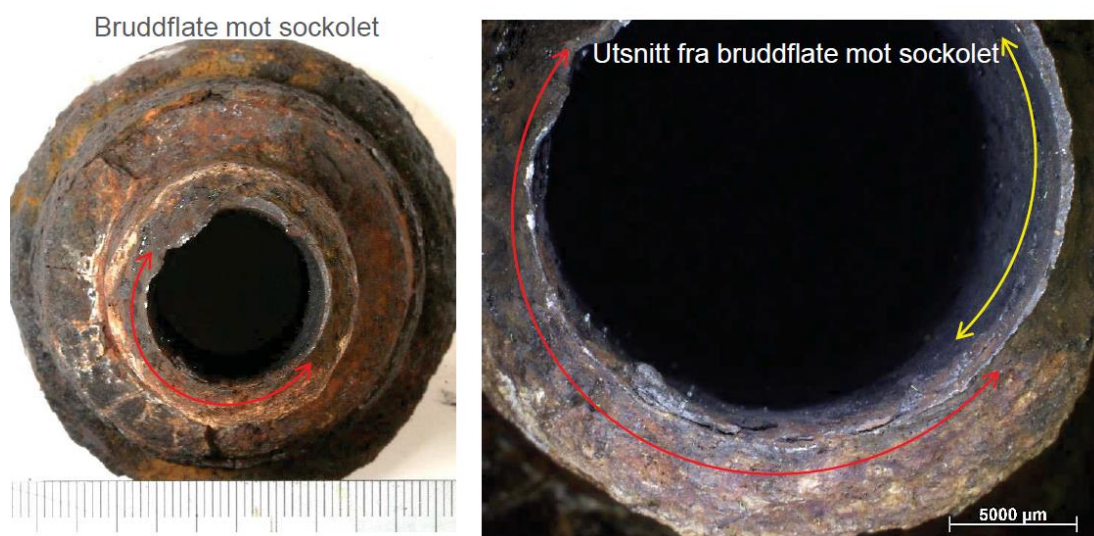
Figure 9: Photographs of the opposing fracture sites. Red arrows show areas where the wall thickness has been reduced to zero. The yellow arrow to the right shows where the fracture has a 45-degree propagation and appears as an overload fracture.

Some rough calculations have been made of residual strength in the pipe cross-section at the fracture and the probability of the pipe end failing with no external load. This corresponds with “exerting a little force” when operating the valve. The possibility that the end could have broken off after “some time” (Statoil, 2017) is not excluded.
