Investigation report

Report	
Report title Report of the investigation of a fire in the air intake of GTG4 at Hammerfest LNG, Melkøya	Activity number 001901043

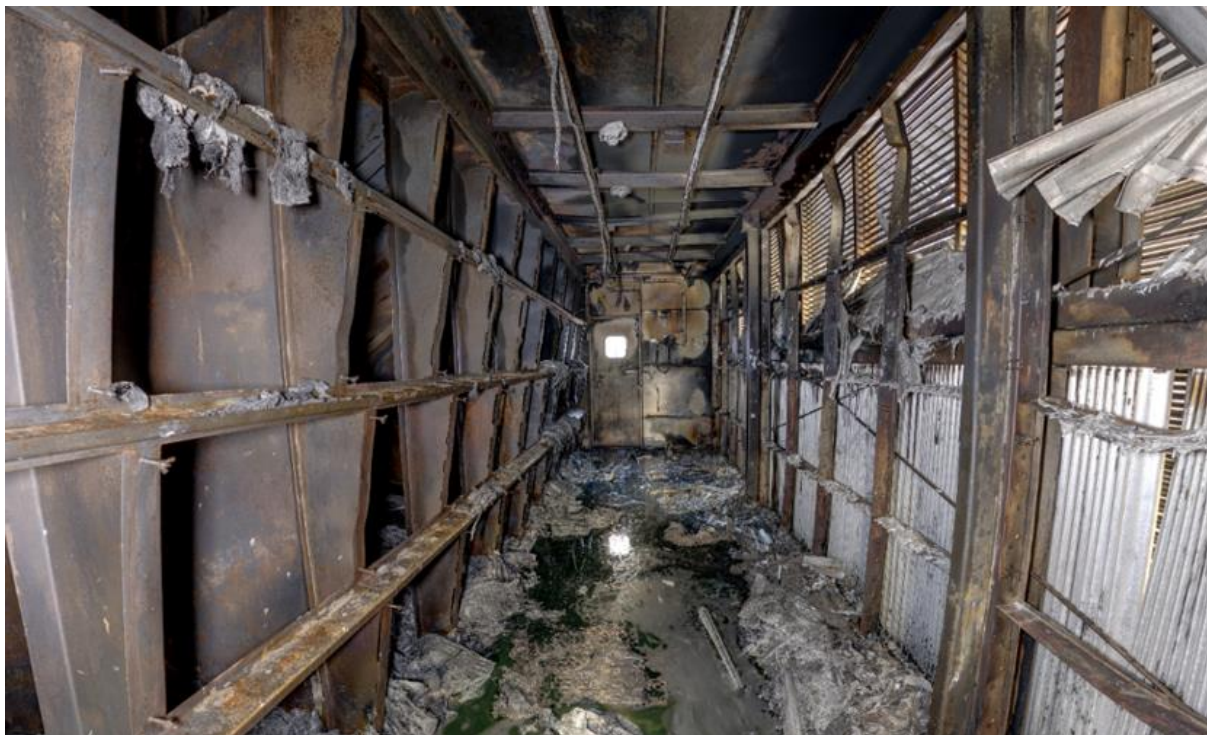
- the structure of the GTG4 filter housing is damaged
- the demister has been destroyed
- extensive deformation to and fractures of tubing in the anti-icing panels
- pre-filters and fine filters have burnt up.

Illustration 9 Interior of the GTG4 filter housing, level 1, after the fire (Photo: Kripas)

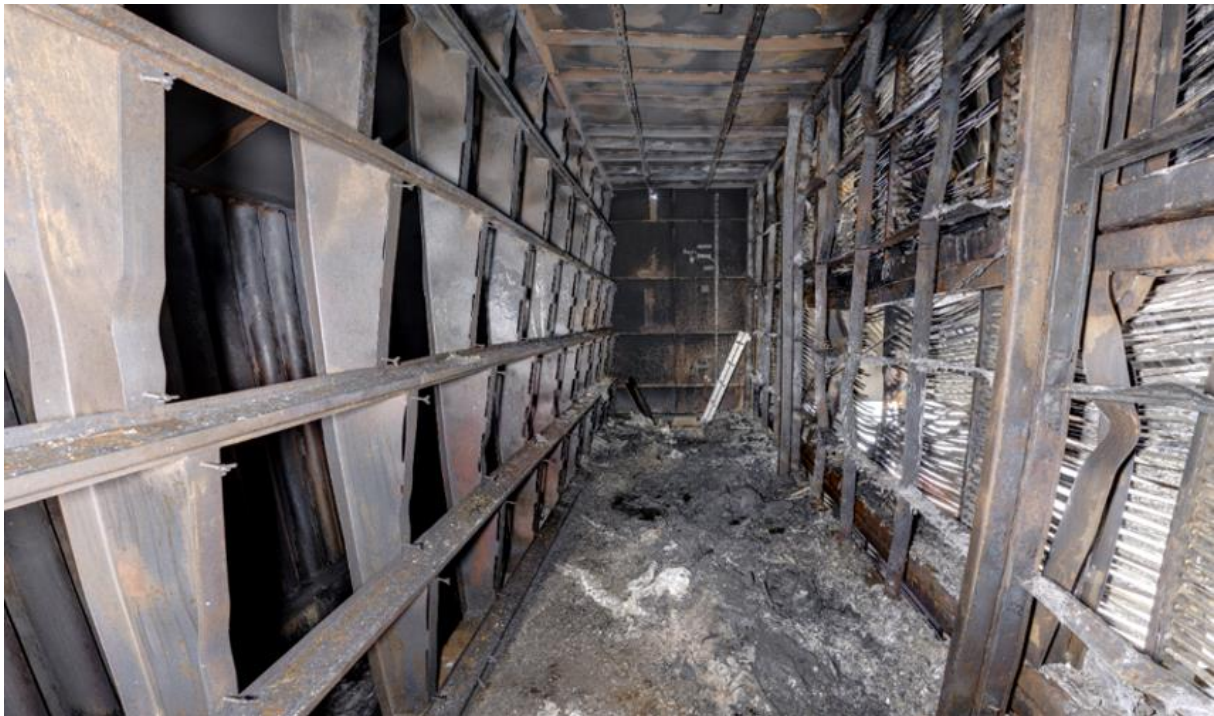
Illustration 10 Interior of the GTG4 filter housing, level 2, after the fire (Photo: Kripos)

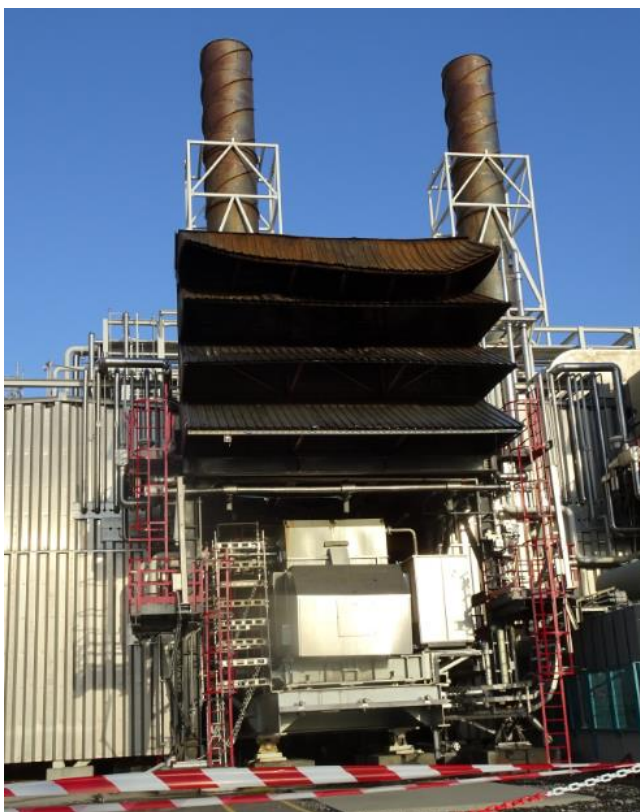
Illustration 11 External view of the damage to the GTG4 air intake (Photo: PSA/AHS)
