Investigation report

Figure 1 The formwork scaffolding where the fall accident occurred on 24 April 2025

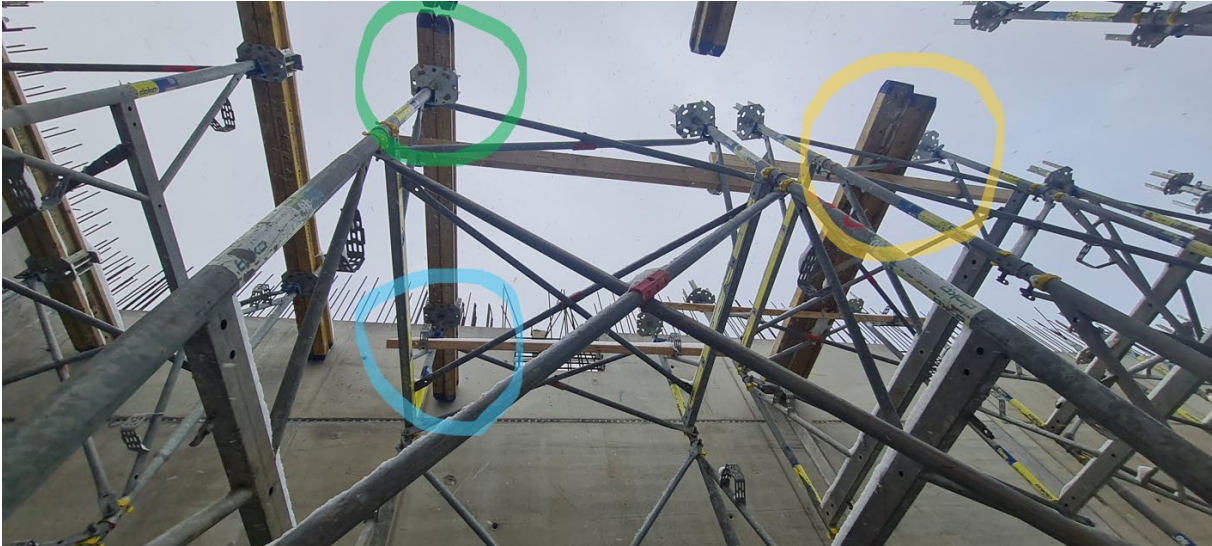
Source: Havtil. Photo taken during inspection on 25 April 2025. The yellow circle in the photo shows the Doka beams that served as a base to stand on when the accident occurred. The blue circle in the photo shows how the Doka beams were laid on 2x4 beams. The green circle in the photo shows the fully assembled H20 Doka beams placed in the top fork, ready for use as a foundation for casting the floor.

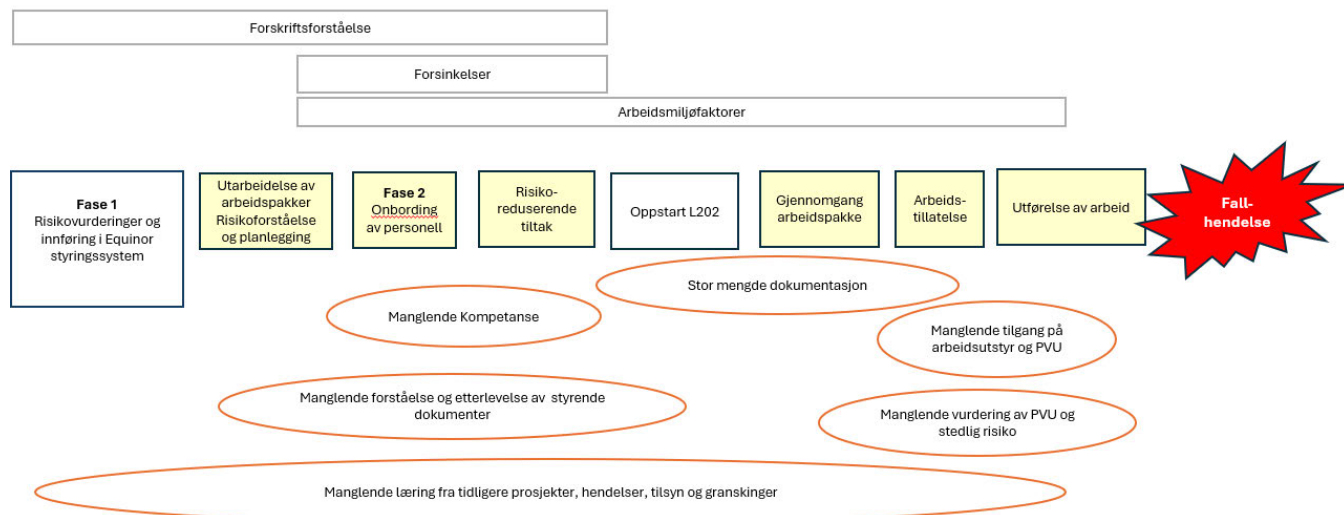
Yellow boxes in the model show where Equinor and Aibel's 'see-to-it' responsibilities did not work.
