Investigation report

Report title Hydrocarbon leak on Oseberg A on 17 June 2013	Activity number 001053028
---	------------------------------

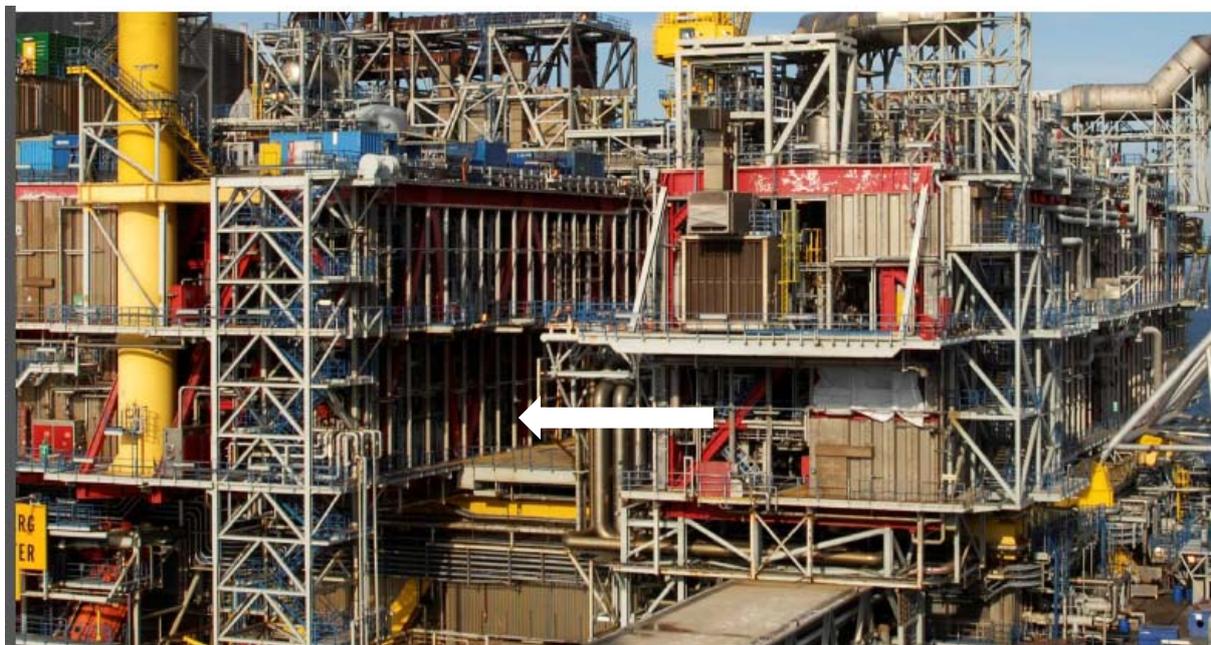
The incident occurred in process module M02. See Figure 2

Figure 2 Process module M. The photograph is taken from Statoil's investigation report. The arrow has been superimposed to show where the leak occurred in M02.

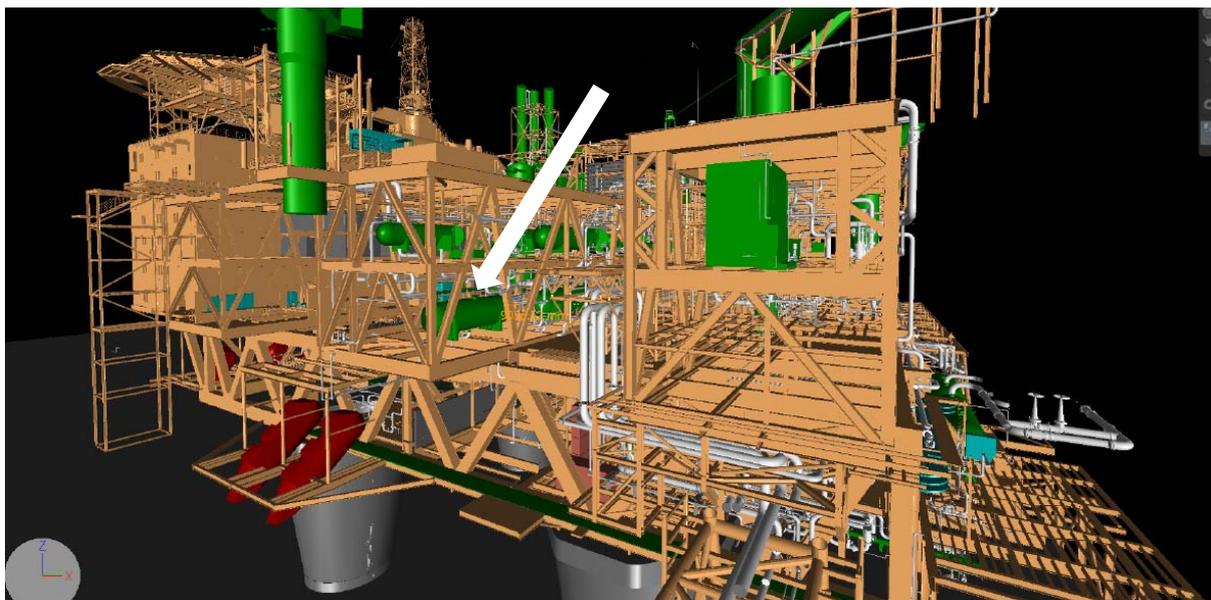
Figure 3 Model of process module M. The photograph is taken from Statoil's investigation report. The arrow has been superimposed to show where the leak occurred in M02.

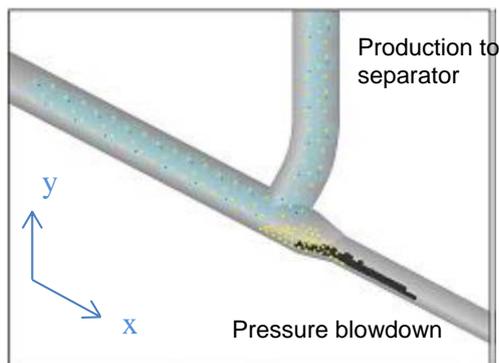
An inappropriate connection point for the pressure blowdown line on the test manifold meant that sand accumulated in the pressure blowdown line.

The pressure blowdown line has an unfortunate connection to the manifold, which means that sand produced into the manifold accumulates in the line. Such lines are normally connected at a high point 90° on the piping segment to be blown down, so that the flow bled off to the flare consists of gas. This also helps to reduce the volume of sand which accompanies the gas into the flare system.

Figure 4 Connection of the pressure blowdown line. Source: Statoil's investigation report.

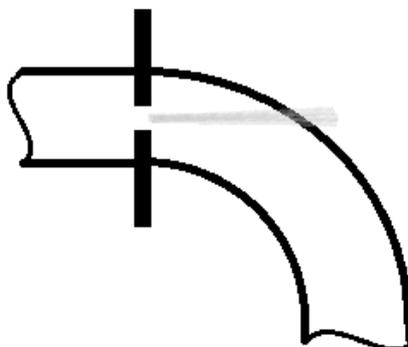
An inappropriate design with an orifice plate before a pipe bend meant the formation of a jet containing sand which struck the pipe bend and eroded a hole.

Because the orifice plate intended to limit the gas flow rate to the flare is positioned directly before a 90° bend, the jet from the plate has imparted very high velocity to the sand before it hits the bend. That has caused a hole to be eroded in the bend, as shown in the diagram and photograph below.

Figure 5 Simplified diagram for orifice plate and bend.

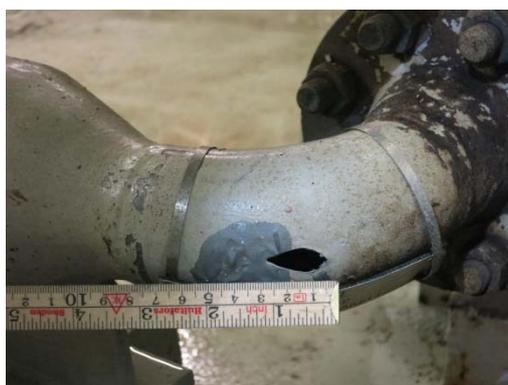
This caused sand erosion, which led to a hole being eroded in connection with the pressure blowdown on 17 June 2013.

Figure 6 Hole eroded in the bend. Photo: Statoil.

Material damage was confined to the pipe bend where a hole was eroded.

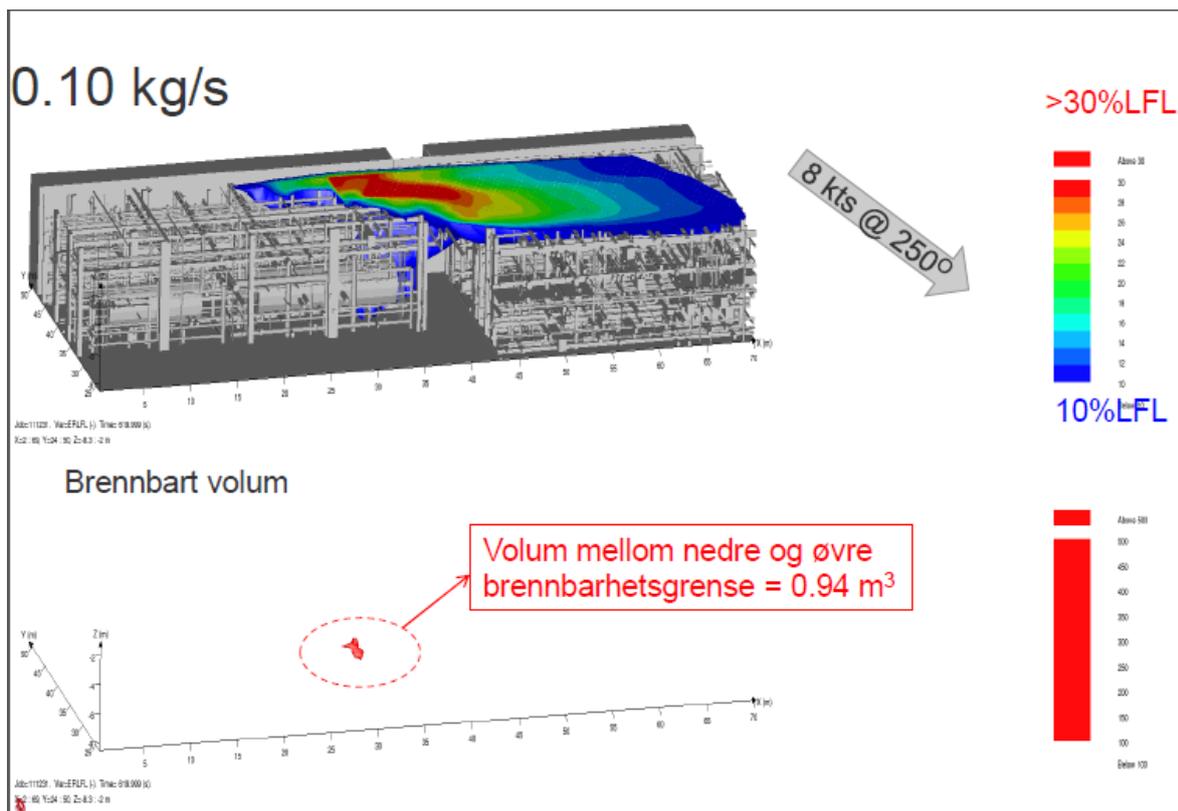
None of the gas detectors detected gas in an explosive mixture. In other words, the leak was not large enough to provide a sufficiently high concentration of gas to reach an explosive mixture where the gas detectors were installed. However, areas will exist around the leak where an explosive mixture occurred. In this case, these appear to have been confined to the immediate vicinity of the leak site. Simulations conducted by Statoil indicate that an explosive concentration of about 1cu.m occurred close to the leak point. Figure 7 presents the simulation of the leak. Since the detectors were primarily positioned high up in the module, however, the motion and concentration of the gas cloud before it reached the detectors are uncertain. Data from tests reported to the trends in risk level in the petroleum activity (RNNP) study show that gas detector reliability on Oseberg A is poor. The failure frequency in 2012 was six times higher than the average for the Norwegian continental shelf (NCS) that year. The process area is a classified area, which is basically not supposed to contain ignition sources exposed to gas. But the possibility of faults in electrical equipment cannot be excluded in the area around the leak point, which could result of the presence in ignition sources. However, the probability of ignition is regarded as low.

Figure 7 Simulation of gas emissions based on detector activation. The figure is taken from Statoil's investigation report. (Key: Ignitable volume; Volume between upper and lower ignitable limits = 0.94cu.m.)

The consequences of an explosion are uncertain because the volume of gas involved in an explosive mixture is unclear. However, Statoil's simulation indicates a volume of about 1cu.m, which is not sufficient to produce an explosion capable of causing further damage and gas leaks in the process plant.

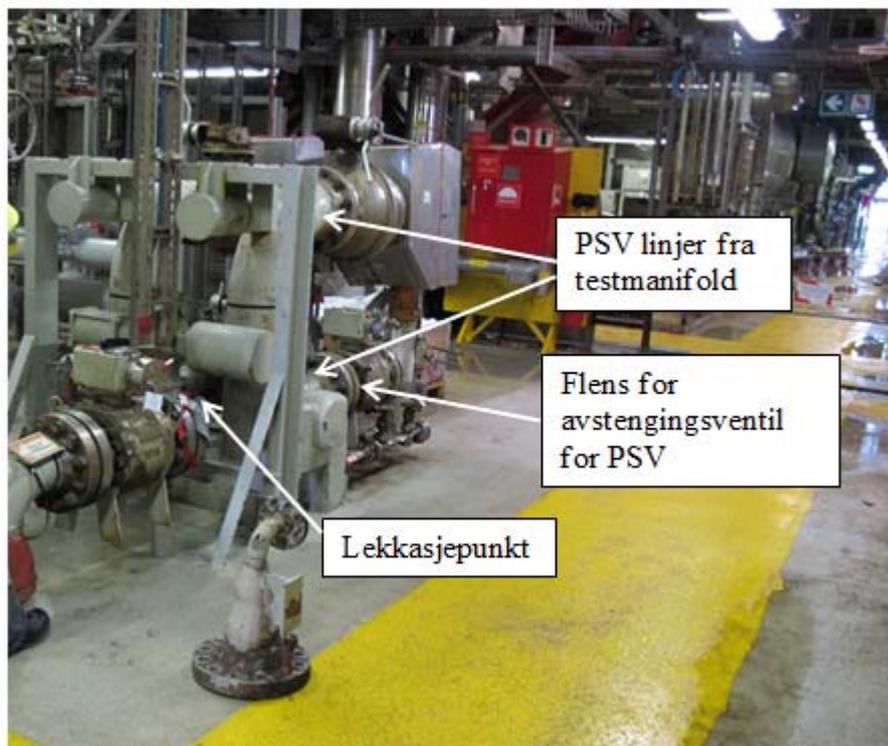
Figure 8 Pressure safety valve (PSV) in the immediate vicinity of the leak point.
 (Key: PSV lines from test manifold; Flange for shutdown valve for PSV; Leak point.)

The safety valves for the test manifold are located in the immediate vicinity of the leak point and would have been exposed to a jet fire. Figure 8 presents the layout. The flange on the shutdown valve for the upstream PSV would have been particularly exposed because it is not provided with passive fire protection. A jet fire could have caused leaks and a further supply of gas to the fire until the test manifold had been blown down. The consequences of leaks in the lines upstream and downstream of the PSVs are uncertain. However, we take the view that the probability of escalation out of the module would be low because pressure blowdown in the module functioned as intended.

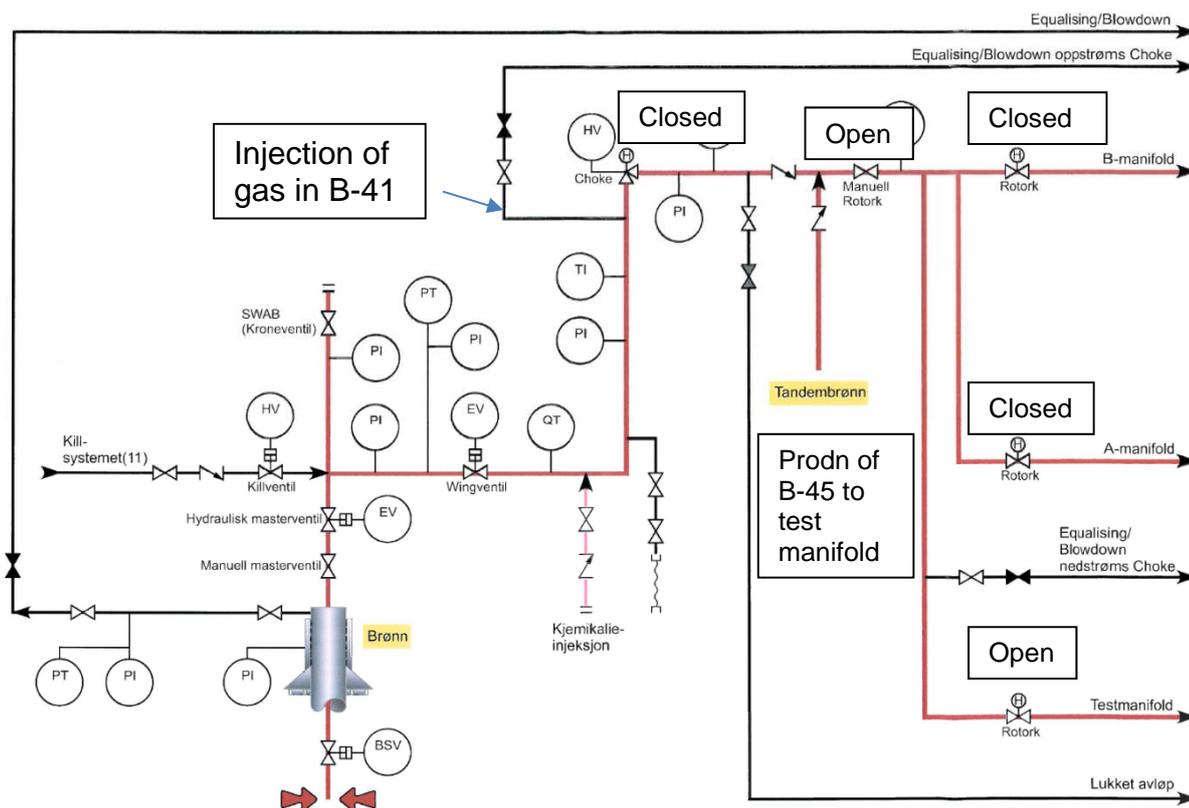
Wells B-41 and B-45 are connected by a common (manual Rotork) valve to the test separator, and are accordingly called tandem wells. See the diagram below.

Figure 9 Layout for tandem wells B-41 and B-45.

At the same time as well B-45 was connected to the test separator, gas was injected in well B-41. This was done via the equalising and blowdown manifold, which is connected to the well upstream of the production choke. Because well B-45 was connected to the test separator, this configuration meant that the choke was the only barrier between the injection gas and the test manifold. The latter has a design pressure of 75barg, while the injection system has no

automatic shutdown function until the pressure reaches 233 barg. In the event of erroneous opening or a leak in the choke, no shutdown function will accordingly be available for the manifold which prevents overpressure as required by the regulations.
