# Investigation report

Report	
Report title Investigation of incident with personal injury on Johan Sverdrup	Activity number 001265069

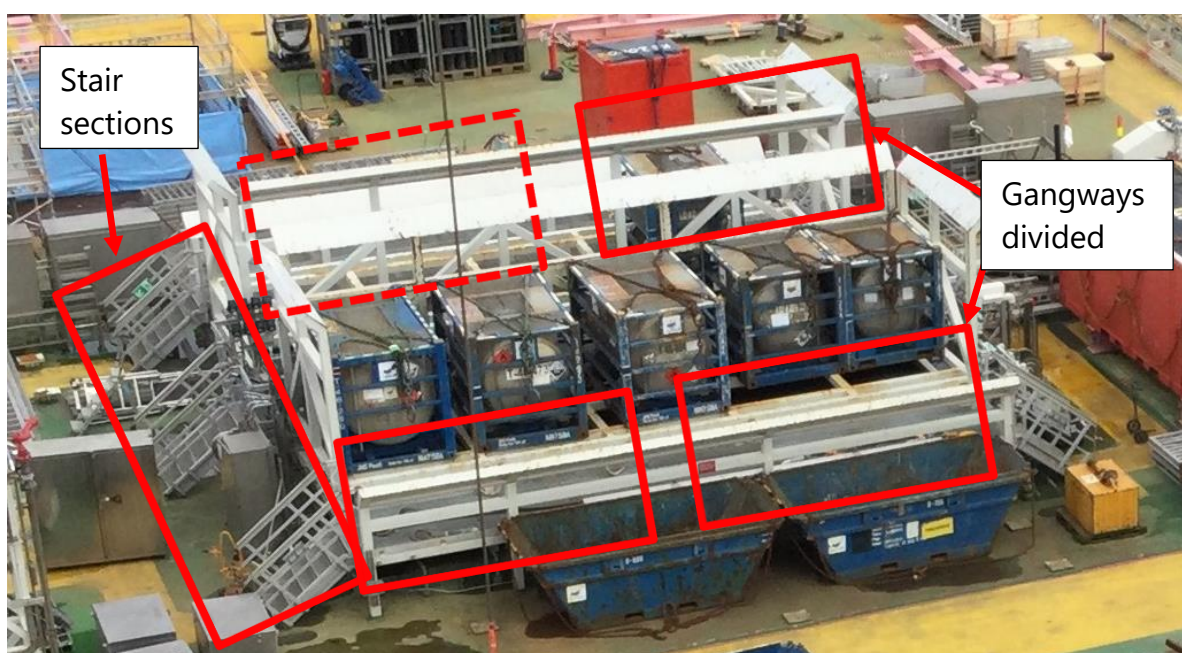
Photo 3 shows the tank frame in use, with box superimposed around the sections to be cut for lifting. The plan was to remove the six stair sections and then split the gangway on each side into two sections and lifting these one at a time. Once ASK had completed the dismantling job, the frame would be left with loose stair sections and four gangway sections secured to it with ratchet straps.

*Photo 3 has been received from Equinor and shows the frame to be removed. Notations by the PSA.*

Photo 3 shows the angle for the crane operator, who had a good view of the west side (bottom of the photo) while much of the east side was in the blind zone.

The incident occurred during work to attach section four to the offshore crane for lifting into a load carrier. Outlined by the box with dashed lines in photo 3, this section is located on the north-east side and in the blind zone for the crane operator.

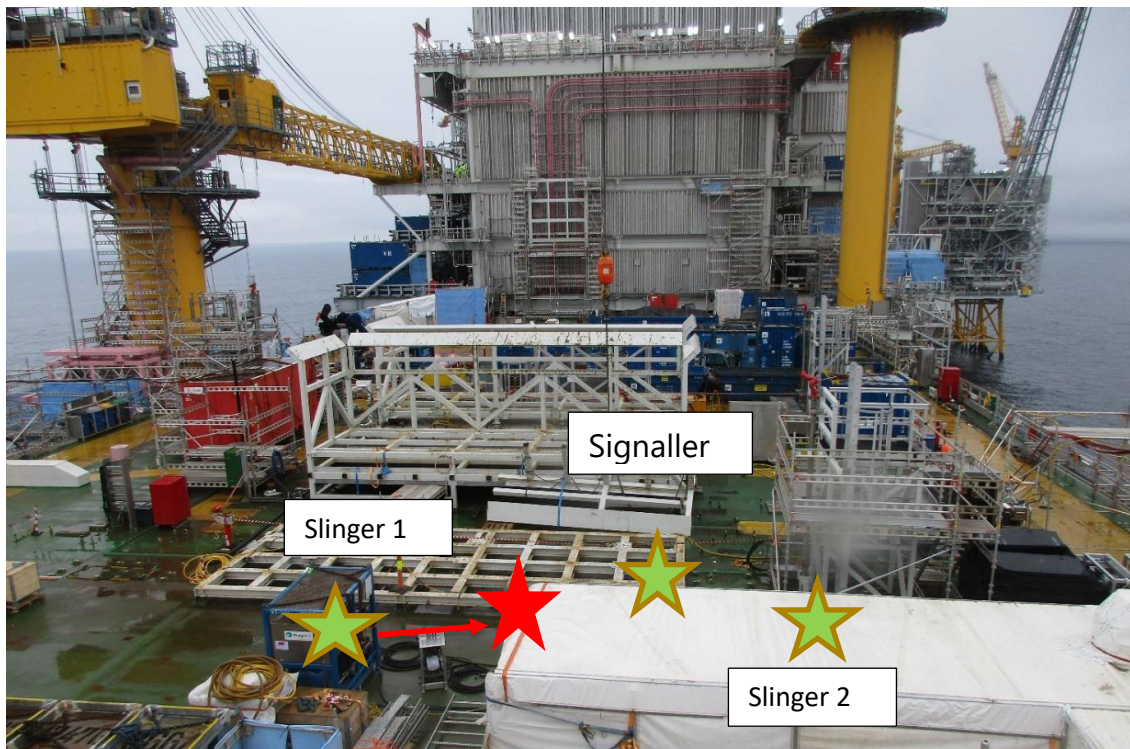
The gangway section was still attached to the main frame as ASK had left it, and the team worked to attach the chains and adjust each chain length. It had opted to use a two-part chain sling, giving four chains to be attached to the section and adjusted for length. When the incident occurred, the team was making a third attempt to tension the crane hook to see how the chains and attachments looked. The positions of the signaller and slingers during this phase of the operation are shown by green stars in photo 4.

*Photo 4 is from the PSA team's inspection of the incident site.*

In addition to shifting forward, the structure also twisted a little. This could have been because its centre of gravity was not quite as expected and also because the structure was still attached to the frame with a strap. At the same time, slinger 1 moved towards the structure in order to release the other strap holding it to the frame. This was attached near the red star in photo 4. That resulted in the person concerned being crushed between a protruding part of the structure and the frame. Slinger 1 was at the red star in photo 4 when this happened.

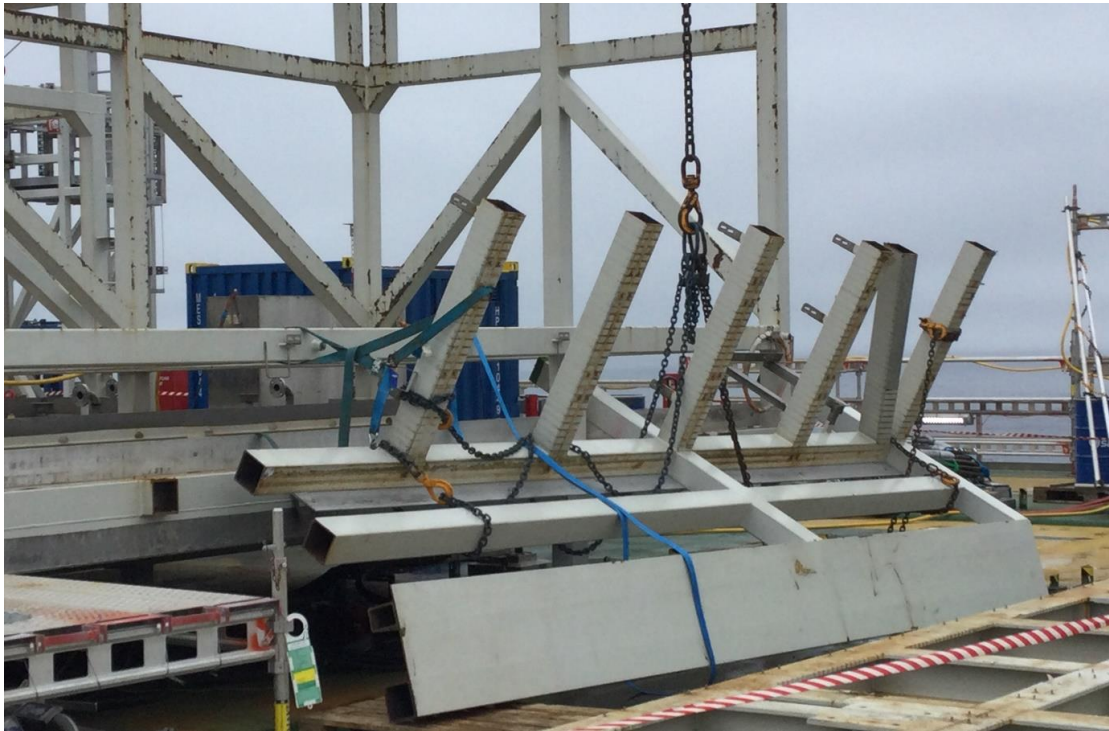
Photo 5 shows the structure as it was positioned when the PSA team arrived at the incident site. The structure had then been lowered to the deck and had folded over so that the beams which had supported the deck gratings are sticking up in the photo. It was part of this structure which struck slinger 1.

*Photo 5 is from the PSA team's inspection of the incident site.*

The crane operator secured the load by lowering the structure to the deck as shown in photo 5. It twisted through about 110 degrees and moved roughly half a metre north in relation to where it was hanging before the incident.
