Report title Investigation of an incident resulting in personal injury on Deepsea Nordkapp on 8 October 2025	Activity number 405007010
--	------------------------------

Team A-3	Approved by / date Ingvil Håland/15 April 2026
Investigation group participants [REDACTED]	Investigation leader [REDACTED]

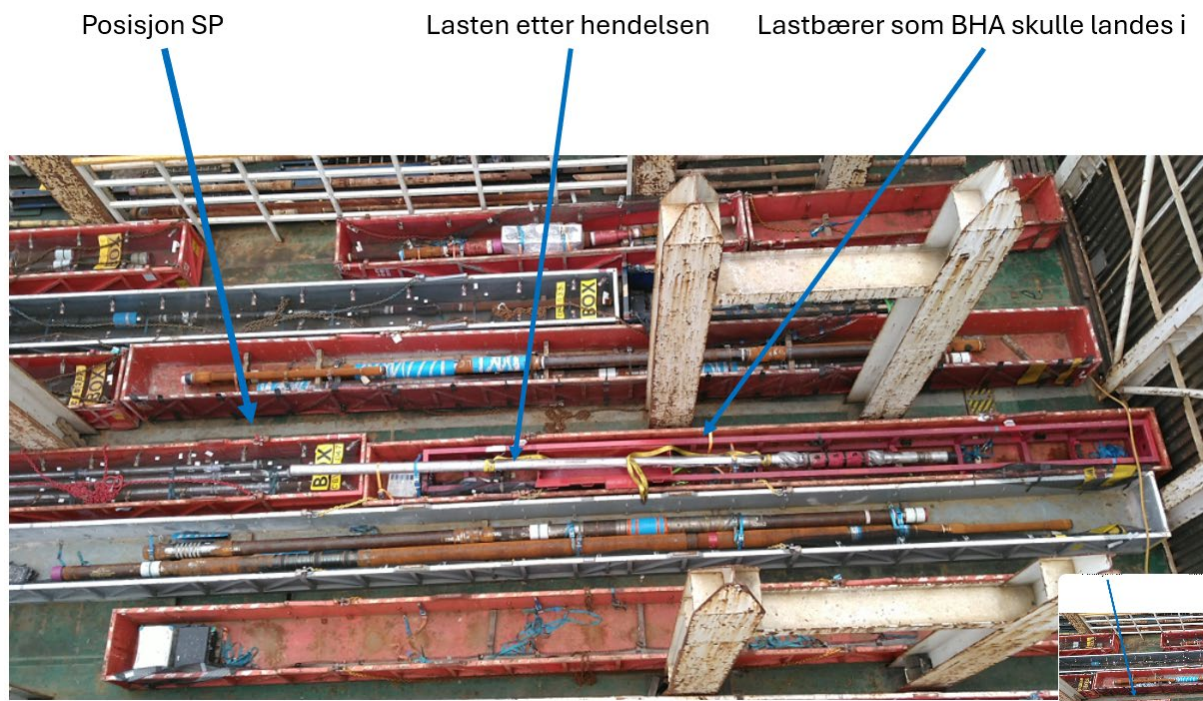
At that point, the logging tool was hanging askew, and because of its length, it was difficult to handle. During lowering, the logging tool underwent uncontrolled lateral swaying motions. IP touched the logging tool several times and was positioned underneath it on several occasions. Touching the logging tool had not been authorised by the crane operator.

Figure 3 – Overview of the incident

The direct cause of the incident was that, during a lifting operation, the load was not fully under control, and the injured person (IP) was standing in the travel path in front of and, at times, directly beneath the load. As a result, IP was struck by the load while the crane operator was trying to regain control.

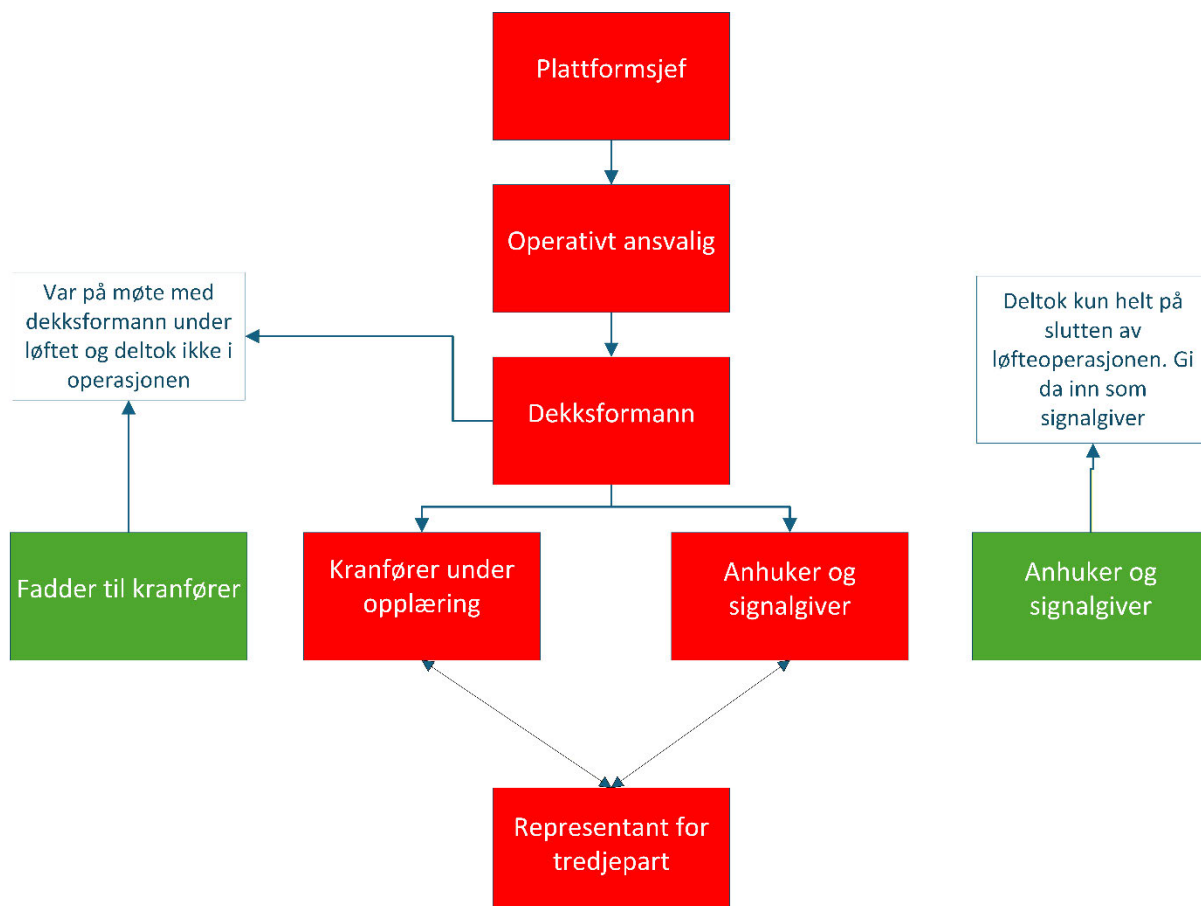
A generic organisational chart is shown in the figure below. The organisational chart shows that everyone, from the OIM down to the deckhands, was either new to or inexperienced in their roles. The red boxes indicate the roles mentioned in the bullet points above, while experienced personnel are shown in the green boxes.

Figure 4 Illustration of the relevant part of Nordkapp's offshore organisation. Red indicates individuals on the shift with insufficient experience and expertise.

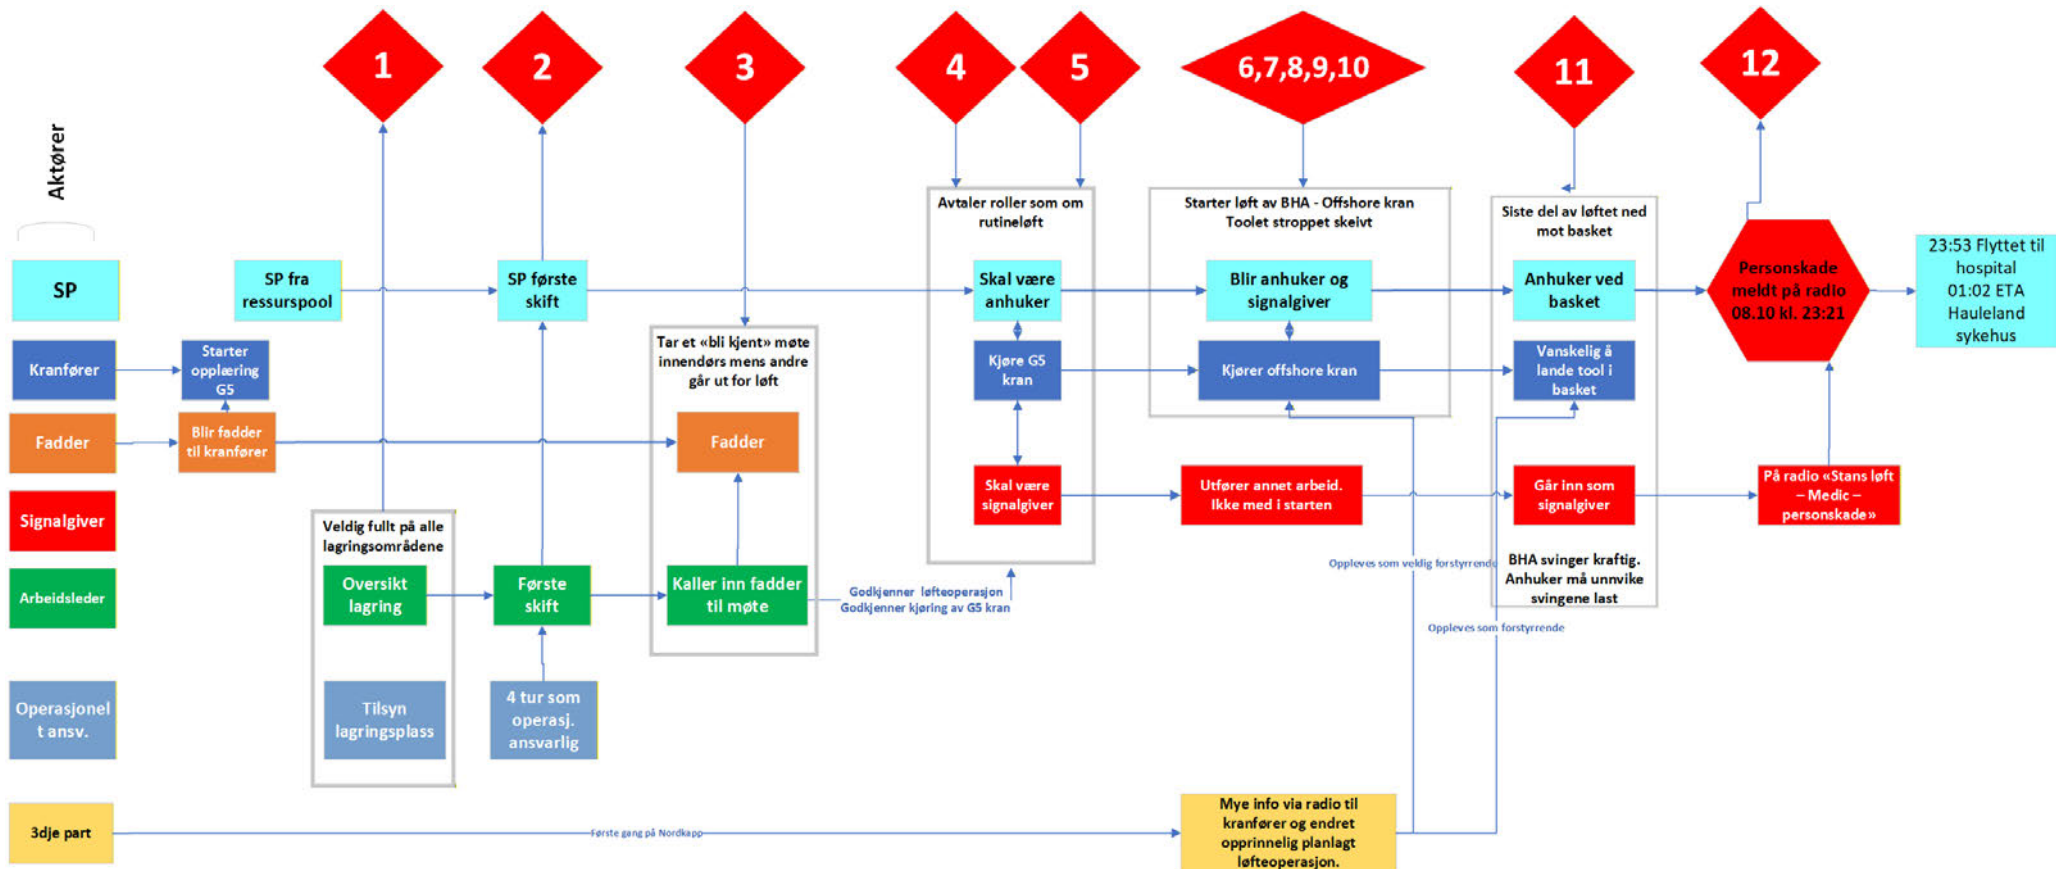
1. Trange dekk meldt som bekymring fra dekk og kran
2. Flere nye i sikkerhetskritiske oppgaver
3. Fadder og dekkformann på møte under løfteoperasjon
4. Mangler ved planlegging av løft. Ikke del av handover.
5. Kranfører under opplæring for G5 offshore kran
6. Finner ikke tilhørende spesialbasket
7. Flere endringer gjennom løfteoperasjonen og «Støy» på radiosambandet
8. Fadder eller formann deltar ikke i operasjon
9. Ingen stans av arbeid ved farlige situasjon
10. Endret rollefordeling ifm med løfteoperasjonen
11. Anhuker (IP) under last og uten ryggen fri
12. Ingen GA aktivert

Figure 5 Simplified version of the STEP diagram showing the main elements of our investigation

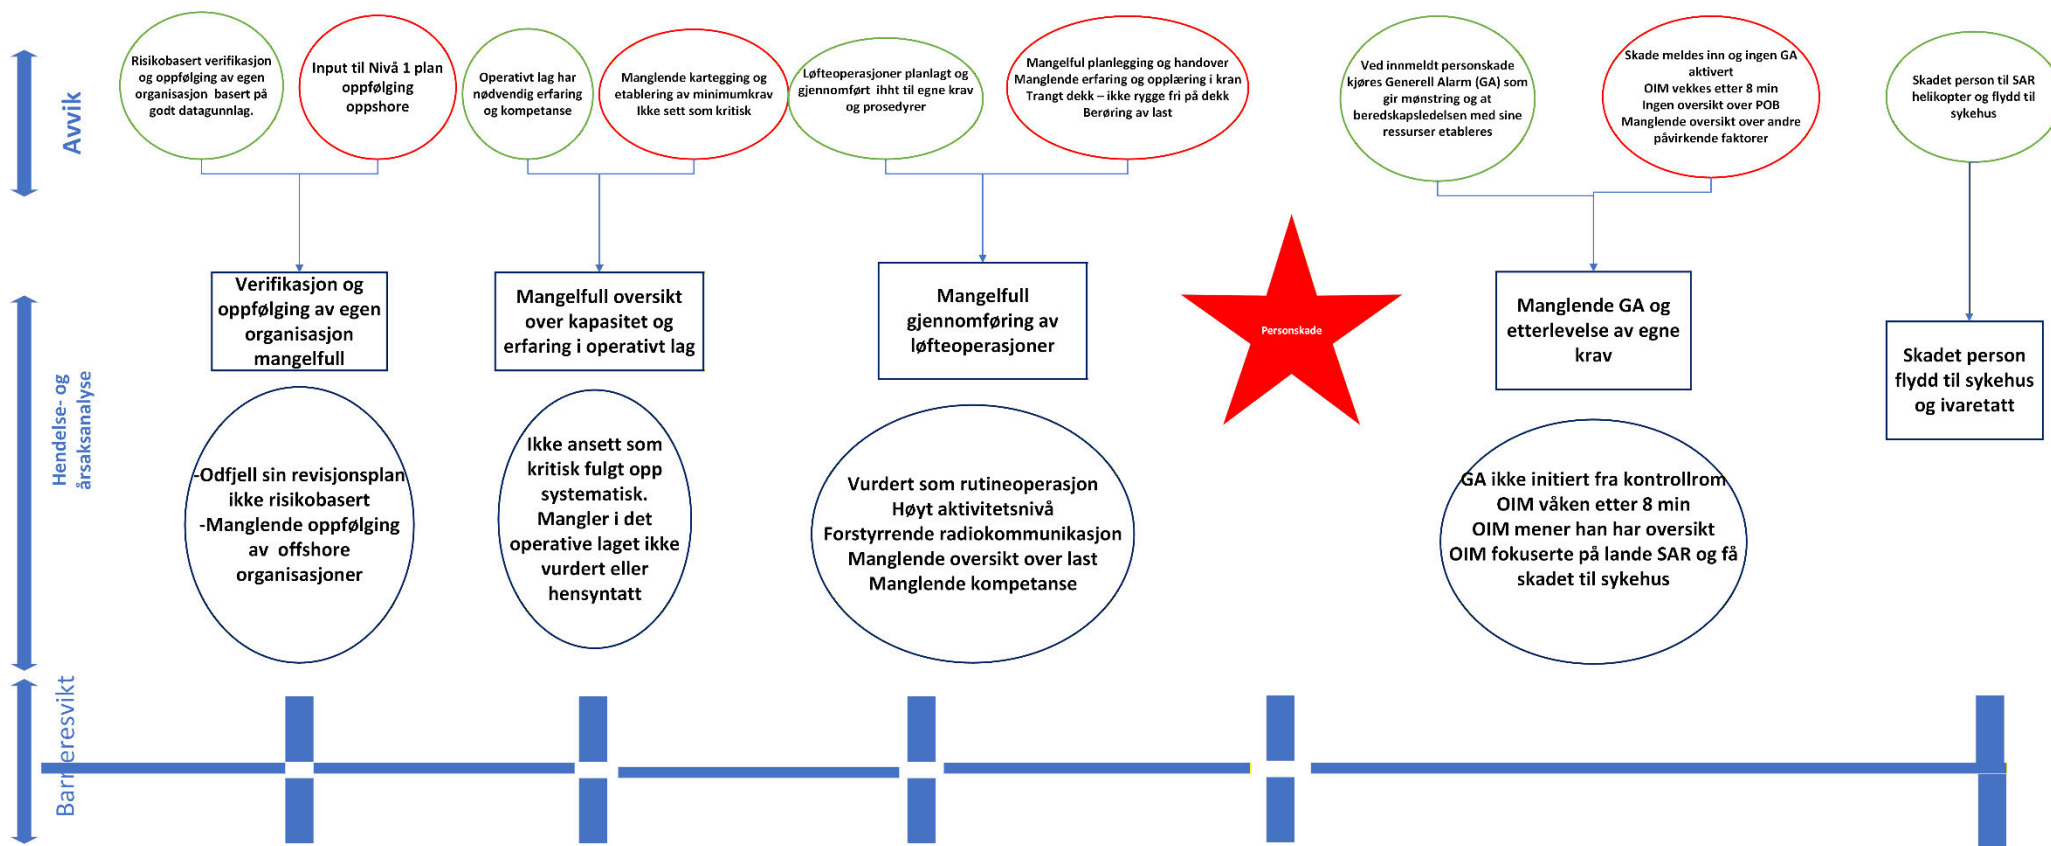
Figure 6 Simplified HTO analysis of the key elements that led up to the incident and then until the SAR barrier functioned.
