<b>Report</b>	
Report title Investigation of unwanted incident at the Brage field on 21 November 2023 involving personal injury	Assignment no. 2023-1556
<b>Classification</b>	
<input checked="" type="checkbox"/> Public	<input type="checkbox"/> Exempt from public disclosure
<b>Involved personnel</b>	
Team A-2	Approved by / date Bjarte Rødne / 8 May 2024
Participants in the investigation team [REDACTED]	Investigation team leader [REDACTED]

## 1 Executive summary

In the course of a scheduled 6-monthly valve test at Well A-20 at OKEA's Brage facility, a serious work accident occurred on 21 November 2023.

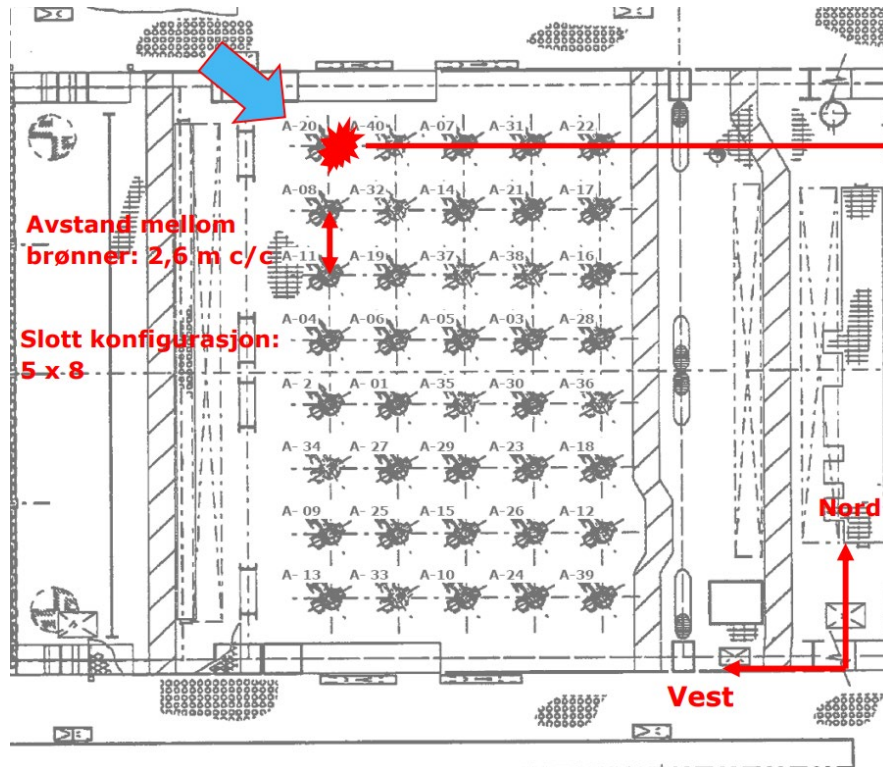
Figure 3 The wellhead deck layout

Well A-20 is located in the north-western corner of the process installation, adjacent to a walkway (Figure 3).

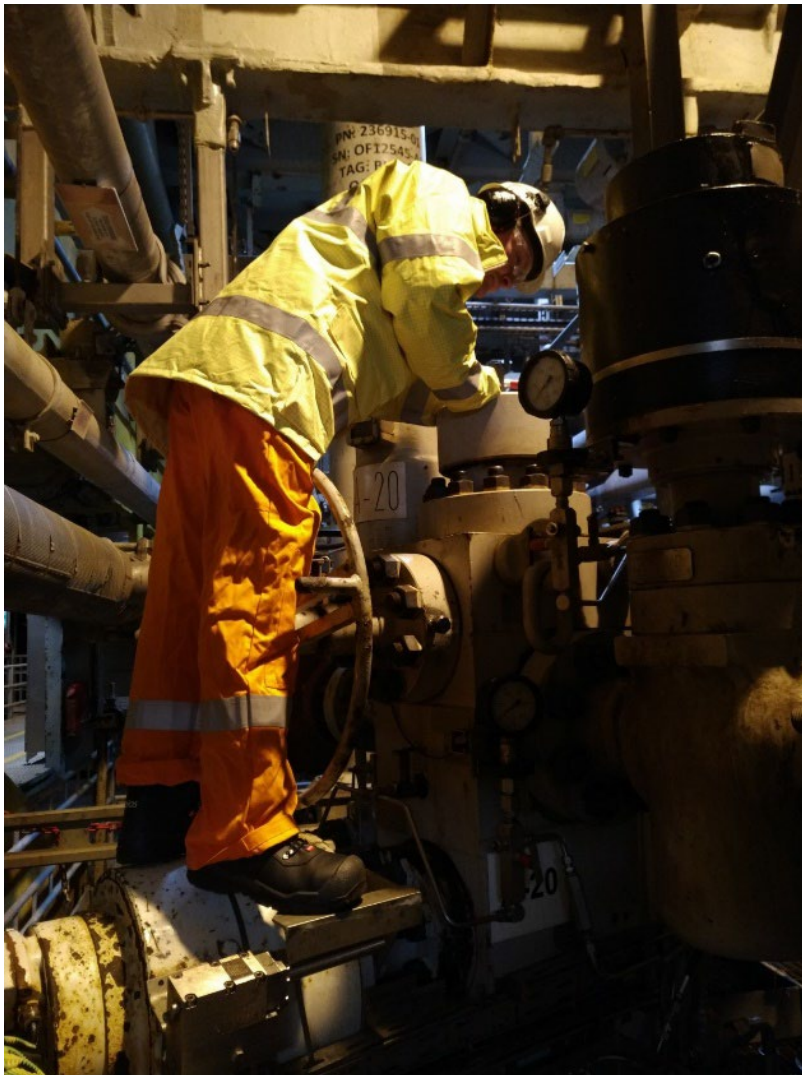
*Figure 6 The process technician's working position. Havtil reconstruction.*

The exhaust outlet of the needle valve was closed by a blind plug which had to be dismantled before connecting a hose and bleeding off the pressure. In order to reach the needle valve and blind plug, IP1 climbed up on the actuator of the hydraulic master valve (HVM), about 1.25 metres above floor level. The height of the tree cap and needle valve above the deck is about 2.25 metres. Both the needle valve housing and the blind plug have right-handed threads. To loosen the blind plug without screwing the entire needle valve housing out of the tree cap, IP1 had to hold the needle valve housing steady using one spanner and unscrew the blind plug with another. Because of his position, outside the hand wheel on the SV, IP1 had to stand bent over the tree cap in order to access the blind plug (see Figure 6).

climbing on the master valve, involving a risk of falling. The work also had to be carried out in a difficult working position (see Chapter 4). The method entailed the process operator positioning himself partly "in the line of fire" above a pressurised system. To reach the top of the master valve and maintain his balance while working, he had to step on the HMV actuator. It can also reasonably be assumed that in the event of a fall, damage could also occur to the instrumentation connected with the actuator.

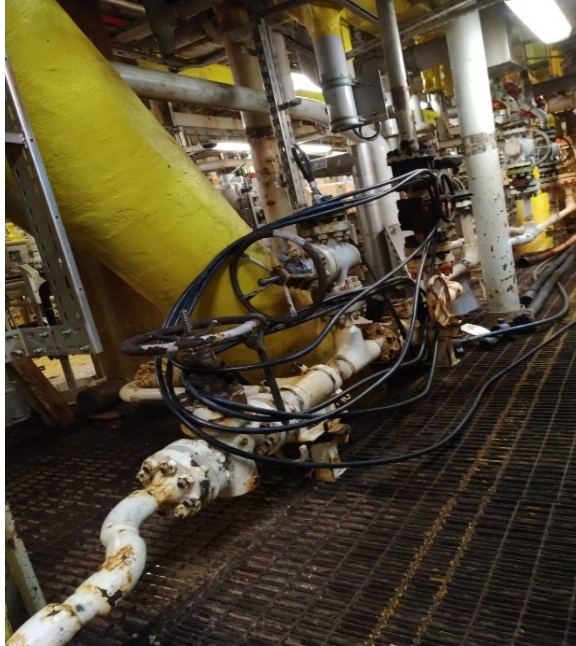
*Figure 7 Hose to closed disposal system*

Showing the hose used to bleed hydrocarbons to closed disposal system.

There was no history for the hose connected to a closed disposal system. OKEA could not document when it was brought into use or by which unit. It had apparently been in use and connected as in the photograph for several years. The hose was of unknown type and was not certified or approved for use.

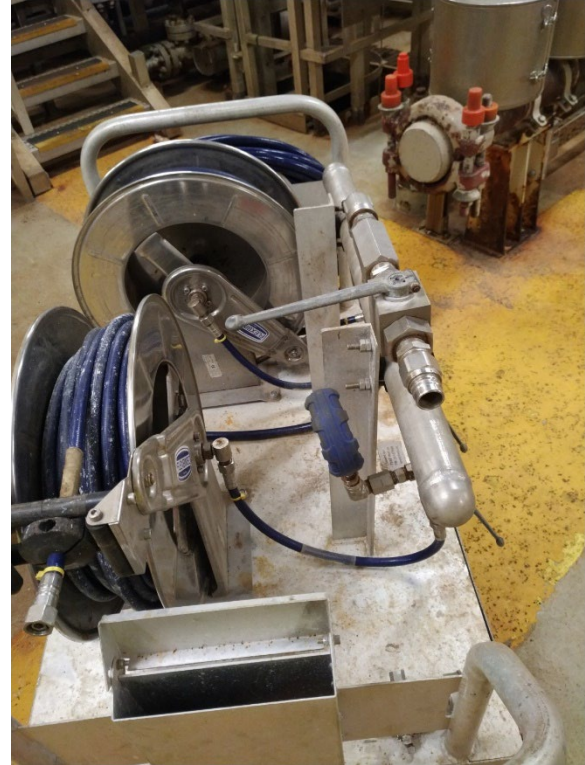
*Figure 8 DB&B cart*

Showing the DB&B cart for depressurisation to safe area.
