Investigation report

Report title Report of the investigation into an incident with a dropped object on Gyda	Activity number 049019009
--	------------------------------

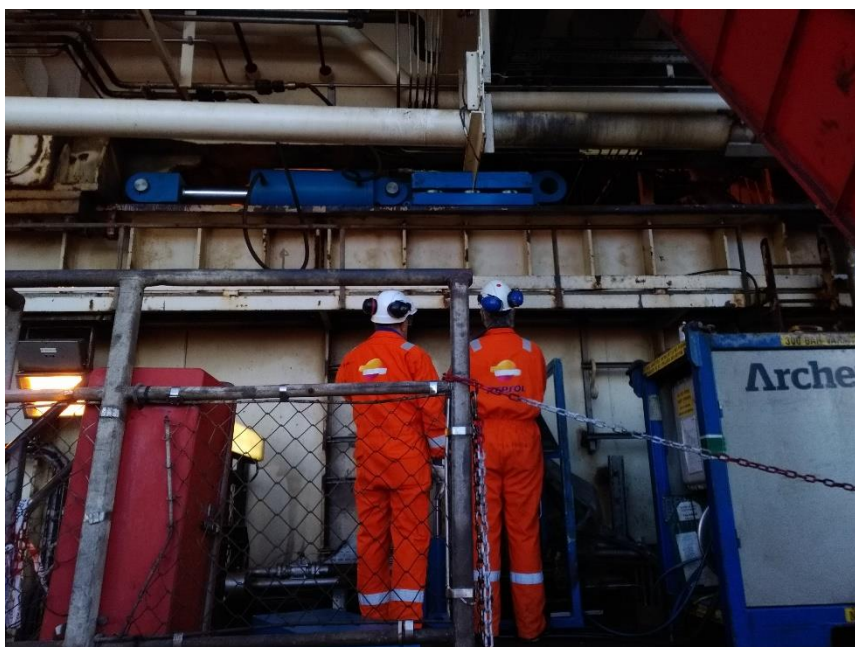
Figure 3: Reconstruction of the position of personnel when the incident occurred. The gripper system above is without the side plate.

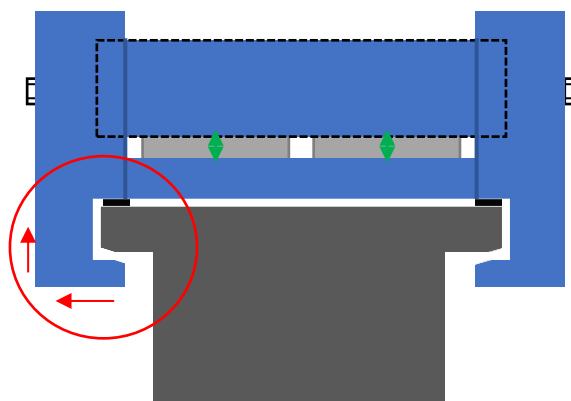
Figure 8 : Cross-section of the gripper system and skid beam. The circle indicates the area shown in greater detail in figure 9.

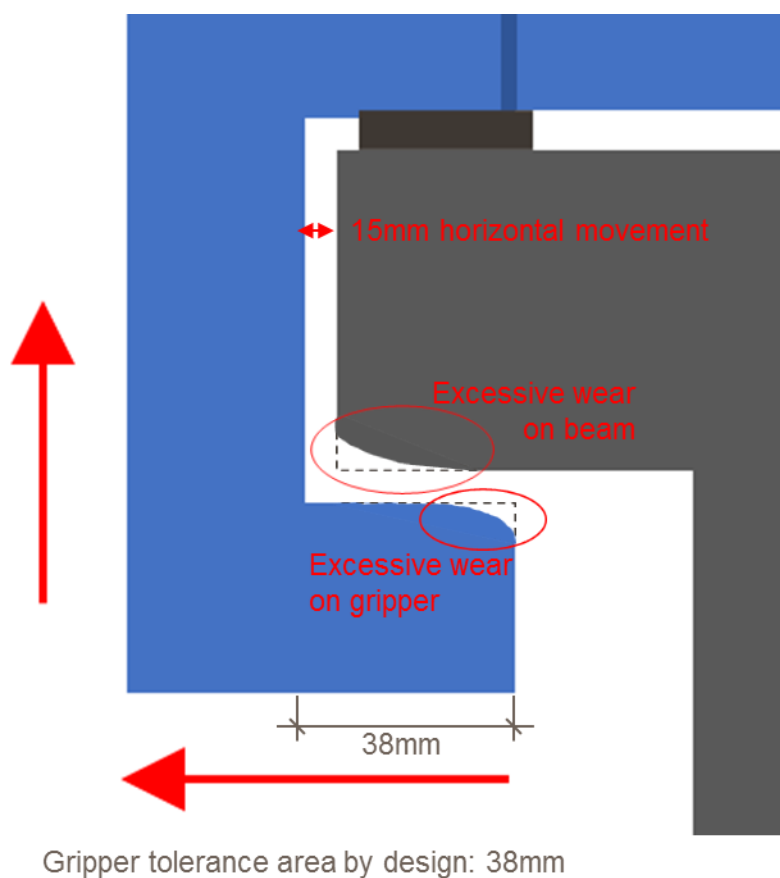
Figure 9 : Detailed cross-section showing wear and direction of force.
