Investigation report

Report	
Report title Investigation of overpressurisation in sludge cell 11 on Statfjord A on 26 November 2019	Activity number 001037047

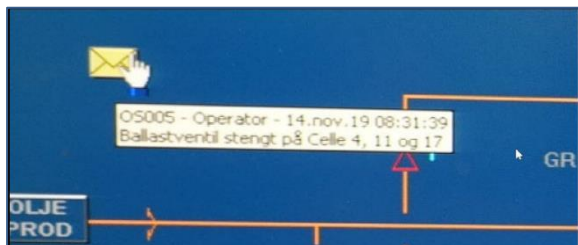
The CCR placed this information on the PCDA screen, described as “Envelope”, with details of the closure of ballast-water valve to cells 4, 11 and 17.

Image 1: “Envelope” on the PCDA screen (source: Equinor).

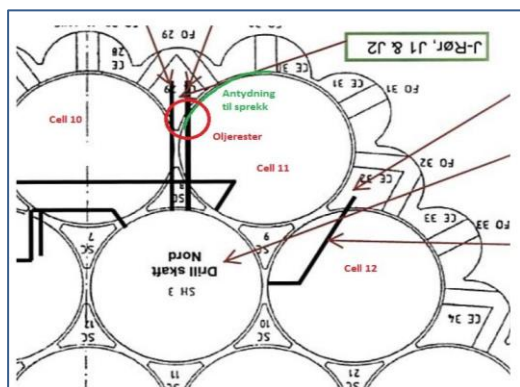
Figure 7: Inspection of cell 11 (source: I-Tech7).

Inspection of the cell wall and top dome did not find areas with fresh traces of cracks or definite signs of oil leakage.

Something which could be interpreted as oil residues, damage and cracking were found circumferentially about 75 centimetres from the outer edge of the dome and from the “embayment” to cell 10, and probably to the end of the towing attachment in the centre of the outer curve. The crack appeared to start from a foundation which spans from cell 11 to cell 10.

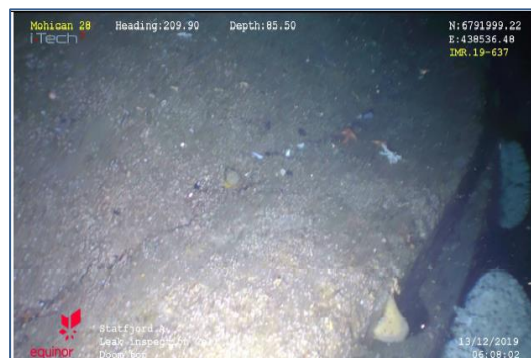
Image 2: Crack indication on dome top (source: I-Tech7).

The closed ballast-water valve on cell 11 meant that produced water could not flow into the cell backed up in the piping system. That in turn increased internal pressure fairly quickly to sea level (where the cell's internal-external pressure difference is equalised). Continued filling raised the internal pressure above the ambient level. Material tension in the concrete therefore changed from compression to tensile. Concrete has very little tensile as opposed to compressive strength. Should cracking have occurred during the construction process or through erosion, shrinkage or loads, existing hairline cracks will open. If the concrete has no previous cracks or openings, it can withstand a small tensile load before cracking. The internal overpressure in cell 11 meant that either existing cracks opened or new ones were created. When reinforced concrete cracks, the prestressing steel will still be able to withstand the tensile load and the structure will not collapse as a direct consequence of concrete cracking. The cracks observed by ROV after the incident are located in the dome close to the transition to the vertical cell wall (see image 2). The image shows no sign of splintering or loss of any noteworthy material – the crack appears to have closed to a residual trace.

Appendix F to Equinor's investigation report states: "The hairline cracking caused to the structure will reduce the concrete's strength and elasticity module. However, this need not necessarily cause any structural weakening of significance for its function. The residual strength in the concrete should be adequate. Possible open hairline cracks can self-heal". Based on Equinor's experience from the earlier incident on Statfjord C mentioned above, the PSA team considers this to be correct with regard to the function of establishing an impermeable concrete shell between sea and oil for the cell. Equinor's report also states that water leaking into the cell (after the incident was halted and underpressure re-established) was declining, which indicates that the crack had closed. Where structural function is concerned, distributing the load from shafts to seabed is primarily done by the vertical walls of the cells. Since these have not displayed damage and are analysed to have greater capacity than the dome, the investigation team takes the view that Equinor's conclusion is also correct with regard to the structural function of the damaged cell.

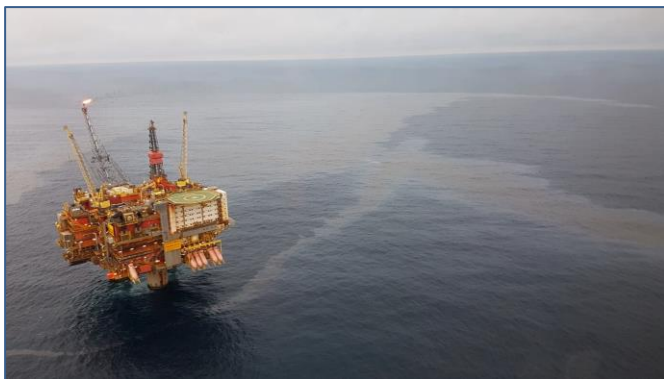
Equinor has estimated that the incident spilt about 150 m³ of oil and sludge to the sea. This volume is based of the amount of liquid led via CD2119 to cell 11 during the time the spill lasted. Density differences between oil and water mean separated oil will accumulate at the top of the cell, where the crack was identified by ROV, and the spill therefore probably comprised mostly oil. The slick on the sea surface was described as a thin film, and too thin for mechanical recovery to be effective. Mechanical dispersion was assessed as the best method of combating the spill.

Image 3: Oil on the sea, 26 November 2019 (source: NCA LN-KYV).

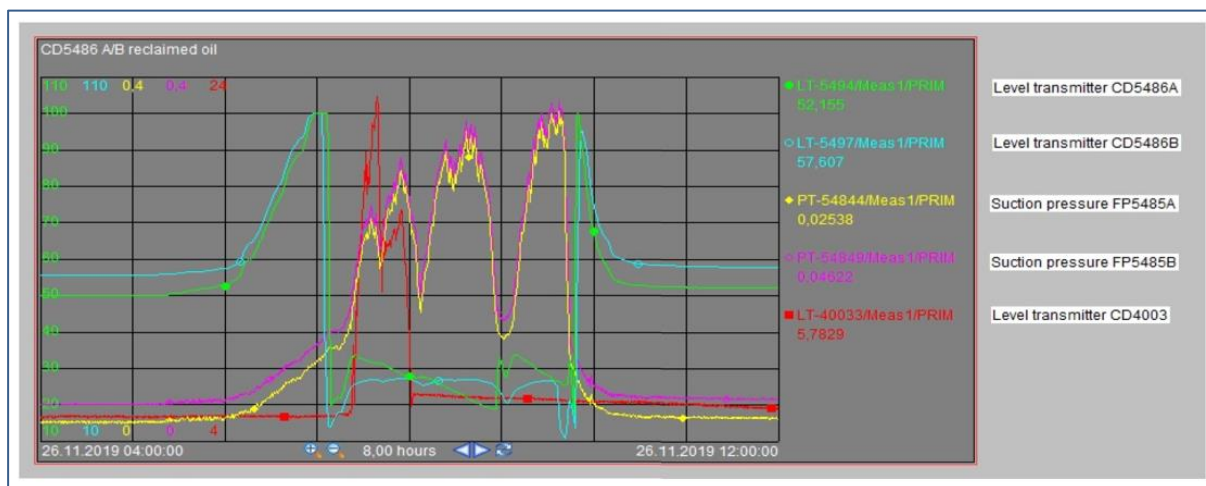
The fill ratio in the enclosed CD5486 A and B drain tanks on the cellar deck began to increase around 06.00 on 26 November, when there was an overpressure of at least 2.5 bar in cell 11. After the incident, the level in the tanks declined and was back to normal by 10.00. In other words, the concrete was subject to at least 2.5 bar overpressure for four hours on the day of the incident.

Figure 8 Level and pressure gauges in the relevant tanks. The graph extends over eight hours, from 04.00 at far left to 12.00 at far right. CD4003 fill is shown by the red curve, which reaches maximum value at 07.40. Levels in CD5486 A and B are the blue and green curves, which parallel each other to 07.00 and fall again a little before 10.00. The big jump from 07.00 to kl. 10.00 most probably reflects measurement error because the instruments were submerged in liquid and measured reflections within it rather than from the surface (source: Equinor).

Maximum overpressure is calculated to have occurred at 07.40, when the level gauge in the vent knockout drum (CD4003) showed 23 per cent full. According to the information in figure 6, the underside of CD4003 is at the 179-metre level and the highest point of the inlet pipe to CD4003 is at 186 metres. That indicates the highest pressure was $186 - 152 = 34$ metres or 3.4 bar. Liquid was measured in the knockout drum from about 07.20 to 08.00 – in other words, with an overpressure of about three bar for roughly 40 minutes.

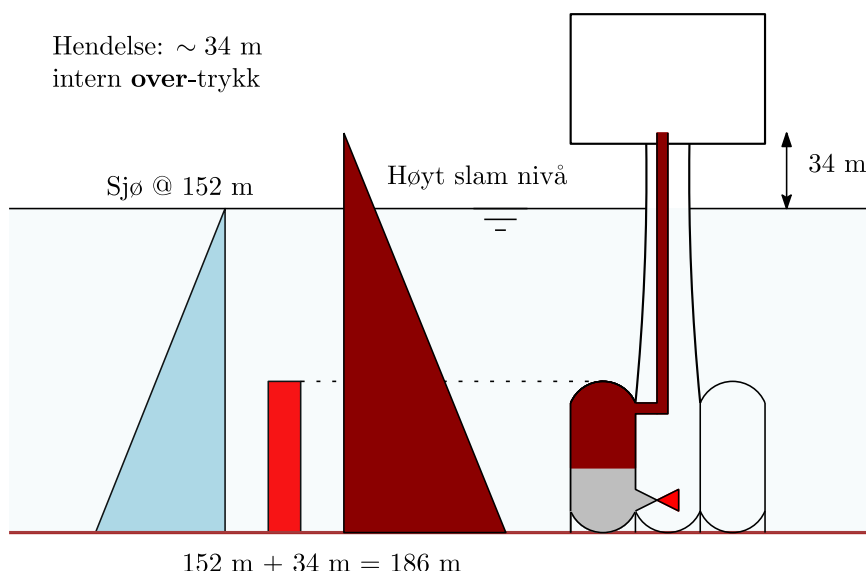
Figure 8 illustrates how internal liquid pressure caused overpressure in the whole of cell 11. The crack(s) in the concrete created contact between external seawater and internal oil. Overpressure was thereby (partially) bled off, in that oil leaked out through the crack(s). The curves for the tank levels fluctuated during the hours the leakage lasted, and these fluctuations probably correspond with variations in the oil leakage rate through the crack(s) on the concrete cell dome.

Figure 9 Illustration of the maximum overpressure in cell 11 on the incident day. Note that the upper level for pressure in the sludge system is based on the liquid column at the highest point in the piping run from CD5486 A and B to CD4003. Key: Incident: about 34 m internal overpressure; Sea level about 152m; High sludge level.
