Investigation report

Report	
Report title Investigation of the incident on <i>Maersk Invincible</i> when tubular stands became detached from the fingerboard	Activity number 400012006

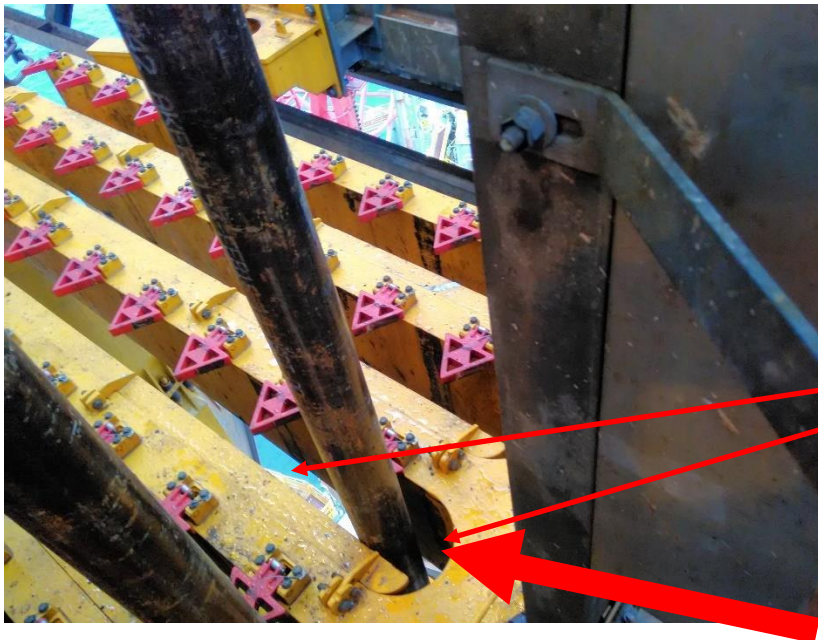
Where the stands involved were positioned before the incident.

Wind direction specified at the time of the incident.

Fig 3: Position of the stands involved before the incident.

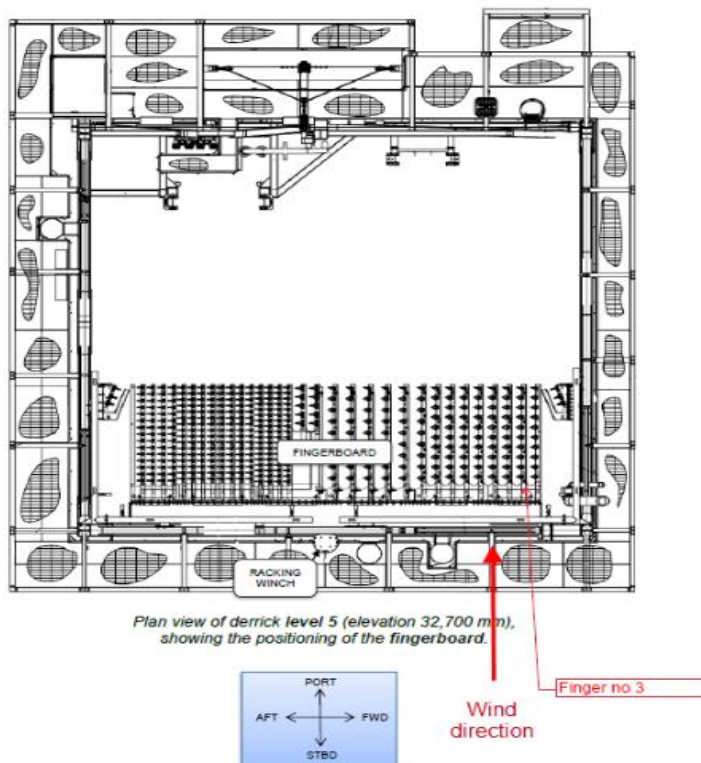
The wind strength on 11 November 2018 was 35 knots, gusting to 38 knots. It was blowing directly towards the direction of fall for the stands.

Fig 4: Wind direction at the time of the incident (from Maersk)

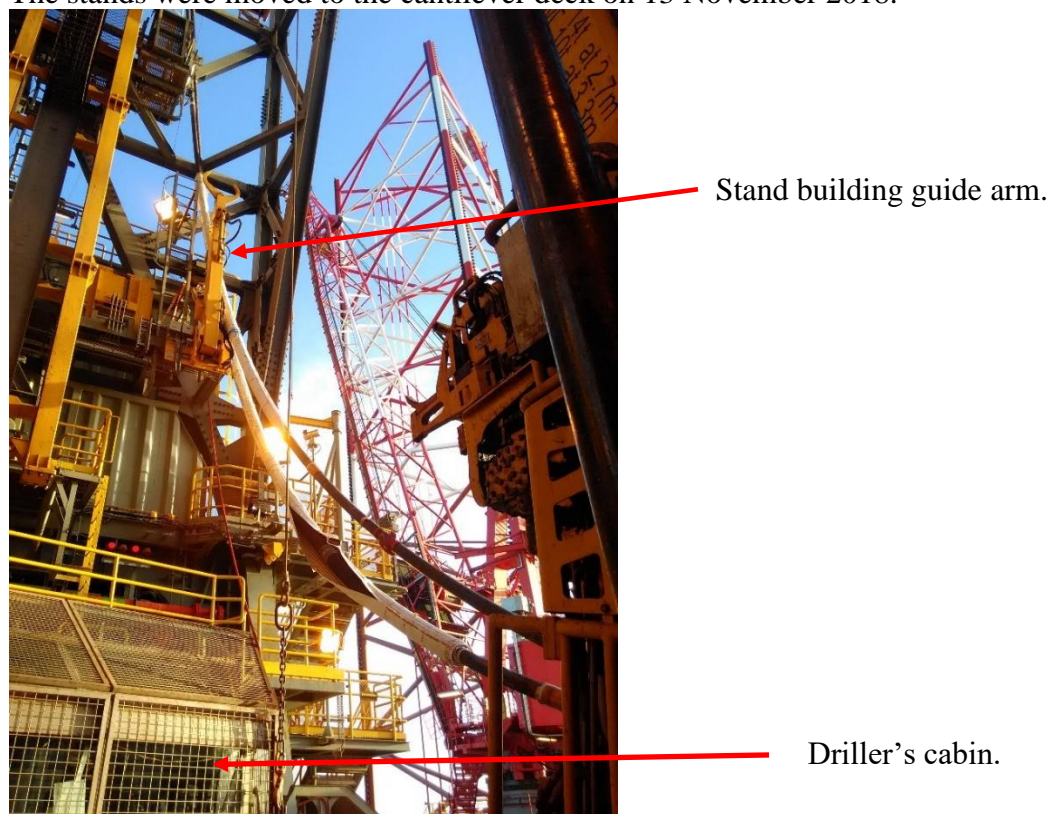
At **22.55**, the stands had worked their way completely out of the fingerboard. They became detached, slid over the drill floor and hit various items of equipment before coming to rest. The stands were then inspected and secured to prevent further movement. One of the swell packers had been bent in the fall. Protectors on both stands had been damaged.

Fig 5: Location of the stands looking towards the driller's cabin and stand building guide arm after the incident.

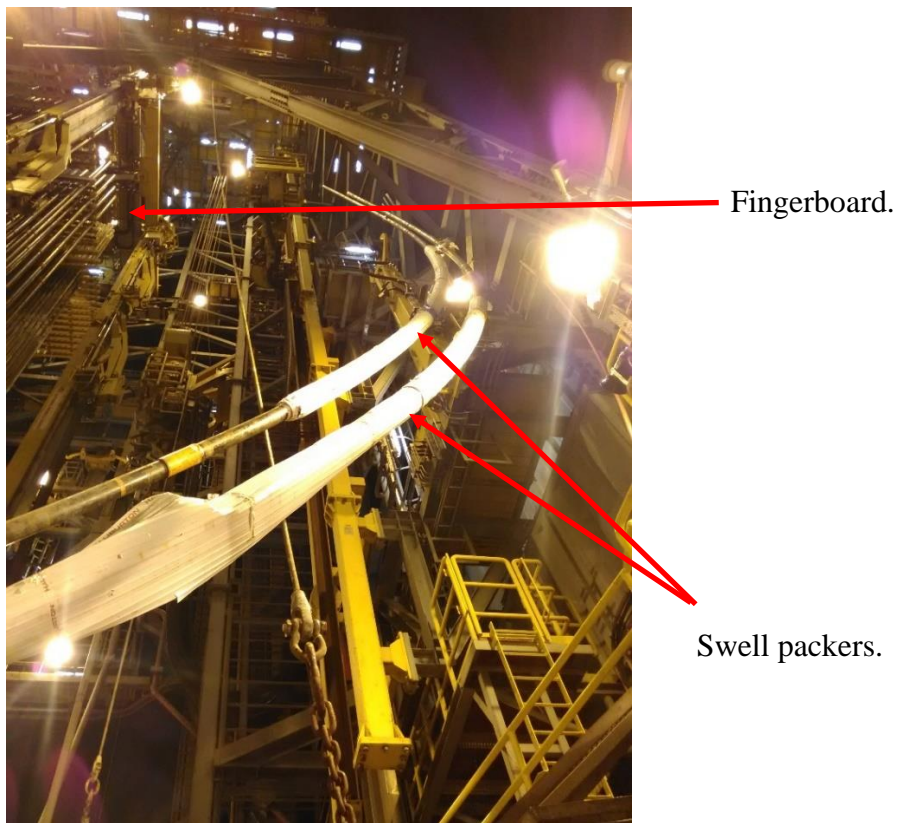
Fig 6: Location of the involved stands, looking towards the fingerboard.

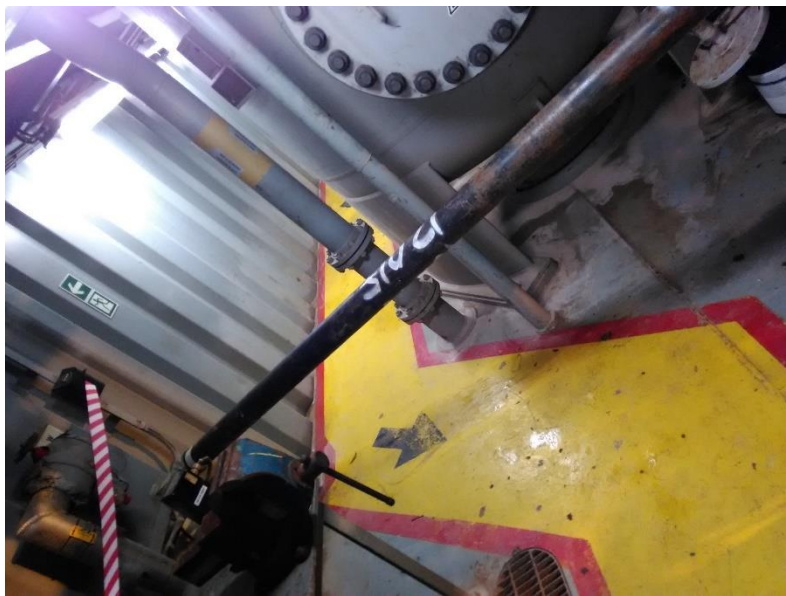
Fig 7: The lower section of the 4 ½-inch tubing halted against the wall to the left of gangway.

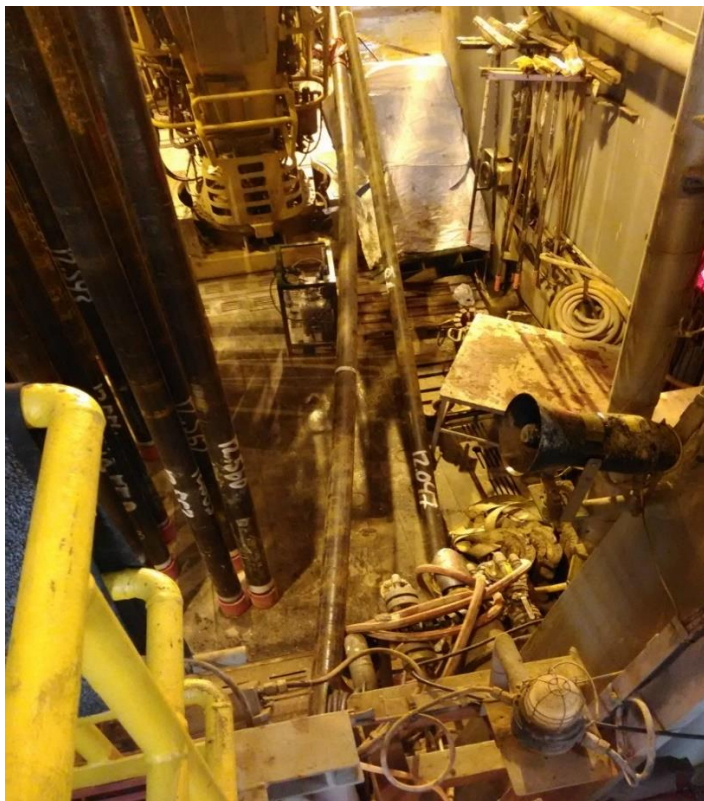
Fig 8: The stand on the left stopped against a wall by a gangway. The one on the right halted in a drain gutter. At the top of the photograph, the stands are leaning against the control panel belonging to pipe-handling company Frank's (white tarpaulin) which has been overturned.

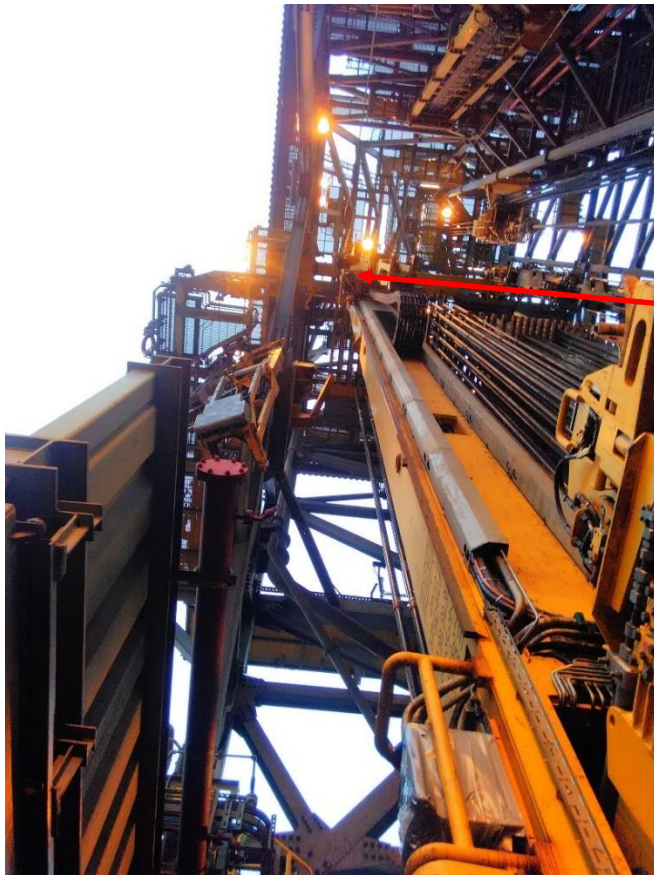
Fingerboard involved in the incident.

Fig 10: Fingerboard involved in the incident viewed from below.

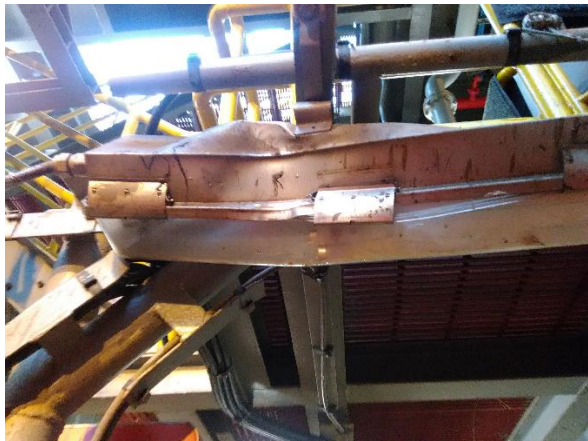
The incident caused no personal injuries. Material damage was a broken hydraulic connection in the stand building guide arm as well as damage to a connection box and a light fitting in the setback area and on the swell packer.

Fig 12: Damaged light fitting in the setback area.

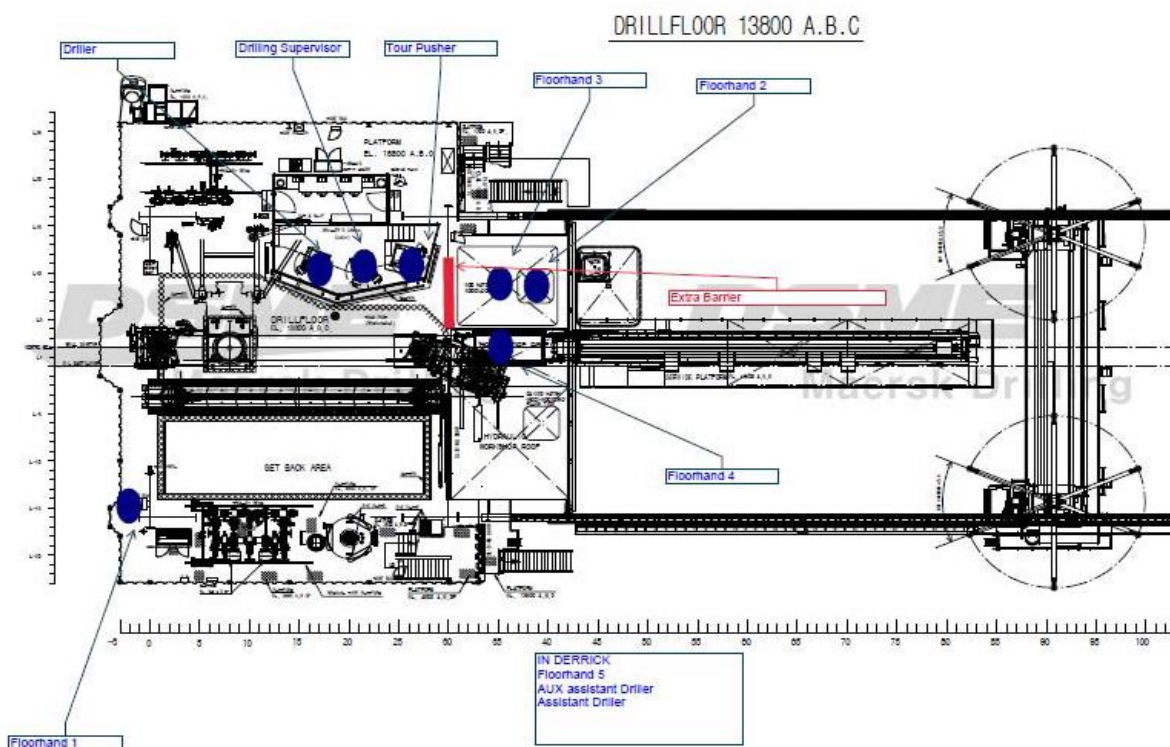
The person who was engaged in securing the area on the drill floor was a few metres away when the incident occurred. However, he managed to reach safety behind a wall when the stands slid.

Fig 13: Position of personnel when the incident occurred. (from Maersk): 1 Drilling supervisor, 2 Tour pusher, 3 Driller, 4 Floorhand 1, 5 Floorhand 2, 6 Floorhand 3, 7 Floorhand 4, 8 Floorhand 5, 9 Aux assistant driller, 10 Assistant driller.

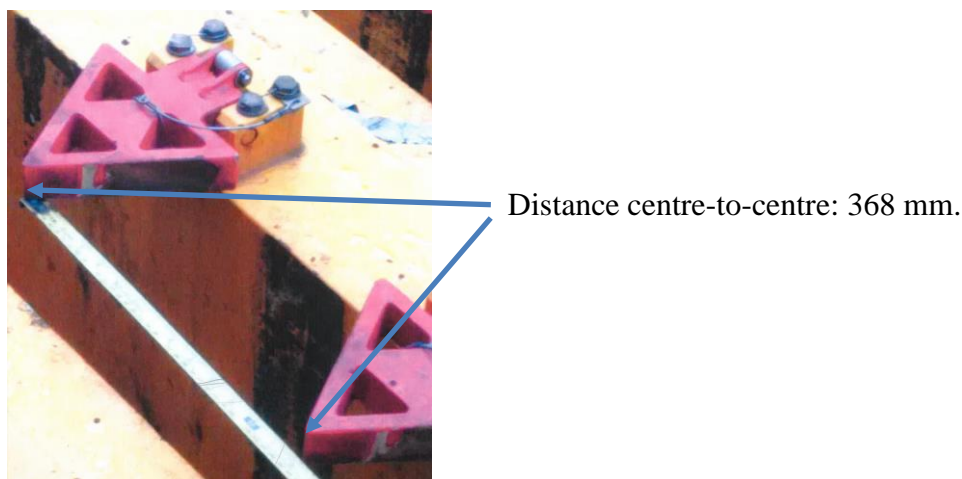
While the fingerboard is located about 33 metres above the drill floor, the stands involved in the incident are roughly 38 metres long. The stands therefore extended about four metres above the fingerboard. The fingerboard had 10 latches spaced 368 millimetres apart from centre to centre. The two stands were placed in the two innermost latches, so there were eight locked latches between them and the end of the fingerboard.

Fig 14: Close-up with distance measurement of the latches involved.

Latches on the fingerboard arm were triangular, with a 45-degree angle to the direction of fall for the stands. In the team’s view, this very probably made it easier to open the latches. Measurements also show that there was space for two stands between two latches, which gives relatively substantial room for movement. (4 ½ inches equals 101.6 millimetres and 101.6×2 equals 203.2 millimetres, while the measured distance was 368 millimetres).

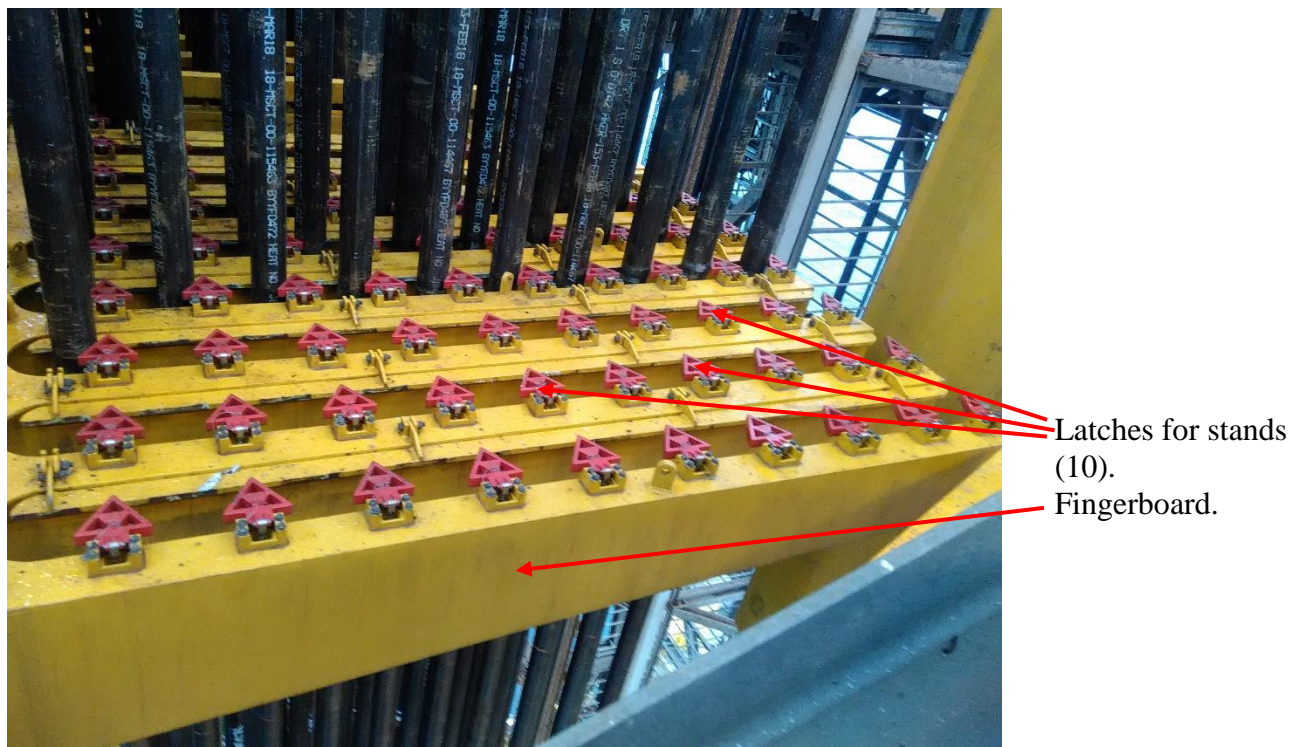
Fig 15: Fingerboard on the Aux side of the derrick. The 4 ½-inch production tubing with swell packer was stored in the second row without stands, in the centre of photograph.

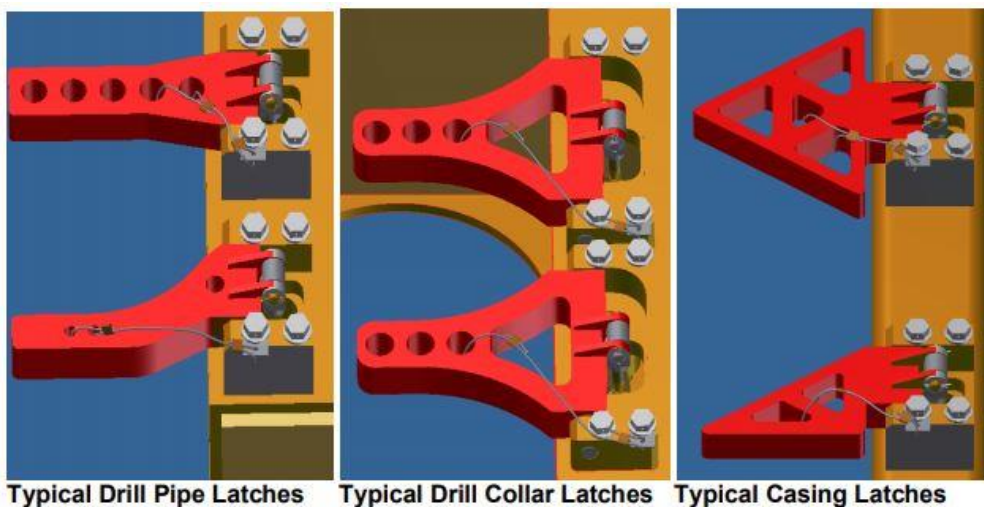
The latches are designed for casing, which means that this position is not suitable for “non-standard” stands with the dimensions of the tubing involved in the incident. It emerged from a meeting with NOV on 13 December 2018 that the rigidity of the stands had not been assessed in connection with the design and user manual for the latches on the fingerboard. This fingerboard solution has been specially developed to be as flexible as possible in connection with effective operation of the pipehandling process.

Fig 16: Various types of latches. The variant on the right was the one in use during the incident (designed for casing).

As a result of this and other incidents, NOV explained that stands with an OD smaller than seven inches should not be placed in a fingerboard unless combined with a bellyboard – a fingerboard installed in the middle of the derrick to support stands. This will be communicated to all their customers who have this fingerboard solution. NOV reported that it does not get much feedback from customers concerning incidents with its equipment. Deliveries from NOV include more than 250 of this type of fingerboard solution since 1998 without many reports of incidents.
