# Investigation report

Report title Report from the investigation of the hydrocarbon leak from the S1 template on Åsgard A – 10 March 2017	Activity number 001094029
--	------------------------------

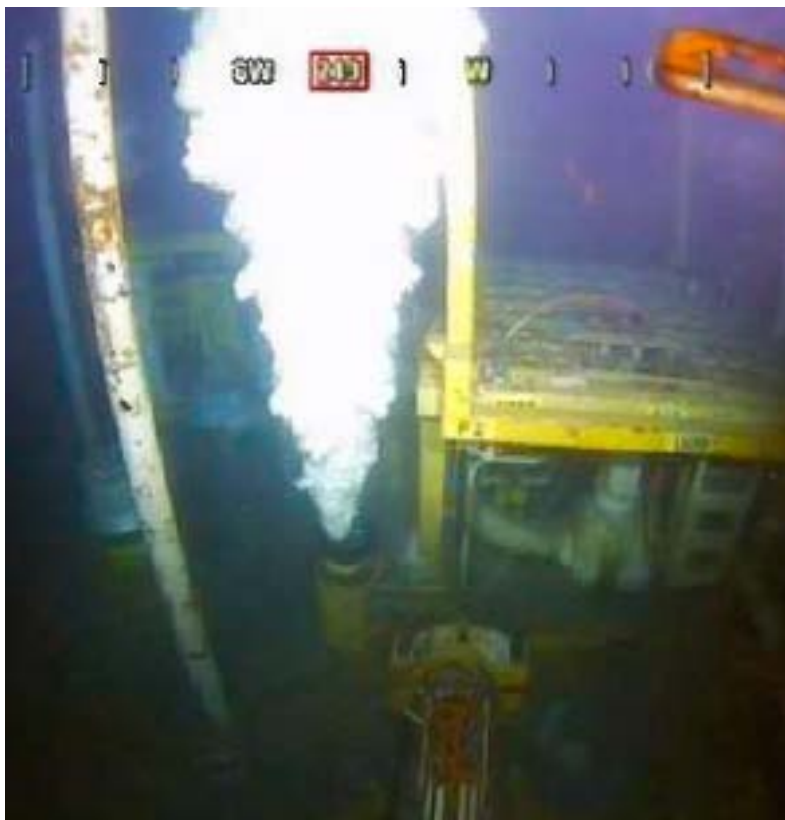
*Figure 1 - Photograph of the gas leak (Source: Statoil)*

No leakage was observed during initial activity with pulling the HPC. The latter was therefore fully unscrewed with a remotely operated vehicle (ROV) to pull it off. At 20.07, the HPC was blown off the manifold hub so that gas and condensate flowed freely to the sea.

Each well on the S template can be isolated from the subsea manifold with a single branch (isolation) valve. The investigation has established that the direct cause of the gas leak from the S template was that the isolation valve stood in the open position when the HPC was pulled.

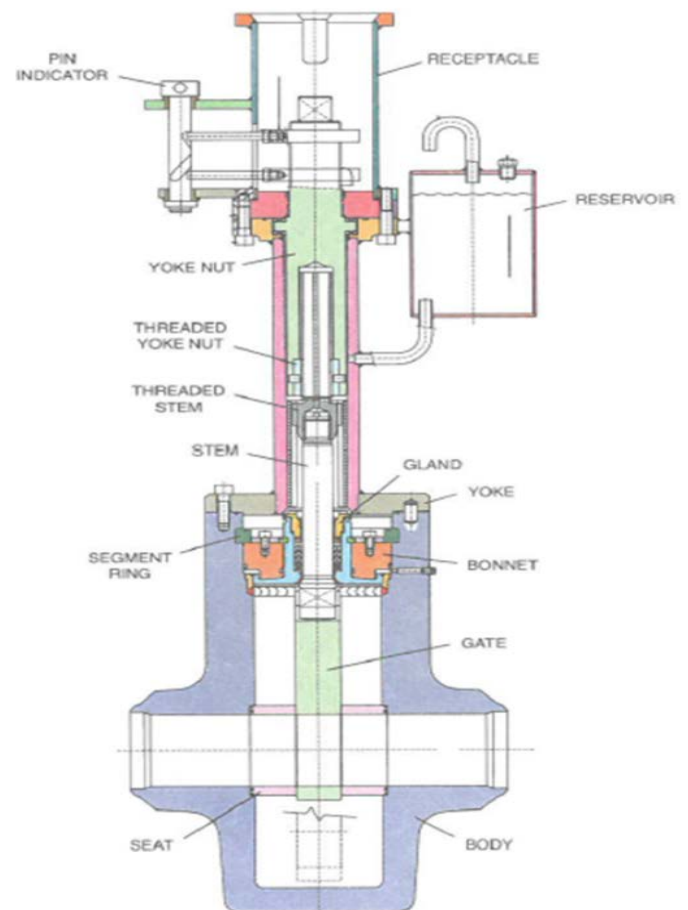
The actuator is constructed in such a way that the valve (gate) can accidentally move if the hydraulic pressure has been bled off on both open and closed sides. If pressure in the flowline is above the hydrostatic pressure, the valve can move towards closed. Similarly, if flowline pressure is below the hydrostatic pressure, the valve can move towards open.

Figure 5 - Isolation valve (Source: Statoil)

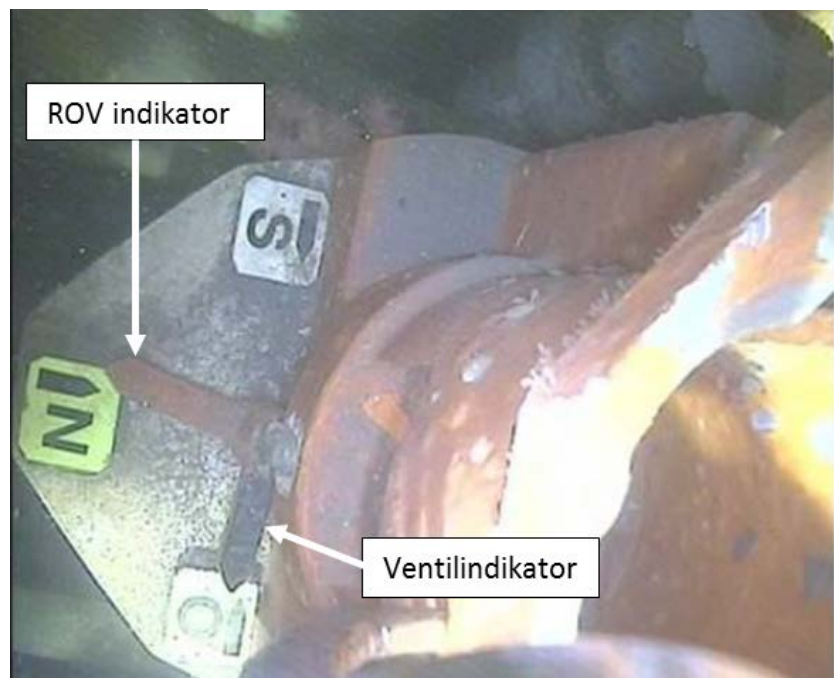
Figure 6 - Indicators on isolation valve 42 (Source: Statoil)

- ROV inspection showed that valves 41 and 42 were not secured in the locked position.
- ROV inspection showed that the position indicator for valve 42 showed it was open. There was no known history of the isolation valve indicators having faults or deficiencies.
- Failure to secure valves 41 and 42 in the closed position and leaks via valve 49 suggested that sub-tasks in the DOP had not been carried out.

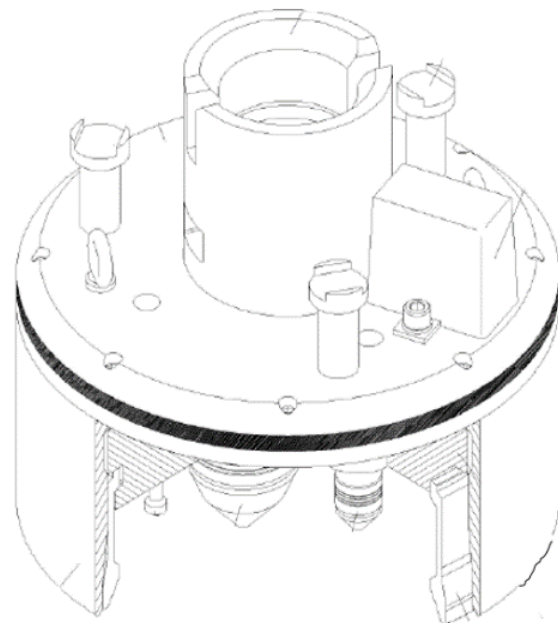
On the S template, the pressure between the isolation valve and the manifold hub cannot be established. Nor is a pressure gauge provided on the HPC itself, which means it is not possible to determine the pressure behind the HPC before it is unscrewed. A special procedure has been established for pulling the HPC in order to check whether a possible leak has arisen in the isolation valve before completely removing the HPC. In addition, a separate line is provided on the HPC for bleeding off possible hydrocarbons behind it. This line is narrow, which means it could be blocked by small impurities.

Figure 9 - HPC (Source: Statoil)

The HPC used in this incident was an older model, unable to indicate whether there was pressure behind it before pulling. The procedure for pulling an HPC (reference OMM-0012419) specifies that it should be turned six times, followed by a check for signs of leakage through the bleed-off line. Finding a leak which does not dissipate quickly suggests that the isolation valve is not closed and the HPC can be screwed back on. Furthermore, the HPC was unscrewed completely through a total of 20 turns. Newer solutions have been developed with opportunities for verifying pressure without unscrewing the HPC. People involved were not familiar with incidents reported earlier where the bleed-off function on the HPC had become blocked.
