Investigation report

Report	
Report title Investigation of a serious lifting incident with personal injury on Oseberg B on 16 April 2020	Activity number 001053062

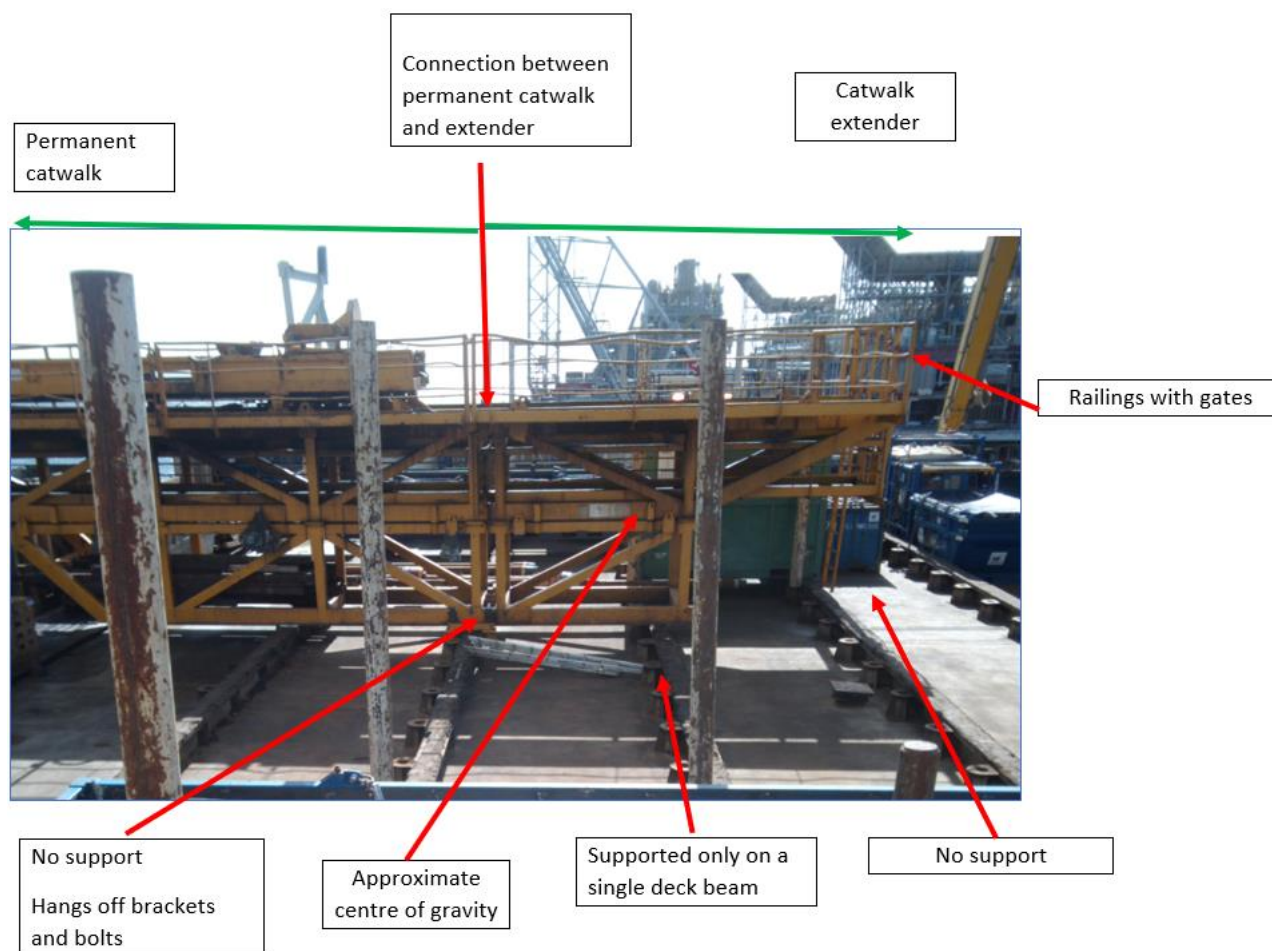
Figure 2 - Position before the incident. (From Equinor's presentation of the incident. The photo was taken on the day of the incident, but immediately before it occurred). Annotations by the PSA.

In retrospect, when assessing the pre-incident photograph (figure 2), it emerges that the extender was supported solely on a single deck beam and probably rested against the permanent catwalk in the brackets when the bolts were removed. See figure 2 which provides an indication of the centre of gravity on the left-hand side of the deck beam. The PSA's assessment is that the extender could become unstable in its longitudinal direction with small weight changes on top, or with a minor shift in its position on the single deck beam. Furthermore, the team also considers that a possibility existed for the snagged sling, on being tightened, to move the section so that its centre of gravity changed. Assessing figures 2 and 6, and looking at how the extender lies in relation to the permanent catwalk, the possibility exists that it moved longitudinally away from the catwalk, was held in place by the snagged sling and twisted over onto its side. That is because photographs show that the extender is both displaced and twisted somewhat in the longitudinal direction.

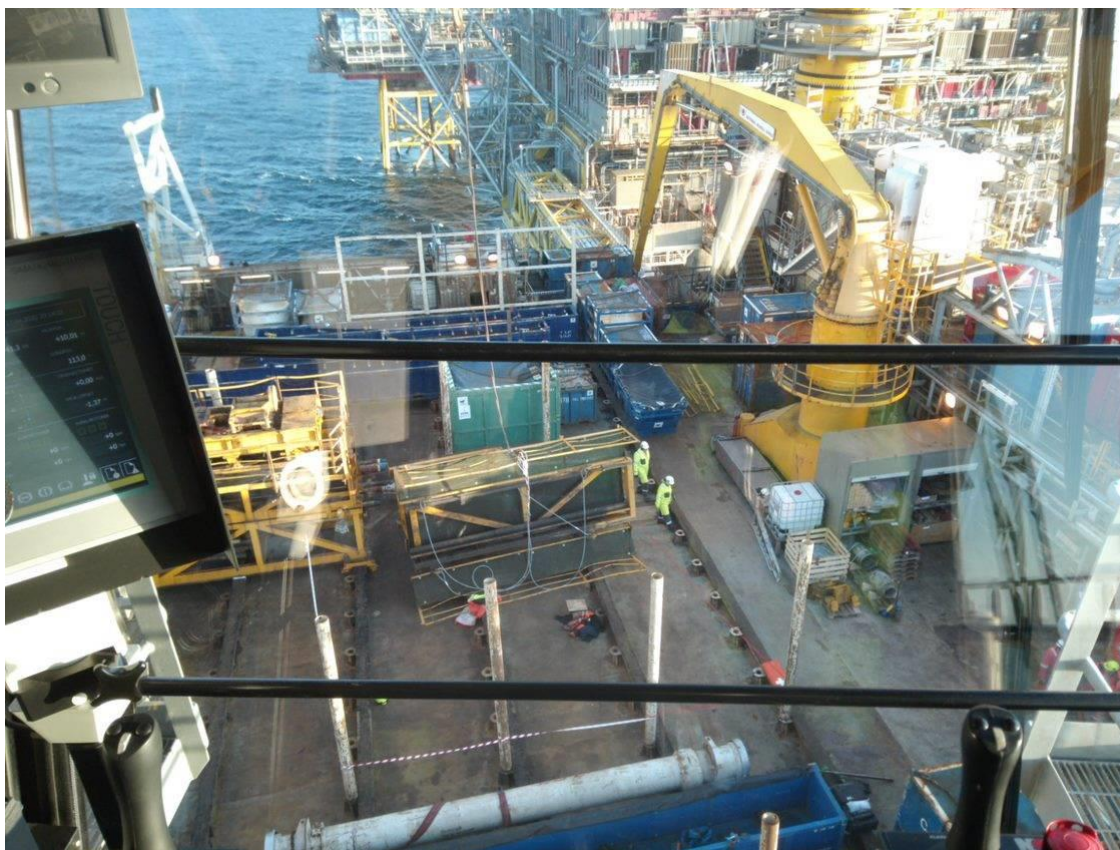
Figure 3 - The catwalk and the tipped-over extended, viewed from the operator position in the crane cabin.

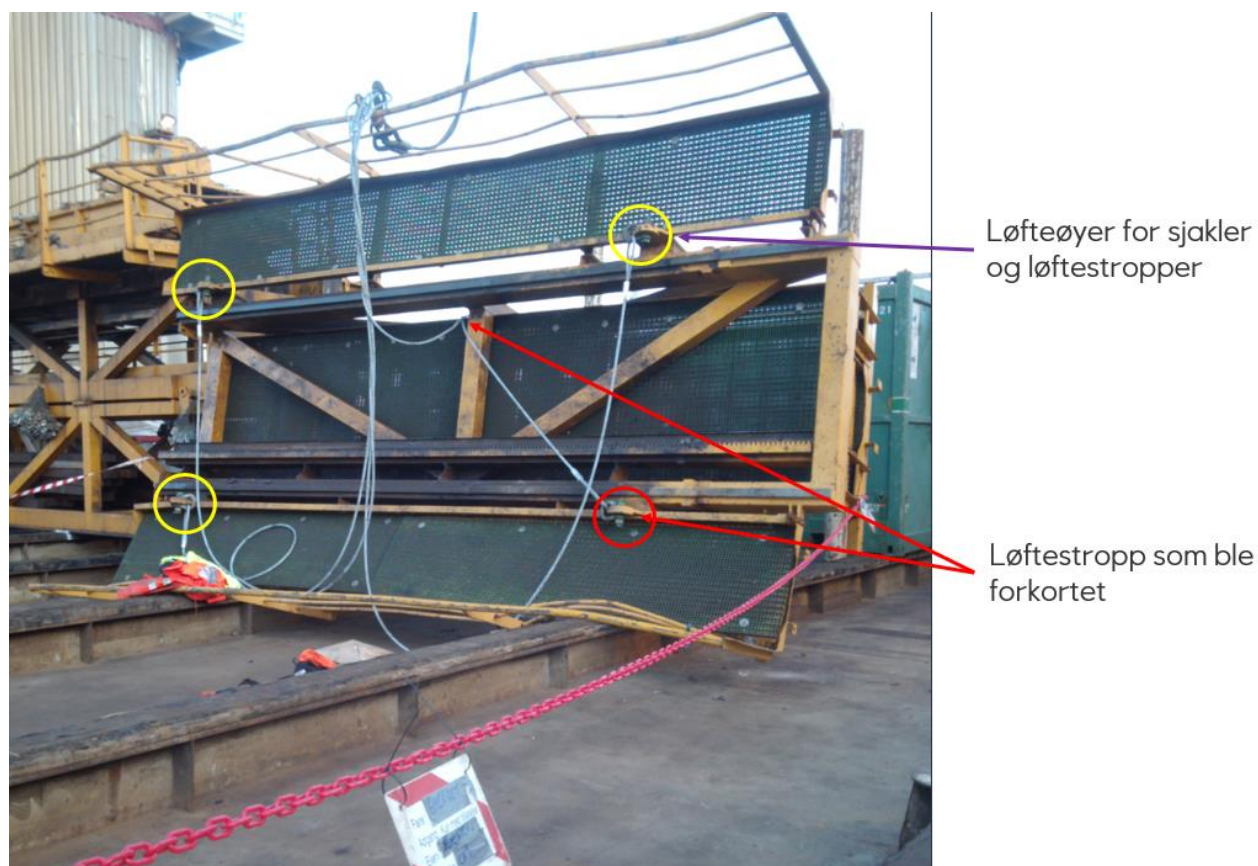
Figure 4 - The catwalk and the tipped-over extender seen from the operator position in the crane cabin. From Equinor's presentation of the incident.

Key: Pad eyes for shackles and slings; Sling which became shortened.

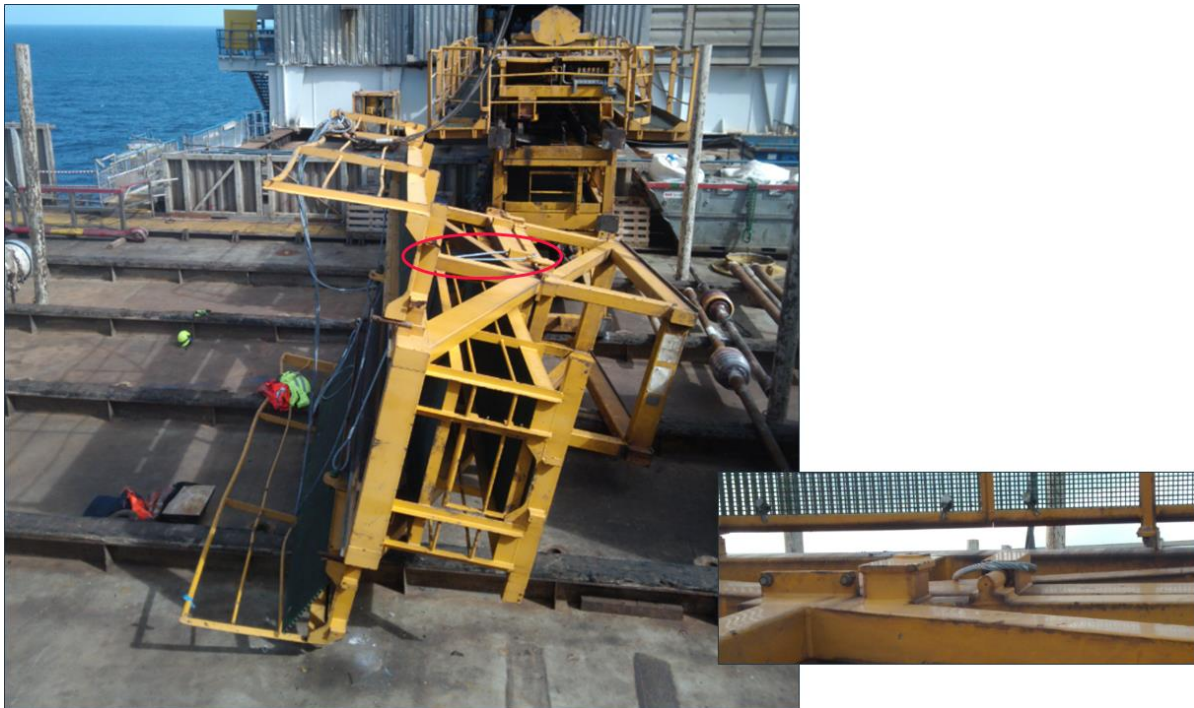
Figure 5 - The structure where the wire rope sling became snagged. From Equinor’s presentation of the incident.

The direct cause of the incident was that one lifting sling became snagged on the extender's structure as the crane hook which the sling had been attached to was raised.

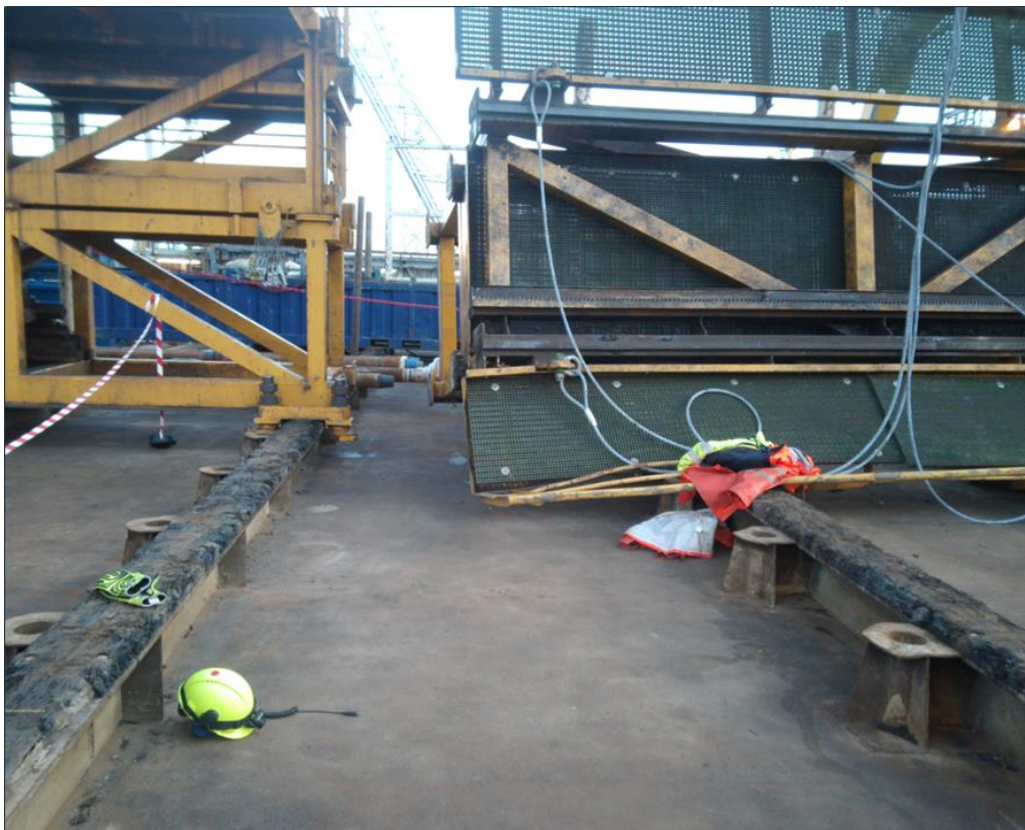
Figure 6 - The structure displaced in the longitudinal direction away from the permanent catwalk and twisted somewhat in the same direction. From Equinor's presentation of the incident.
