Investigation report

Report	
Report title Investigation of incident on 31 January 2024 involving a cabin window on Åsgard A being forced in by green water	Activity number 001094054
Classification	
<input checked="" type="checkbox"/> Unclassified	<input type="checkbox"/> Exempt from publication
Parties involved	
Team A-1	Approved by / date Kjell M. Auflem / 8 January 2025
Investigation team participants [REDACTED]	Investigation leader [REDACTED]

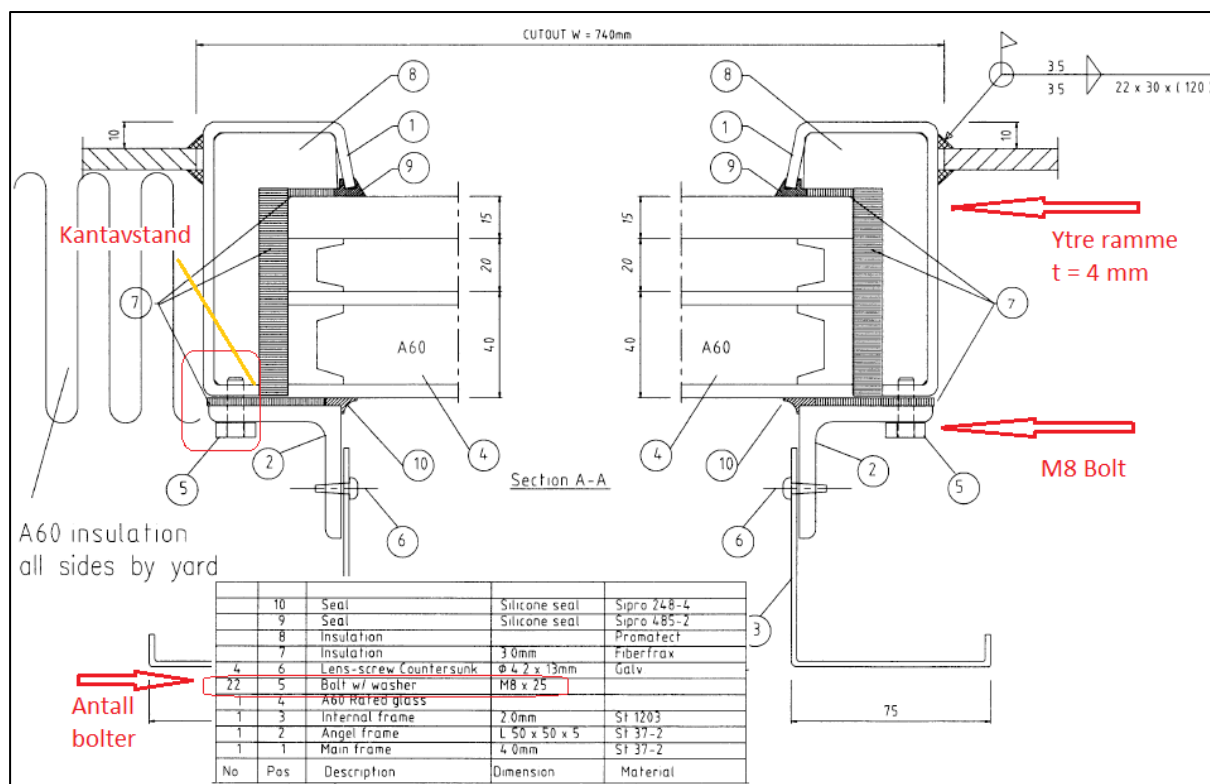
Figure 6: Extract from drawing C055-HX-C-XF-7550-07, rev. 01F (source: Equinor)

The type W1 windows are mounted using 8mm bolts screwed into threaded holes through the outer frame. The outer frame is a prefabricated, 4mm-thick profile made of 37-2 grade steel with a yield strength of 235 MPa and a tensile strength of approx. 370 MPa. The frame itself is welded using a 3.5mm fillet weld on the outside and inside of the bulkhead.

Equinor's investigation report shows that 26 bolts are used to secure the window, based on the photographs taken after the incident. However, 22 bolts are shown on drawing C055-HX-C-XF-7550-07. It is uncertain whether this difference is due to a typographical error or later revision of the drawing.

It is assumed that the windows are installed by drilling and threading the outer frame at the construction site. The part of the outer frame used for attachment is measured on the drawing above as being 20mm, including a plate thickness of 4mm. Edge distances for the window's bolted connection were measured and are shown in Table 4-2 of Equinor's investigation report. Edge distances ranged from 2.2mm to 7.6mm, which is significantly less than the value of 1.2 times the bolt hole diameter specified in the NS 3472 standard dating from 1984.

As the chosen attachment method was difficult and the margins for adjusting the windows in situ were small, this resulted in bolt holes generally having small edge distances and, in the case of the broken window, two bolt holes which did not have a full circumference.

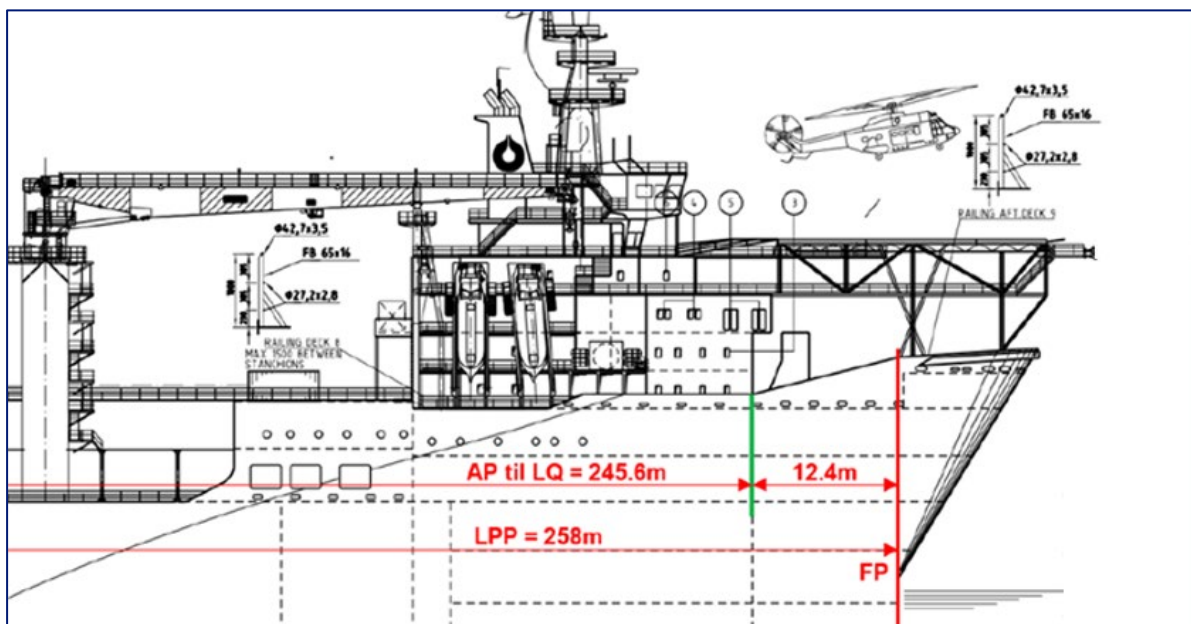
Figure 7: Deck elevations for description of freeboard above still water level to LQ and FP. Illustration for Åsgard A. (Source: Equinor)

According to Equinor's investigation report, at the time of the incident, Åsgard A had a draught measured amidships of 18,455m with an aft trim of 3,493m (0.7758 degrees). This gives a freeboard above still water level of 22.8m on the forward perpendicular (FP), and 18.9m at the bulkhead towards the bow (front wall of living quarters). This means that, during the incident, Åsgard A had approximately 0.5m less freeboard above still water level at the living quarters than Norne FPSO is able to operate with when in winter condition. Equinor also states that the freeboard on the FP was 3.2m higher on Åsgard A than the minimum for Norne FPSO in winter condition.

Equinor considers it likely that this incident was caused by a wave coming from the starboard side rather than over the bow. We have no reason to doubt this conclusion.

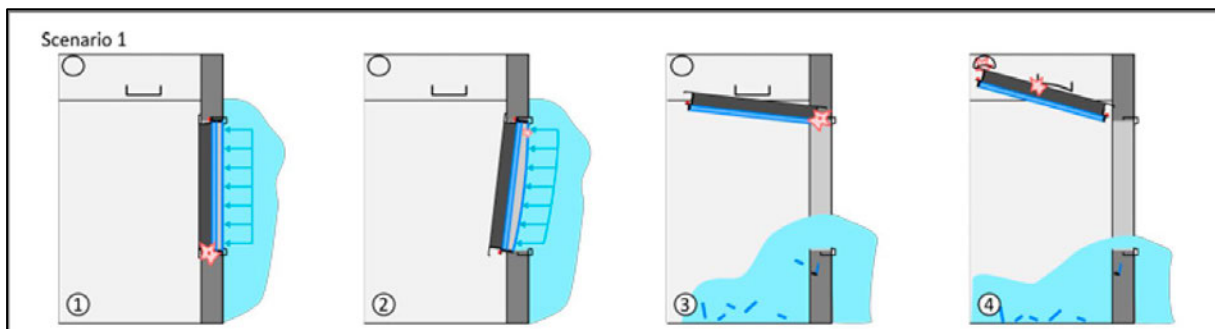
Figure 8: Most likely sequence of events (Source: Equinor)

Equinor's investigation report assumes that the most likely sequence of events is that the window frame and window came loose at the bottom and were pushed up through the ceiling by the water that was forced into the cabin and then landed on the floor. The glass most likely broke due to stresses in the frame as the window was forced in. Equinor has used an external party to assess the likely sequence of events.

The bolts along the top edge of the window were the last to become detached and acted as hinges before being wrenched out of their fixings. Finally, the window and frame landed on the floor.

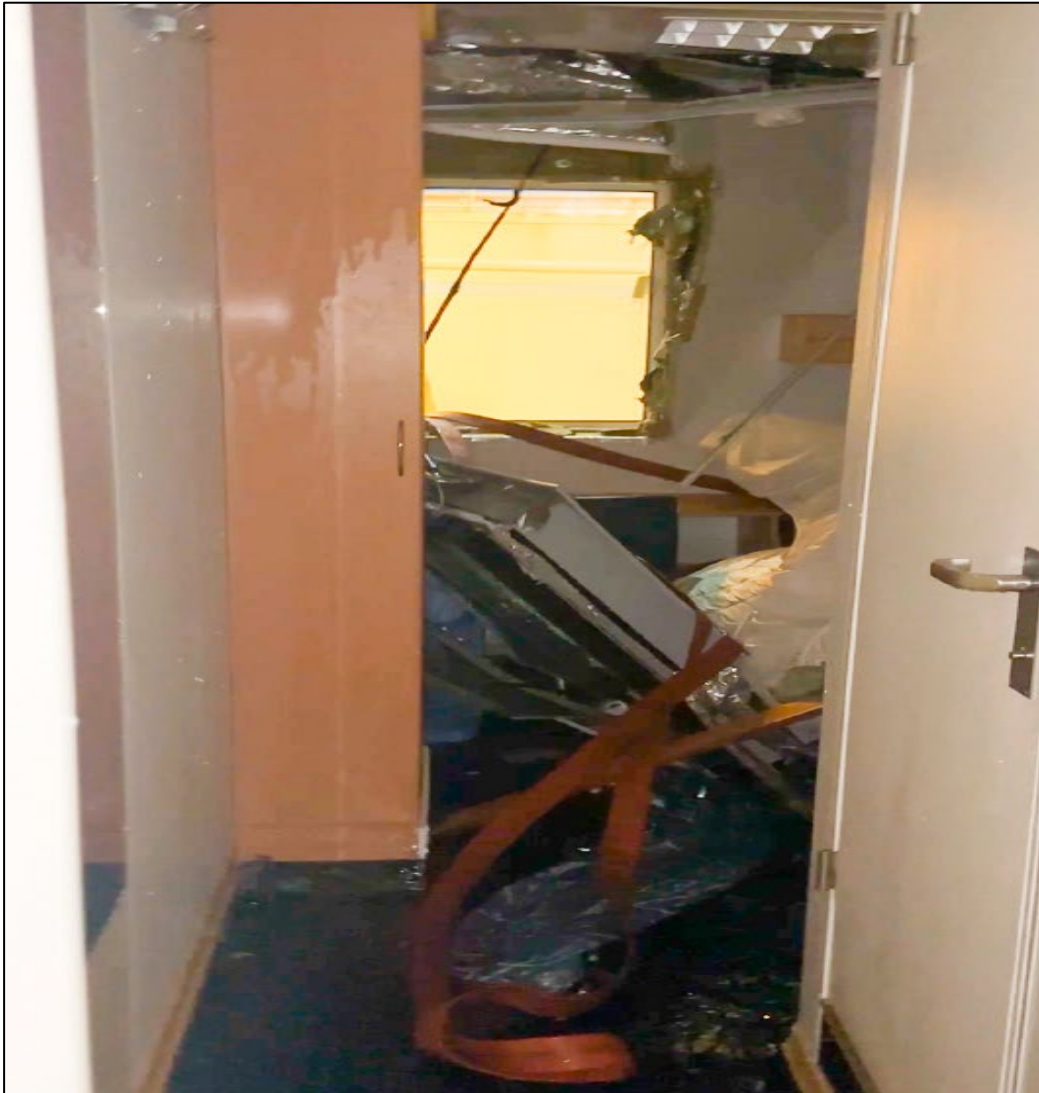
The incident caused material damage where the window and frame of cabin 812 were broken. The window's outer and inner glass layers were smashed into lots of small round fragments. Seawater was washed into the living quarters on deck 8 and down the elevator shaft and stairs to the stairway on deck 7. Water got under the cabin's ceiling panel and flowed from there into the adjacent cabins 810, 811 and 813. Water penetrated deck 7 and the ceiling of the medical facility. Ventilation pipes and cable trays in the ceiling of cabin 812 were damaged. External cable trays and lighting fixtures were damaged during the incident. The fire-protection box on the front deck came loose and parts of the box and fire hose were found inside cabin 812.

Damage to cabin 812

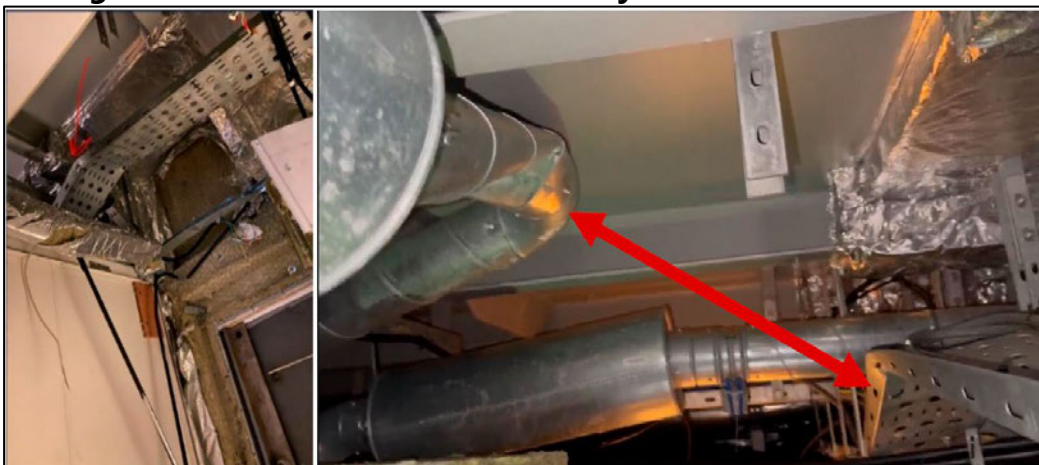
Damage to ventilation duct and cable trays in cabin 812

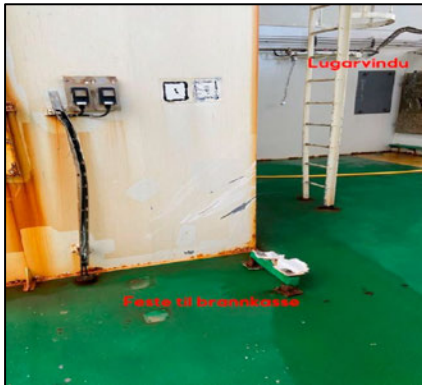
Fire-protection box attachment torn-off

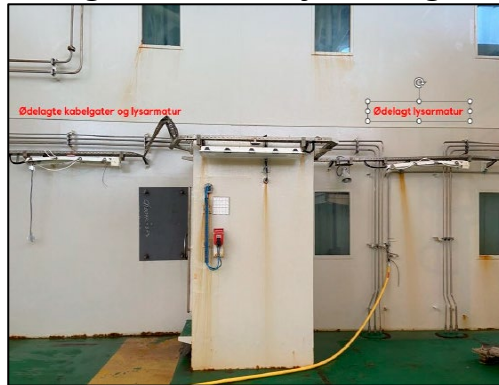
Damage to cable trays and lighting fixtures
