Investigation report

Report title Report of the investigation into an unplanned emergency shutdown and acute oil spill to the sea on the Eldfisk complex in the period 6-8 August 2014	Activity number 009018525
--	------------------------------

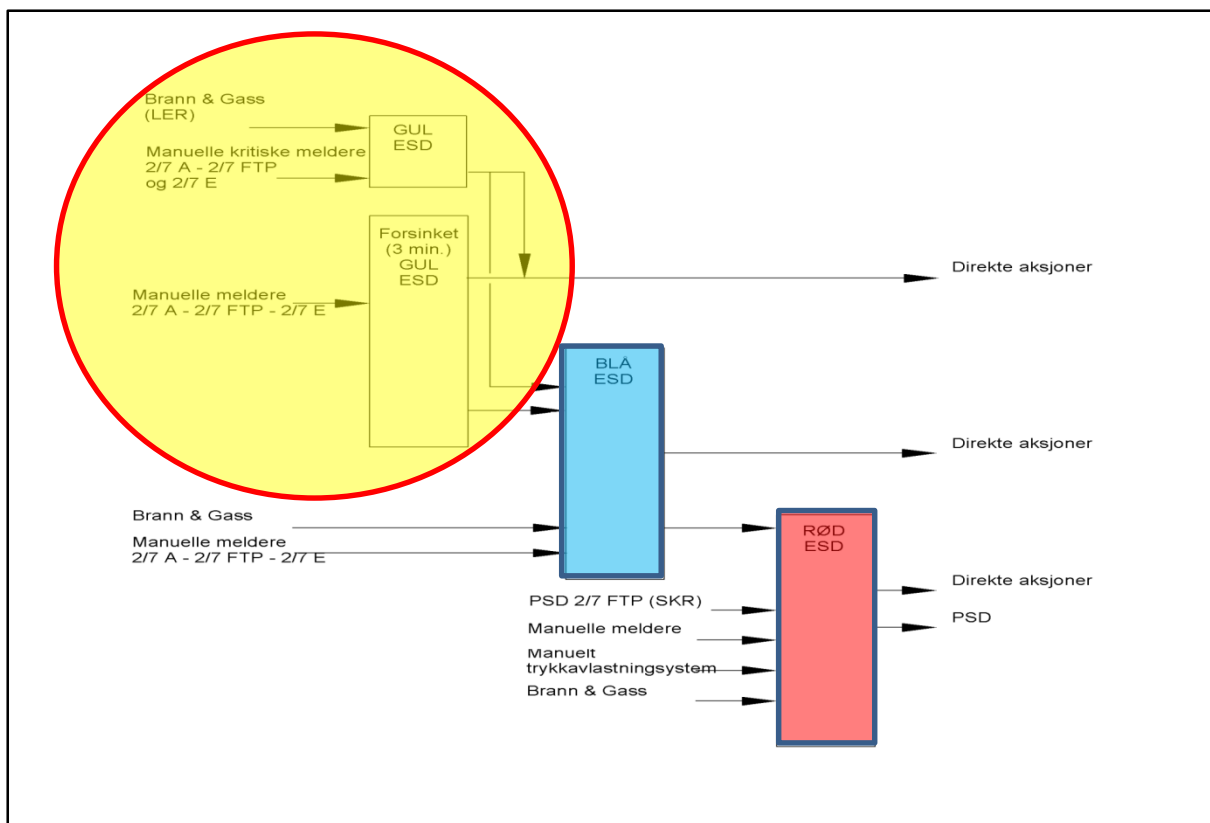
Figure 3 Diagram of the emergency shutdown logic for the Eldfisk complex. Source: ConocoPhillips

A yellow ESD means total loss of power throughout the facility/complex – in other words, all ignition sources are disconnected. The technical solution implemented for the Eldfisk complex to ensure that UPSs and batteries are dead in a yellow ESD is shown in figure 4. Note particularly that the battery breaker for both UPS A and UPS B is connected to the same single output card in the ESD node in the new LER on Eldfisk A. A failure or impairment of the output card accordingly leads immediately to a yellow ESD with a consequent cascade of shutdown actions. The same output card as the one shown in figure 4 is also used to disconnect the battery breakers for both UPS 1 and 2, which are dedicated to emergency power supply for the telecommunication systems.

This solution deviates from the requirements in the regulations, which specify that a single error must not lead to a loss of safety functions.

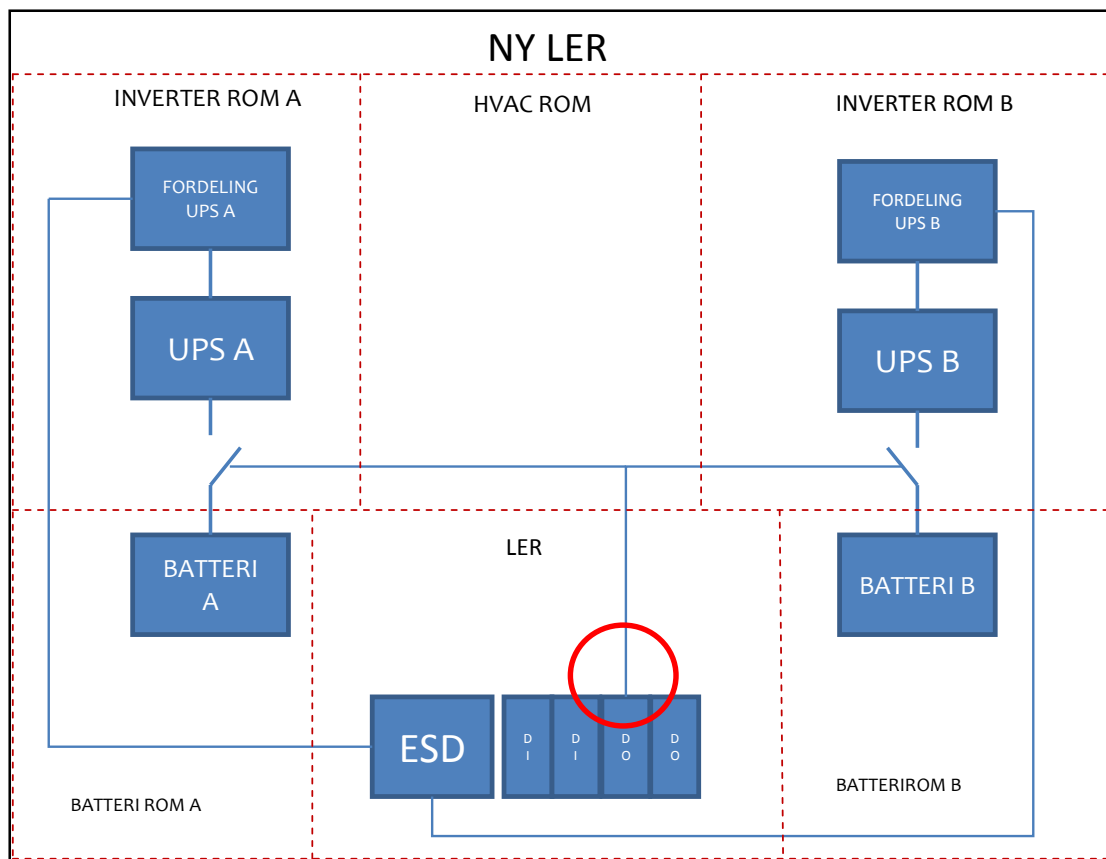
Figure 4 Diagram of ESD node and UPS A/B in the new LER on Eldfisk A. Source: ConocoPhillips

Underlying causes which could have contributed to both UPS A and UPS B being connected to the same output card include:

- inadequate or unclear specifications for ESD, UPS and telecommunication systems in the design phase
- inadequate knowledge of regulations, standards and established practice related to the design of ESD, UPS and telecommunication systems
- inadequate expertise/experience with the design of ESD, UPS and telecommunication systems
- inadequate quality assurance routines for technical solutions at various levels and phases of the project execution
- inadequate checking, testing, commissioning and verification before handover of the ESD, UPS and telecommunication systems from project to operations organisations.

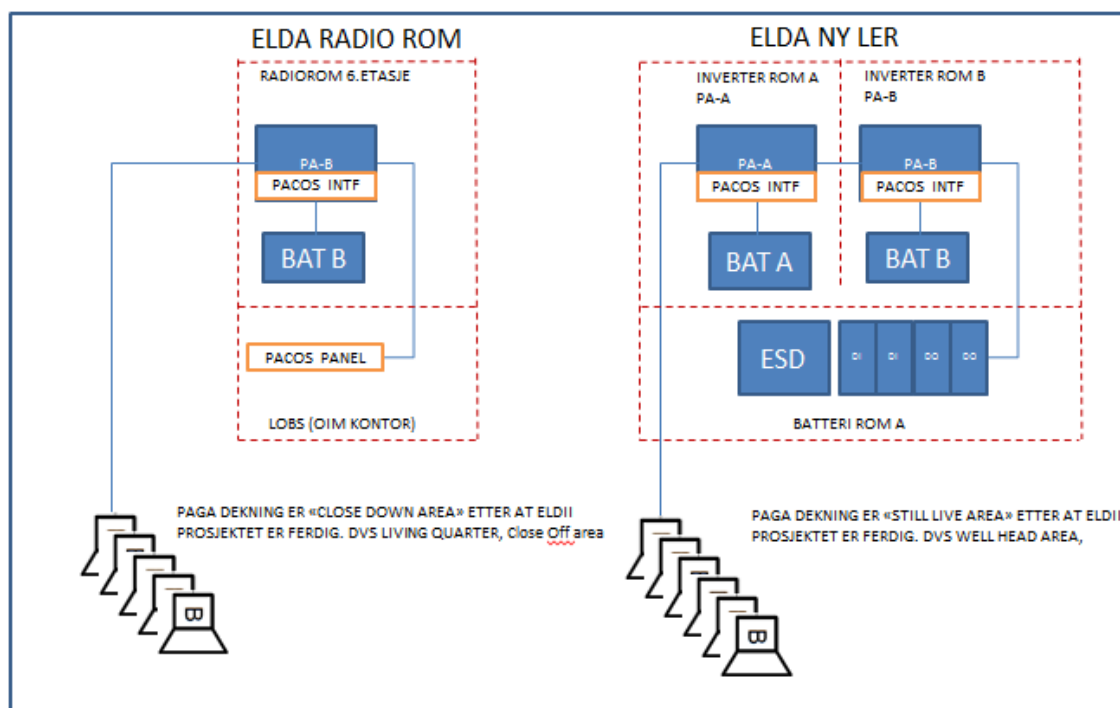
09.45 – The emergency response leader decided to announce over the PA system (in Norwegian and English) that personnel should muster on the bridges. Because of a blown fuse in the power distribution to the PA system in the Eldfisk A radio room, only part of the message was relayed over the system. Personnel on Eldfisk S and *Haven* failed to muster. A general alarm sounded throughout the complex, with the exception of *Haven* and with reduced coverage of Eldfisk A because of the failure of the old PA system. See figure 5. The FeBS was notified.

Figure 5 Diagrammatic presentation of the PAGA on Eldfisk A.

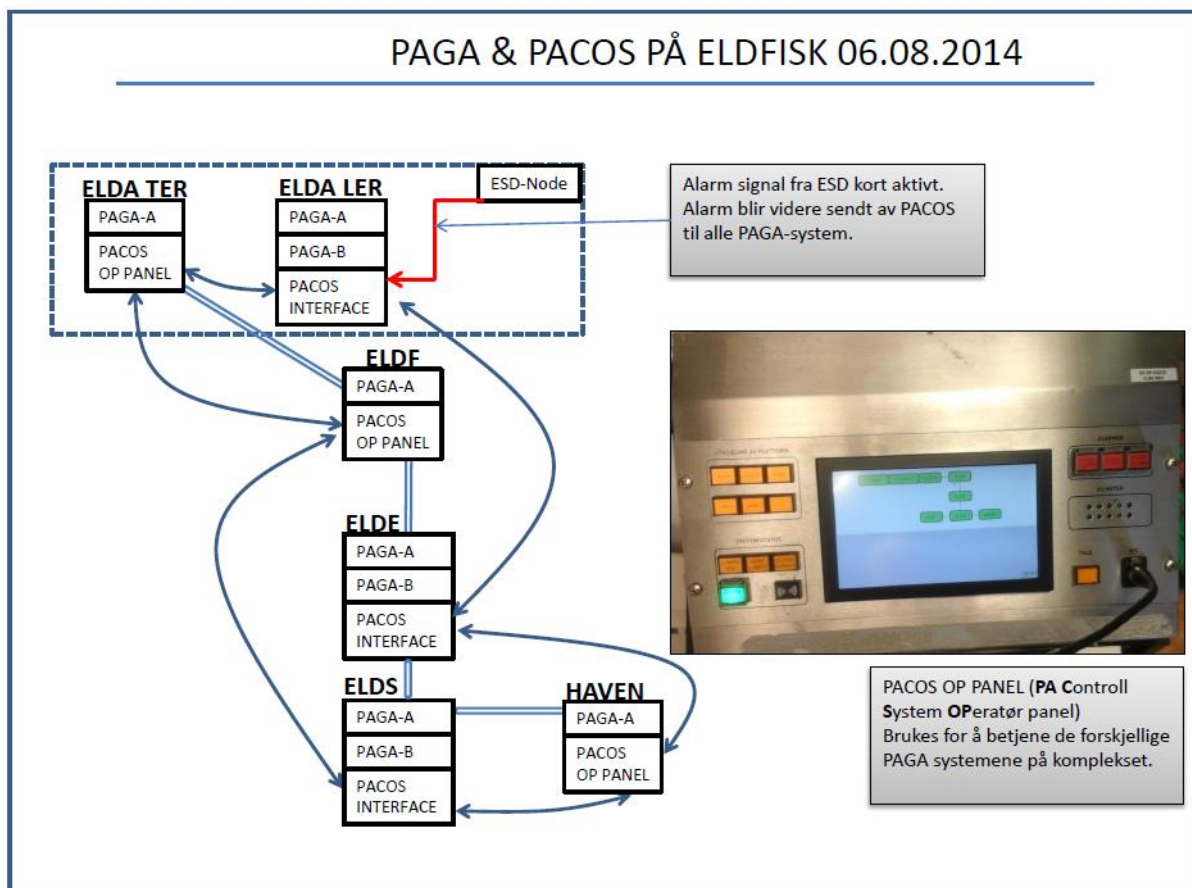
However, the other PA systems on the Eldfisk complex – Eldfisk A (LER), FTP, E and S – remained operative. The general alarm sounded continuously and was only interrupted when announcements were made via the loudspeakers.

Eldfisk FTP CCR and the LoBS made a number of attempts to stop the general alarm. In connection with the modifications for the Eldfisk II project, the PACOS was configured to distribute a general alarm to all the PA systems as long as the ESD signal remained active. No form of bypass had been installed to permit deactivation of the general alarm signal. With support from personnel in the Eldfisk S project, this alarm signal was later (13.01) deactivated by installing a provisional bypass of the signal termination. The blown fuse was also identified and replaced. All PA systems were thereby operational.

Figure 6 Diagram of the PAGA and PACOS on the Eldfisk complex.

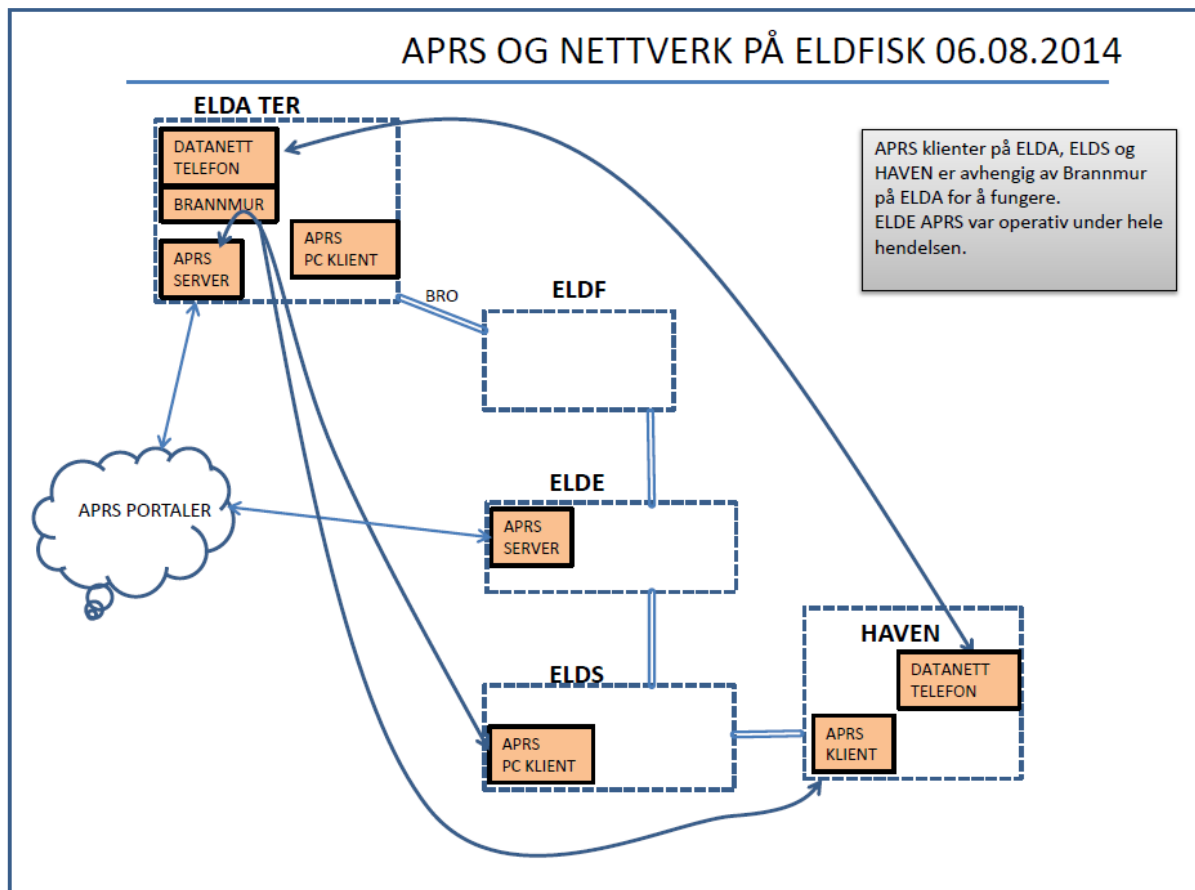
Following a yellow ESD, only telecommunication systems with their own battery bank will be operational. The APRS portals have such banks, but the APRS server and client PC in the telecommunication equipment room (TER) on Eldfisk A were inoperative as a result of the yellow ESD. The APRS back-up server on Eldfisk E was supplied with back-up power and operational during the incident. To function, the APRS client on Eldfisk S depends on the computer network and firewall on Eldfisk A, but the latter was without power. See figure 7.

Figure 7 Diagram of the APRS and network on the Eldfisk complex.

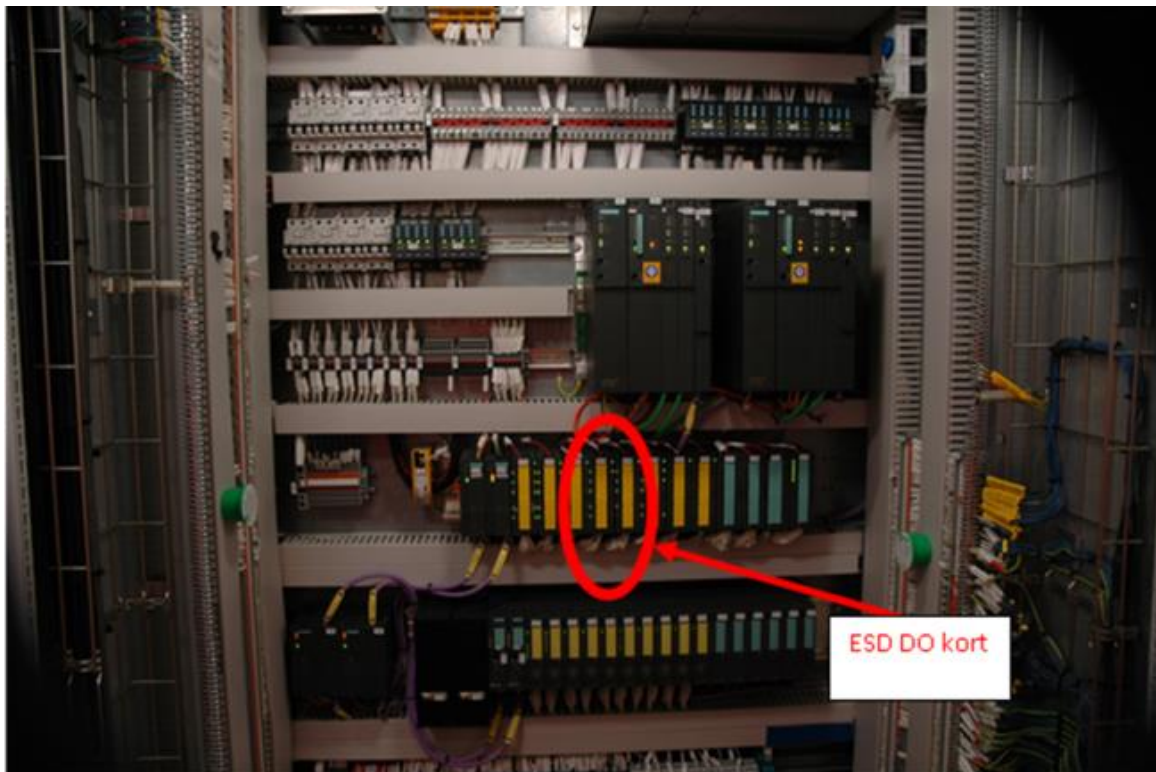
The direct cause of the yellow ESD incident on the Eldfisk complex and Embla on 6 August was the technical failure of a digital output card (A11-U4) belonging to the ESD node in the new LER on Eldfisk A. See figure 8. This caused the immediate activation of the highest shutdown level (yellow ESD) on the Eldfisk complex and Embla. The failure of a single output card should not normally result in a yellow ESD. An underlying design error (see figure 4), whereby the ESD signals to the isolation breakers for both UPS A and UPS B were connected to the same output card in the ESD node, helped to ensure that a failure of the output card caused an ESD at the highest level.

Figure 8 Overview of ESD cabinet with I/O cards in new LER, Eldfisk A.

13.10 – The defective output card in the ESD node was replaced and all faults in the new LER on Eldfisk A were corrected.

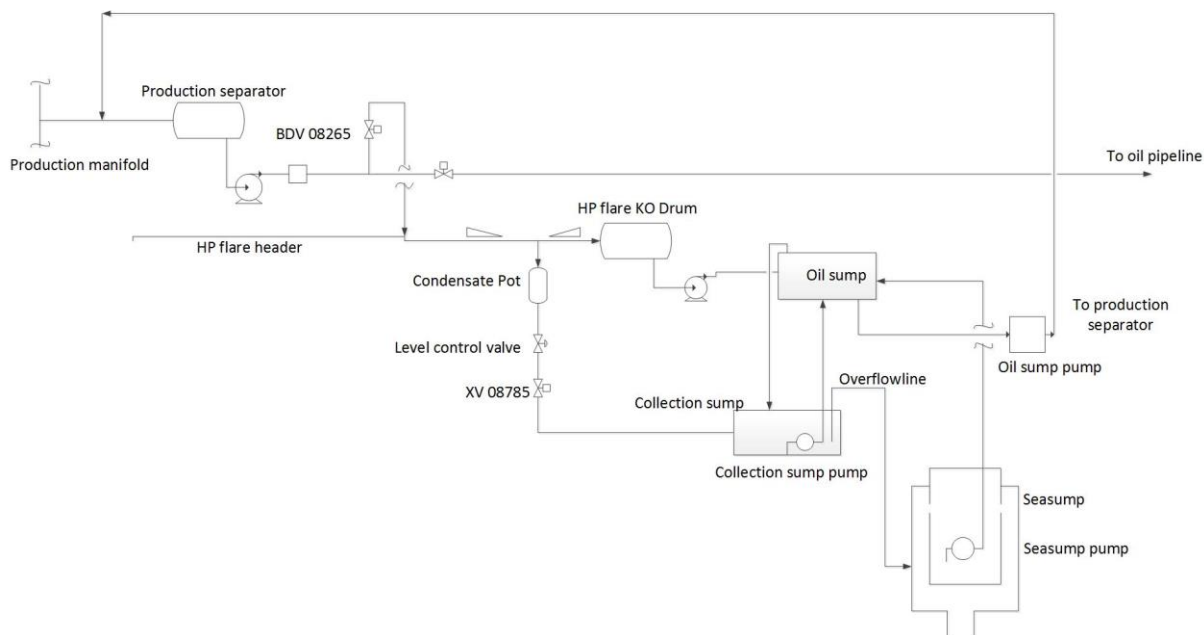
Figure 9 Process, flare and drain system on Eldfisk FTP.

Liquid from the high-pressure knockout drum is pumped to the oil sump, while liquid from condensate pots is routed to the collection sump. The oil sump and collection sump have no separation function, and all liquid entering them is pumped on. Liquid from the collection sump is pumped to the oil sump, while liquid from the latter goes to the production separator. The pump in the oil sump has a capacity of 13 m³/h. Two pumps are installed in the collection sump, each with a capacity of 6 m³/h. Starting and stopping pumps are controlled by level switches in the tanks. Both tanks are fitted with overflows. The oil sump overflow is routed to the collection sump, which in turn has an overflow routed to the sea sump. This means that, if the pumps in the oil and collection sumps lack sufficient capacity to handle the incoming quantity of liquid, the latter will eventually end up in the sea sump via the overflow from the collection sump.

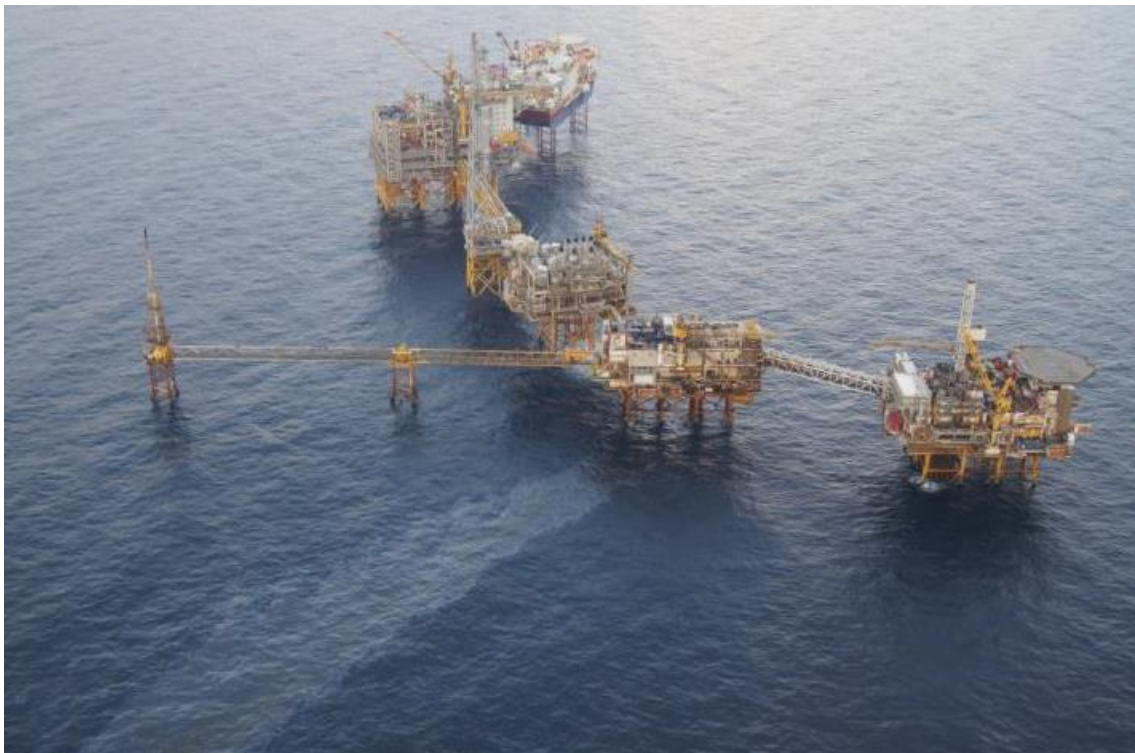
At dawn on 7 August, an oil leak was observed in the sea at Eldfisk FTP. This is estimated to have been in the order of 50-70 m³. The direct cause was that a BDV downstream of the oil metering package on Eldfisk FTP had remained in the open position during the start-up following the yellow ESD the day before. Produced oil thereby flowed into the flare system, on into the drain system and from there to the sea.

Figure 10 Oil spill from Eldfisk FPSO on 7 August, 07.00.

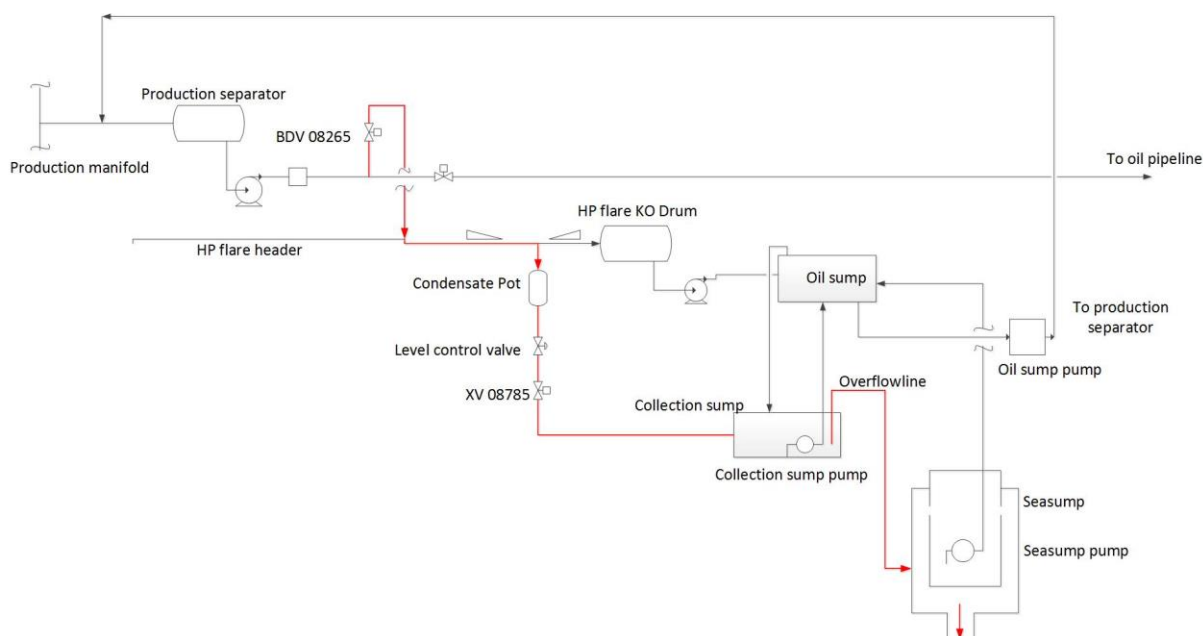
During start-up after the yellow ESD, a BDV downstream of the oil metering package was left in the open position. This caused a continuous supply of produced hydrocarbons to the flare system during the time the oil outlet from the separator was open. Via the condensate pot on the flare header, the oil was routed to the drain system and from there to the sea. The BDV in the wrong position was the direct cause of the acute oil spill.

Liquid from the flare system is routed to the drain system as described in chapter 6.1. The failure of instrumentation for level measurement and pump control meant that oil return from the drain system to the production separator did not function as intended in the design. At the same time, pump capacity in the drain system appears unable to handle the maximum liquid quantity which could flow from the condensate pots.

The sea sump was eventually filled with oil via the collecting-sump overflow. Level measurement did not indicate that the sea sump had become oil-filled, and its pump failed to start. All water in the sea sump was eventually displaced by oil, which then escaped to the sea through the open end of the tank.

Printouts received of screenshots showing levels in the high-pressure flare knockout drum and the sea sump during the incident indicate that the pumps in this system were not operating before the sea sump pump was started manually. Figure 11 below illustrates the probable direction of flow for the bulk of the oil through the BDV, via the collection sump and the overflow line to the sea sump and from there to the sea.

Figure 11 Liquid flow from the separator via the flare and drain system to the sea.

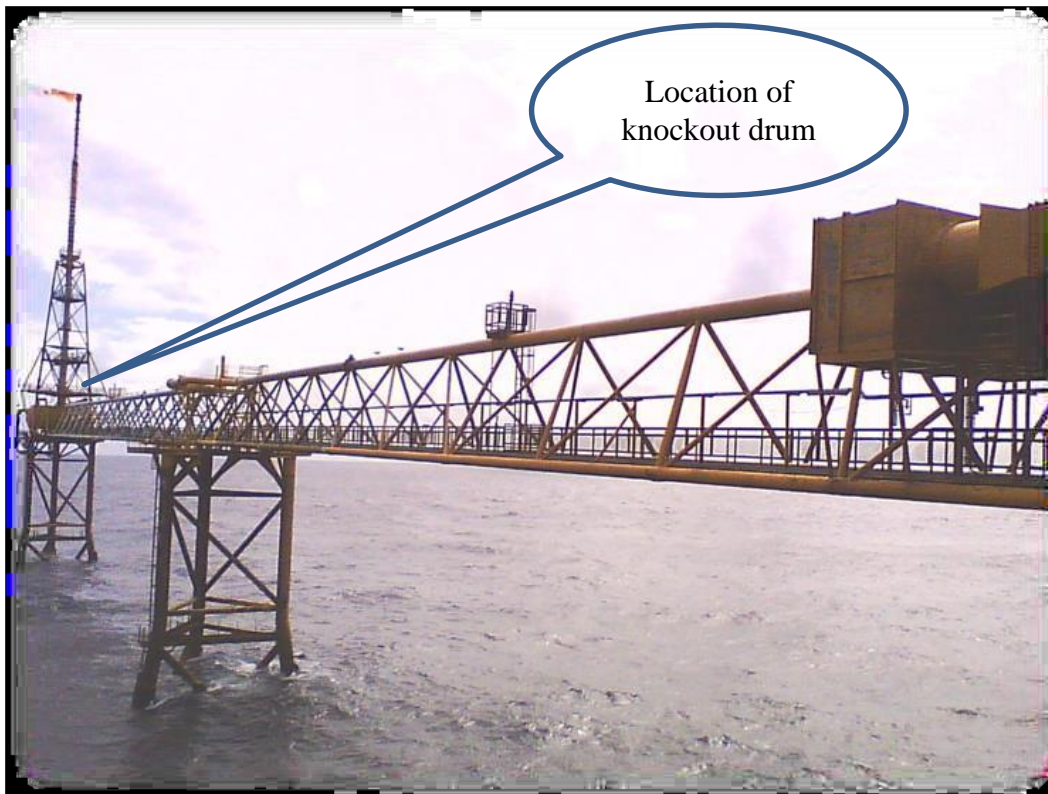
The flare knockout drum on Eldfisk is positioned at the end of a bridge leading from Eldfisk A, about 200m from Eldfisk FTP. Compensation for the lack of slope in the line from the flare header to the knockout drum is provided by a condensate pot at the low point of the line on Eldfisk A. This drains automatically to the collection sump on Eldfisk FTP.

Figure 12 Location of knockout drum.

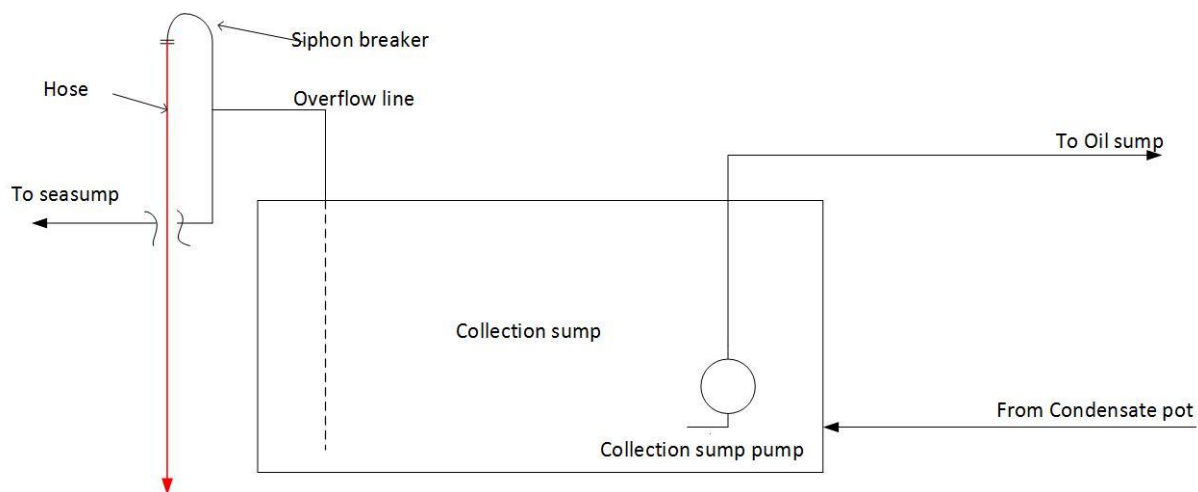
that liquid continues to flow through the overflow even if the level in the collection sump is reduced.

Installation of the plastic hose is not documented in the P&ID. Its purpose, when it was installed and whether the consequences of the change have been assessed are uncertain.

Figure 13 Simplified diagram of the collection sump with overflow.

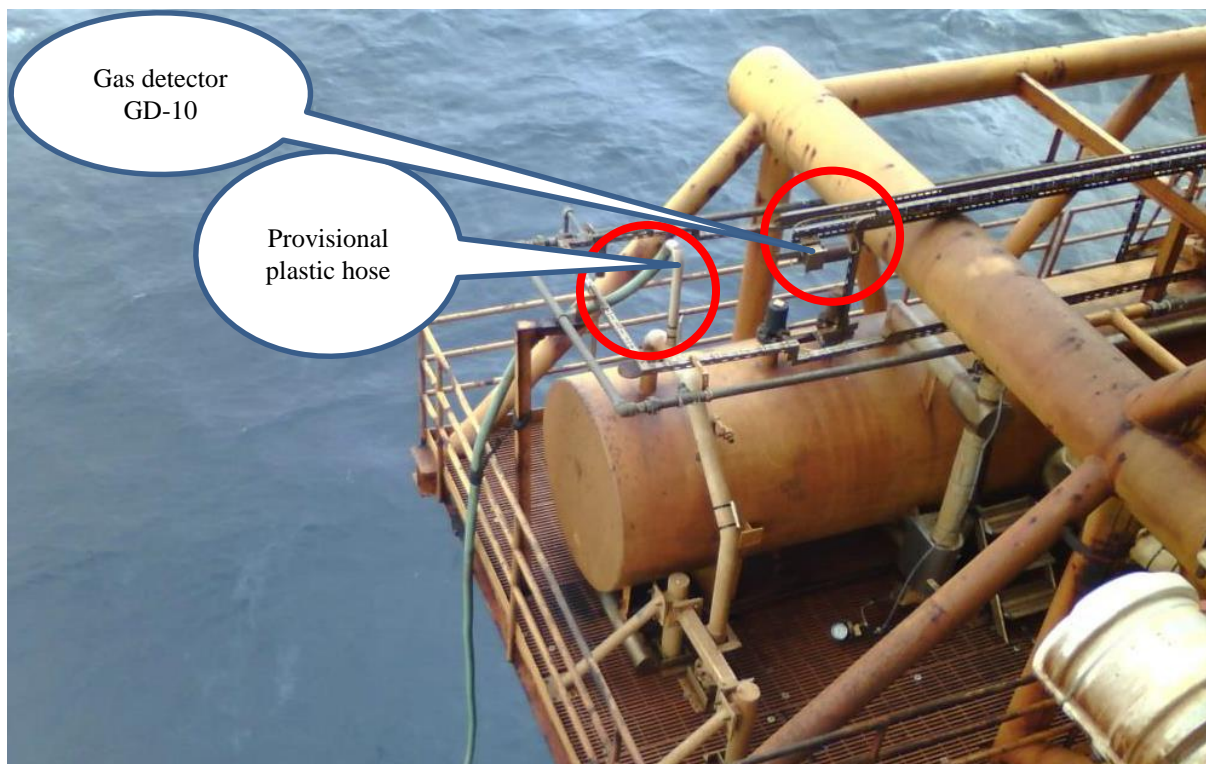
02.25: A high level of liquid was recorded in the oil sump. The plant operator went out to check, and also observed that liquid was flowing from a plastic hose mounted on the overflow from the collection sump. See figures 13 and 14. Start-up of well A29 increased the temperature in the production separator, and the liquid from the hose was assumed to reflect an increased volume of condensed gas from Eldfisk A to the drain system because of the high separator temperature. Production from A29 was halted, and it was reported back that the flow from the hose had stopped. The liquid level in the oil sump went from low to high in less than 10 minutes, even though no high level alarm had been received from upstream equipment (collection sump, flare knockout drum or sea sump).

Figure 14: Gas detector GD-10 and provisional hose on collection sump. Source: ConocoPhillips
