Investigation report

Report	
Report title Mongstad refinery - Naphtha leak in cracker, 24 October 2017	Activity number 001902045

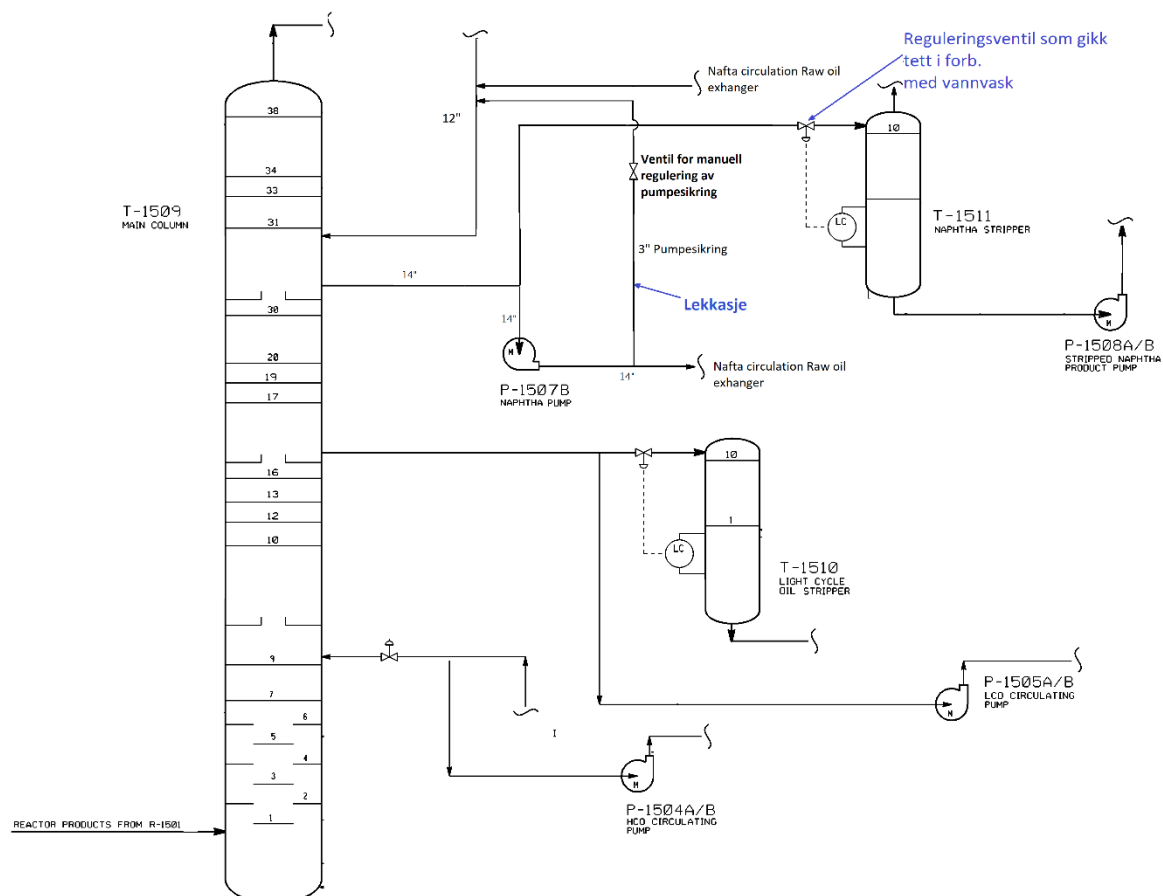
Figure 1: Flow diagram for the fractionation column and naphtha offtake. The arrows show the leak point (*Lekkasje*) and the valve choked as a result of water washing.

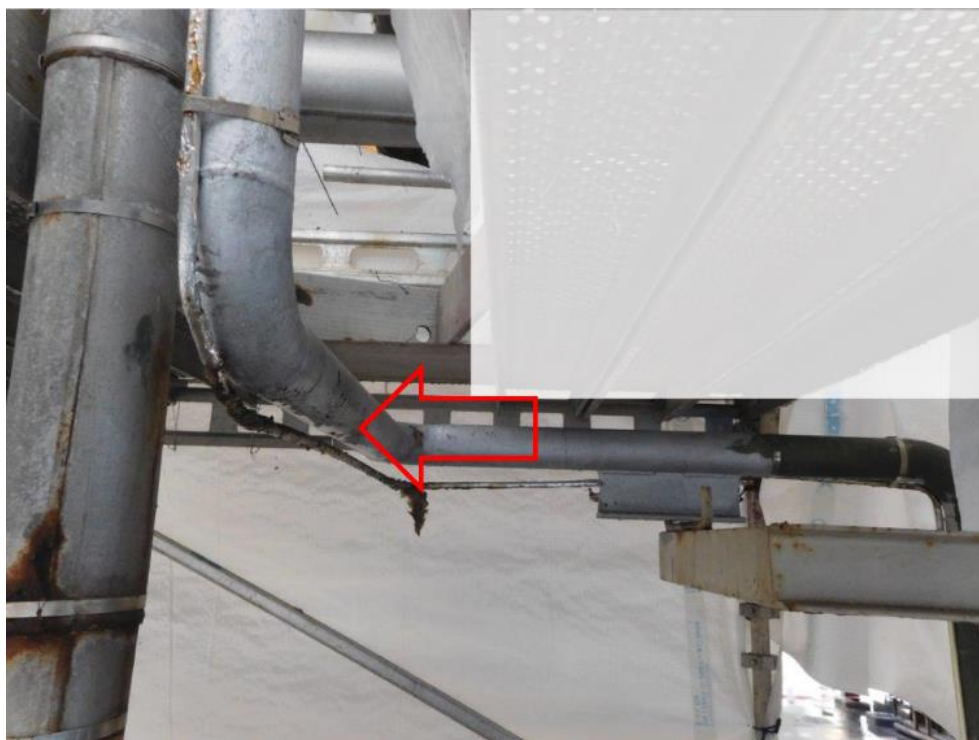
The three-inch pipe where the leak occurred is a protection line installed to ensure that pump P1507B is not run against a closed outlet. The leak point is shown, after removal of insulation, by a red arrow in Figure 3.

Figure 3: The leak point marked by a red arrow. Pipe insulation was removed after the incident. Source: Statoil.

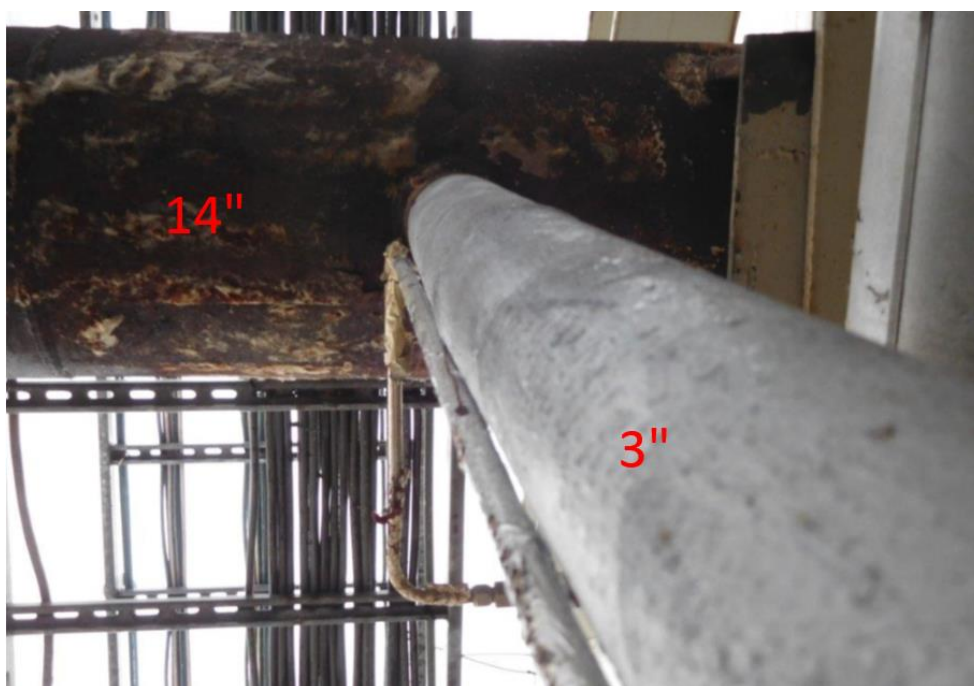
Figure 4: Transition between the 14-inch main pipe and the three-inch pump protection line. The pipe insulation was removed after the incident. Source: Statoil.

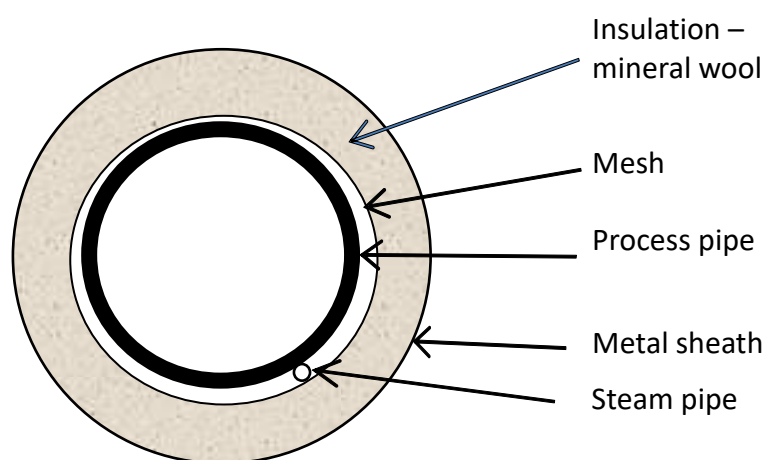
Figure 5: Illustrative cross-section of insulated three-inch pipe with a nominal wall thickness of 5.5 mm and a 1.5 mm corrosion allowance in the pump protection line.

The leak on 24 October 2017 also occurred in an insulated pipe, as illustrated in Figure 5, but the corrosion was internal rather than external as in the case of CUI. This pipe was inspected externally in 2014, when surfaces with corrosion were subject to surface treatment, but had not been checked for internal corrosion since 2013 (Statoil, 2017C).

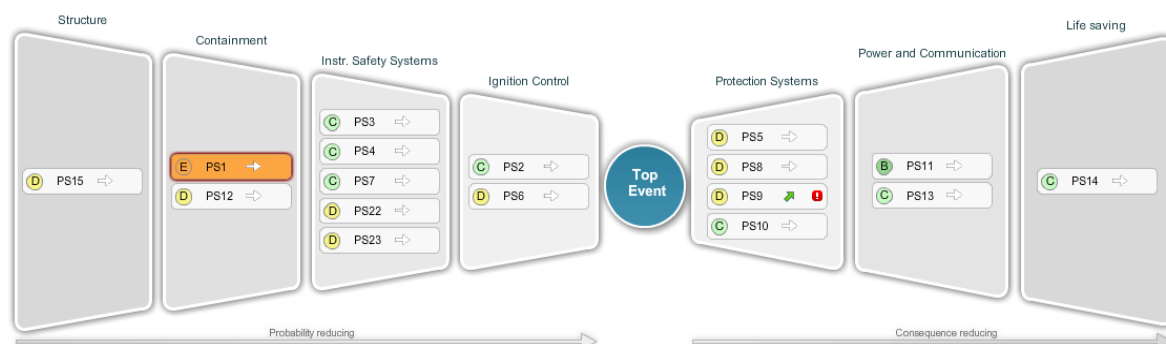
The refinery is exposed to corrosion, both external and internal. This is reflected in the Timp assessment of PS1 containment as level E. Figure 6 presents the Timp for the whole of Mongstad – but representative for the cracker – in May-June 2017. Statoil concludes in the Timp assessment that area B1 has:

- areas where surface condition remains unclarified, many finds in the surface project
- high internal corrosion in the naphtha circulation
- many unregistered leaks in 2016
- a substantial number of inspection order notifications with a high level of risk.

Figure 6: Timp for Mongstad, May-June 2017.

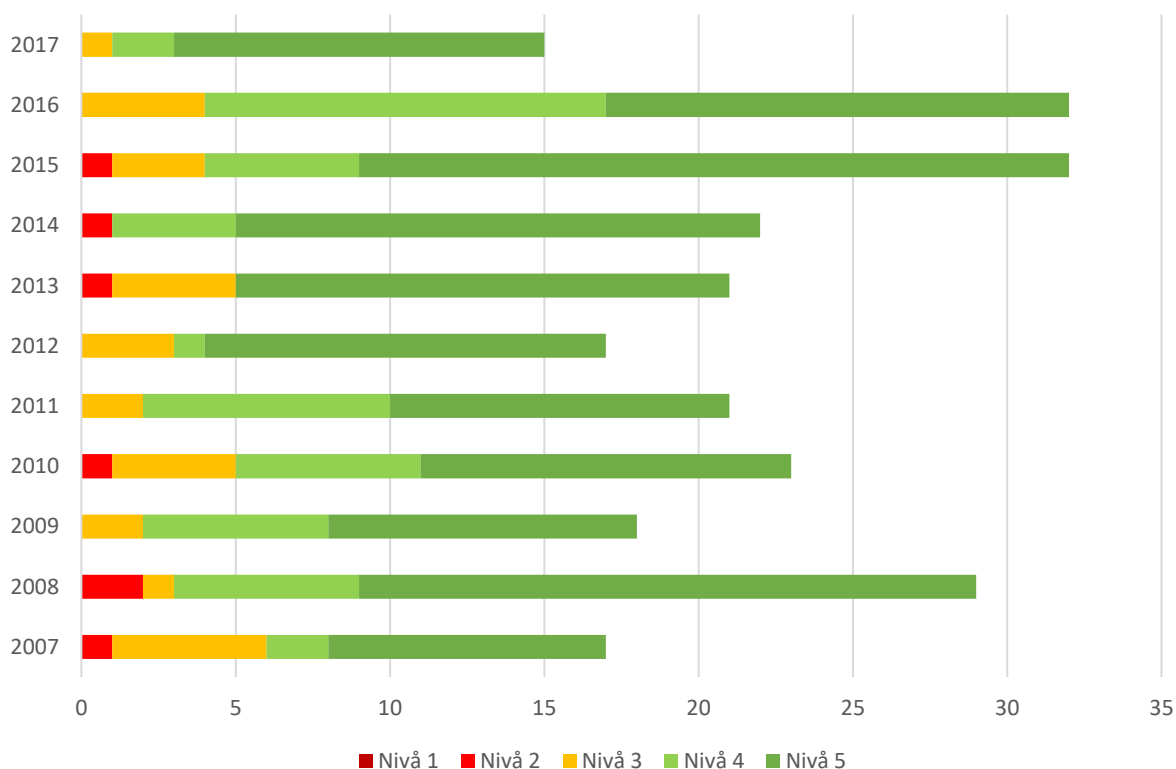
Figure 7 present the development of leaks at Mongstad in terms of number and leak rates. Determining a specific trend is difficult, and the degree of seriousness is affected by a number of factors. These include the medium, the amount leaked and the leak point. A number of serious leaks in recent years have been caused by corrosion.

Figure 7: Overview of oil and gas leaks per annum at Mongstad categorised by leak rate. Level (nivå) 1 comprises leaks of > 10 kg/s, level 2 is 1-10 kg/s, level 3 is 0.1-1 kg/s, level 4 < 0.1 kg/s, and level 5 << 0.1 kg/s.

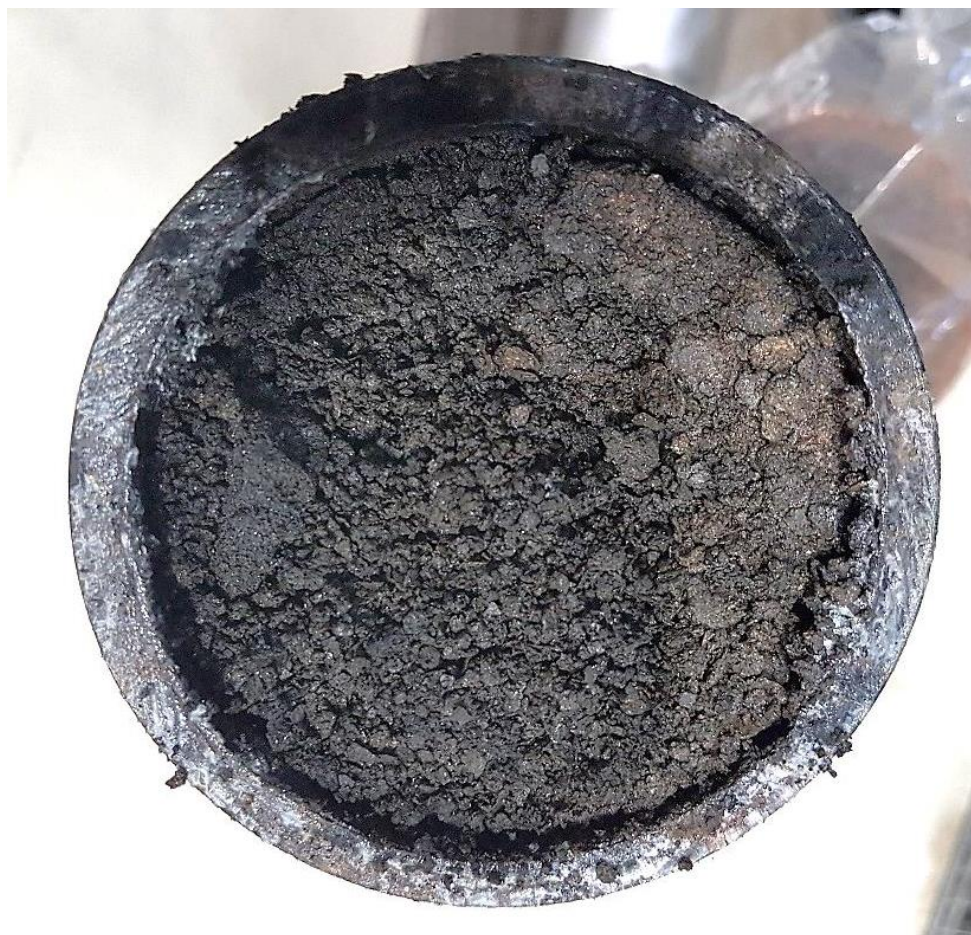
When the pipe was cut out, the section upstream from the valve was found to be full of corrosion residues/salt, see Figure 8. This means there cannot have been much flow through the pipe and, without the opportunity to measure flow, it has not been discovered. Without flow, the result will be a blind gate. According to the RBI programme, these are particularly vulnerable to corrosion. The temperature here will fall because there is little or no flow, and water can condense out and result in corrosion.

Figure 8: Vertical section of the pipe filled with porous/uncompacted deposits. No sign of significant wall thinning could be seen in this part of the pipe. (Statoil, 2018)

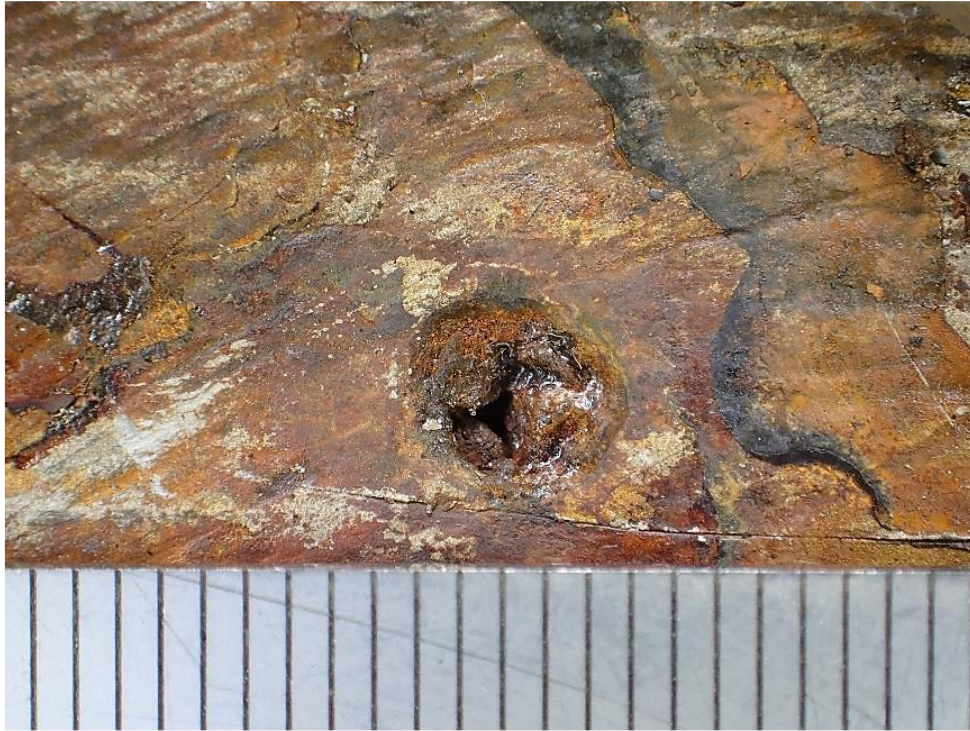
A close-up of the leak site on the underside of the horizontal section (which proved on close inspection of the incident site to have a slight upward inclination) is shown in Figure 9. In practice, the area where the leak occurred was corroded right through, as seen in Figure 10. The investigations showed that "the centre of the pipe is filled with uncompacted but nevertheless fairly tight-packed deposits in the centre and towards the top of the pipe, and in addition by hard and layered coating/scale against the pipe wall between about 1 and 11 o'clock. Substantial wall thinning coincides with the hard coating, most prominently at 6 o'clock. An intermediate 'mixed' zone also shows signs of layering, but is not as compacted and falls out when removing the uncompacted deposits in the centre." (Statoil, 2018). Figure 11 shows a cross-section of the pipe with the coating, which resembles tree rings. The report also states "The hard coating found in the pipe where the leak has occurred comprises in the order of 35-40 'strata', which corresponds with the number of water washes carried out since 2014, and which could therefore indicate a relationship between coating formation and the water wash procedure."

Figure 9: Close-up of the leak site from the outside of the pipe. Little sign of external corrosion, but discolouration and rust run-off can be seen in the area around the leak. Scale in millimetres.

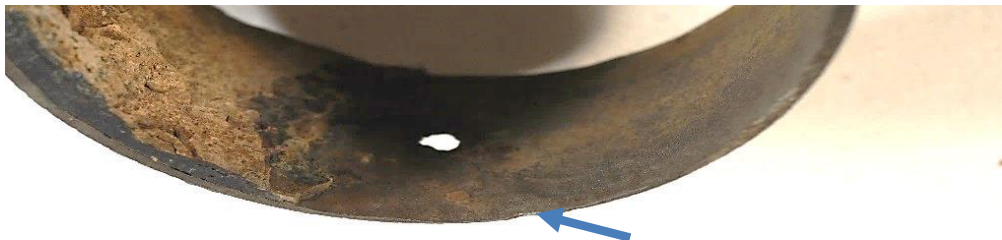
Figure 10: The arrow indicates that, in practice, the pipe wall has been corroded all through in the area near the leak point (light circle in the centre). Distance between leak point and arrow is about 20 mm.

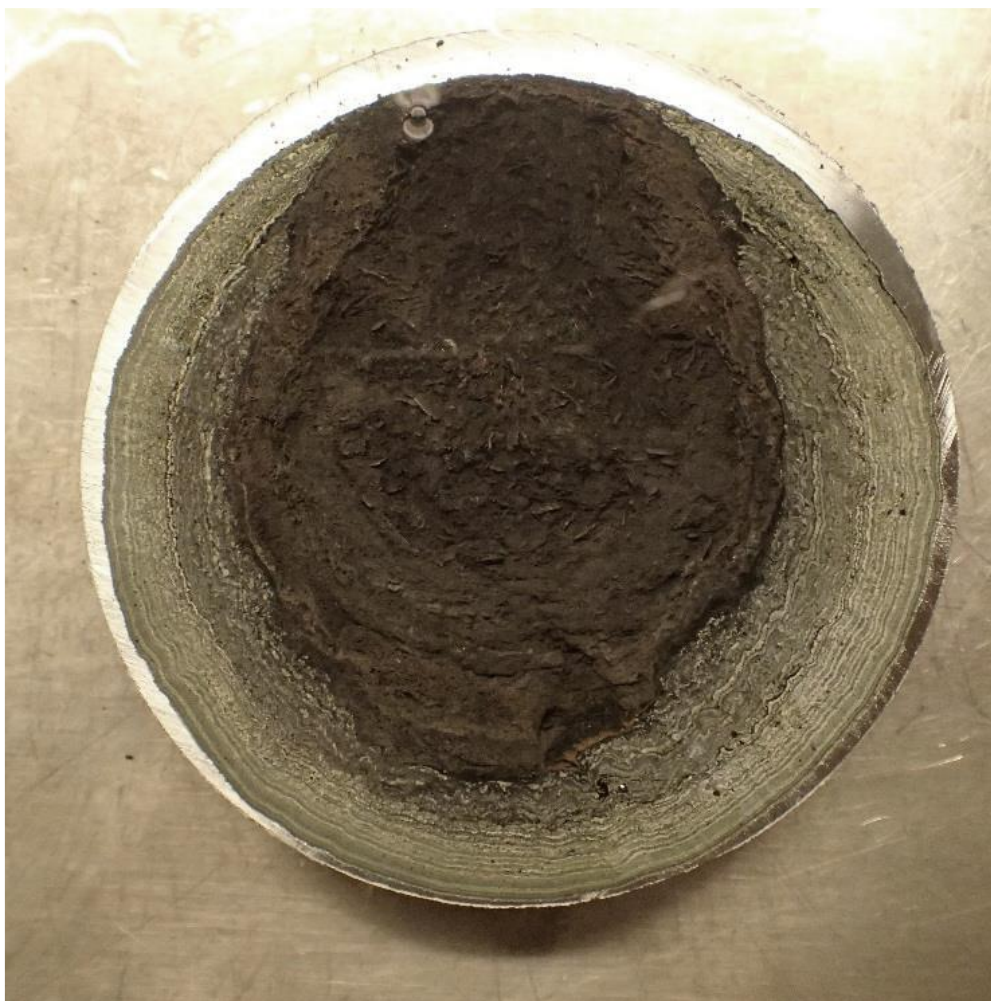
Figure 11: Cross-section of the horizontal section of the pipe loop. Twelve o'clock is at the top and 6 o'clock at the bottom.

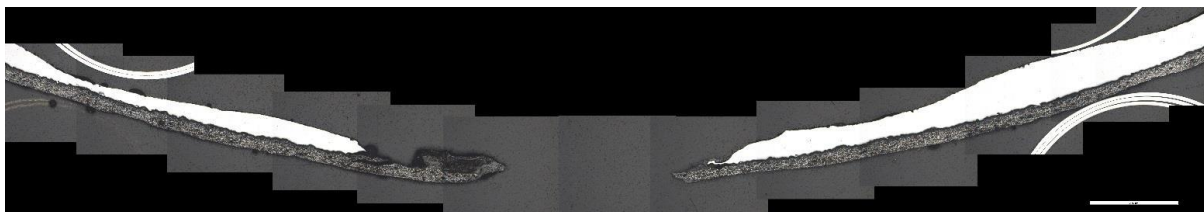
Statoil's notification gave a preliminary estimate of 0.3 kg/s for the leak rate, later calculated as 0.013 kg/s. However, it is difficult to specify the actual leak rate with certainty because the pipe interior was filled with corrosion residues. How much this helped to reduce the leak is uncertain. An analysis of the pipe where the hole occurred shows that the latter was restricted by the coating. This is illustrated in Figure 12.

Figure 12: Cross-section of the pipe wall over the hole. The metal coating (grey) covers some of the opening in the pipe wall (white), so that it is in reality larger (about six mm) than was observed when measuring on the external surface.

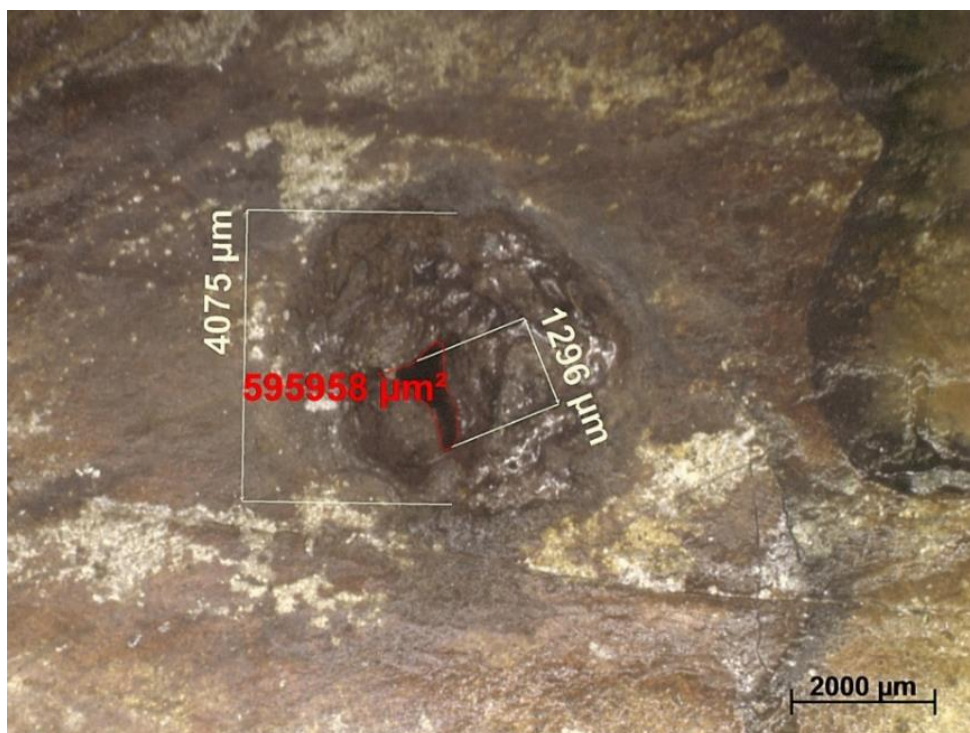
If the leak had lasted longer, the coating might have broken off and the hole would have become considerably larger, with an associated increase in leak size. The leak route was also hampered by corrosion products as shown in Figure 13.

Figure 13: Measurement of the leak route with the aid of stereomicroscopy. Since compact (internal) corrosion products largely cover the hole in the pipe, the leak route (area) is probably somewhat smaller than an “open” hole would suggest. Stereomicroscopic measurements suggest in the order of 0.6 mm².
