Report	
Report title Investigation of an electrical incident with serious personal injury at the Kårstø plant on 25 July 2020	Activity number 003912038

Involved	
Team T-L	Approved by/date Kjell A Anfinsen, by authority, head of supervision 10 March 2021
Members of the investigation team Jan Sola Østensen, Irene B Dahle, Eivind Sande and Bård Johnsen	Investigation leader Bård Johnsen

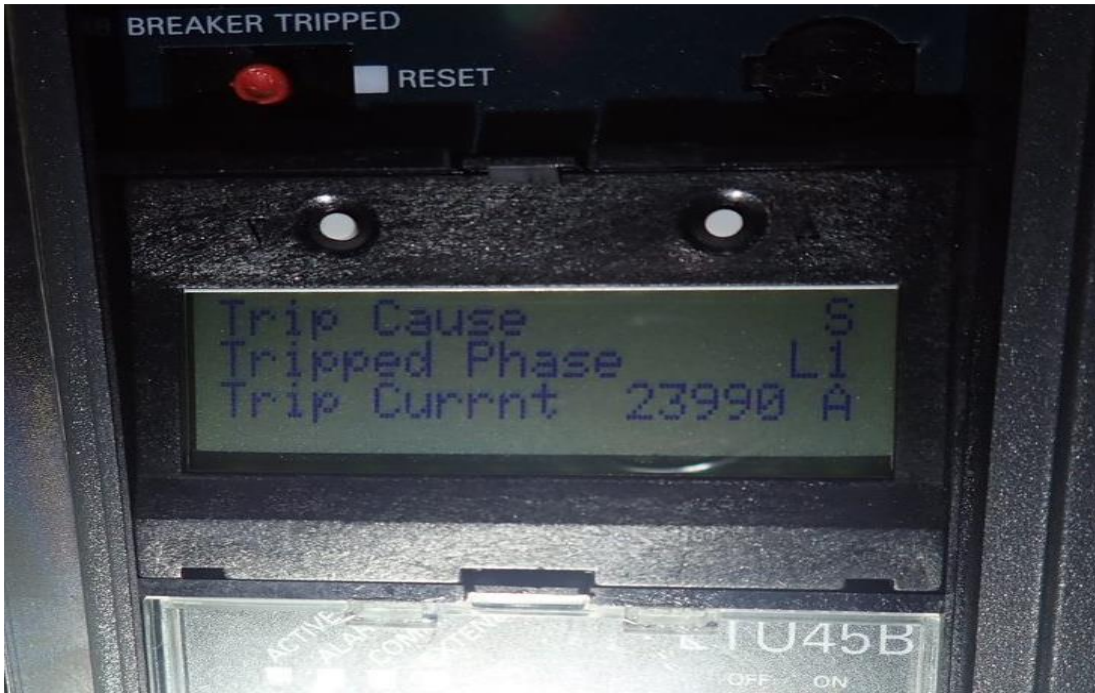
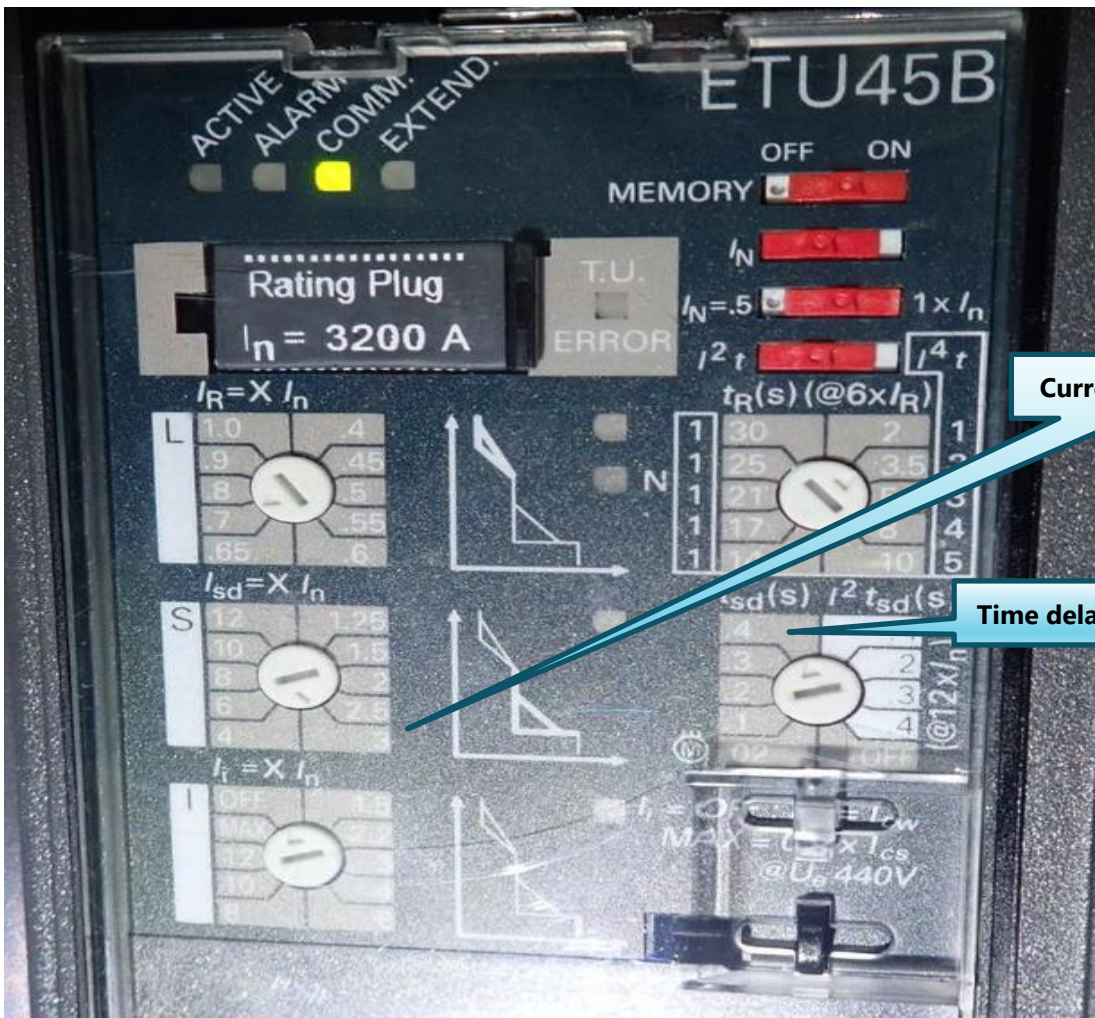
Figure 12 Trip status for incomer circuit breaker.

Figure 13 Settings for incomer breaker protection at the time of the incident. Source: Equinor

The set point for the overcurrent value (I_{sd}) which would activate the protection was 3. In other words, if short-circuit current I_{sd} exceeded $3 \times 3200A = 9.6kA$, the protection device would activate after a delayed trip time (t_{sd}), which was set to 0.4 seconds. See figures 12 and 13.

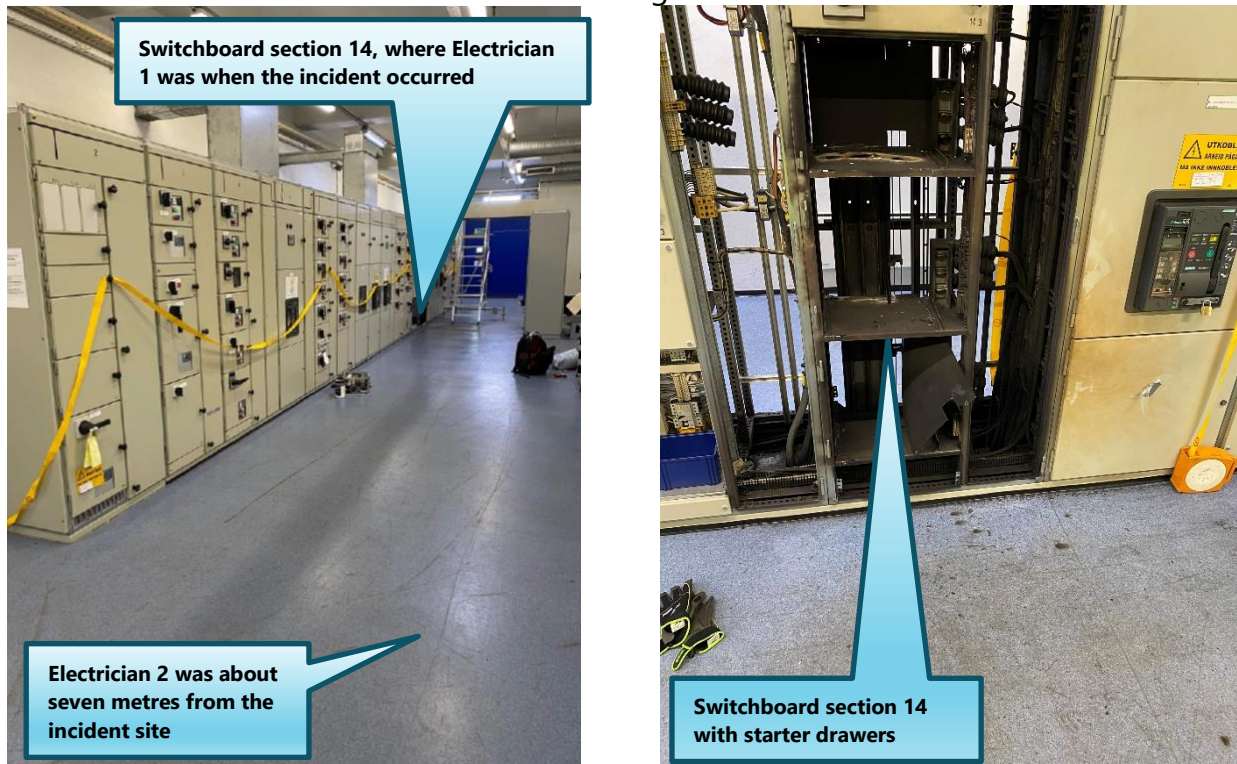
Figure 14 Front of switchboard 82-EN-520B and the switchboard section after the incident.

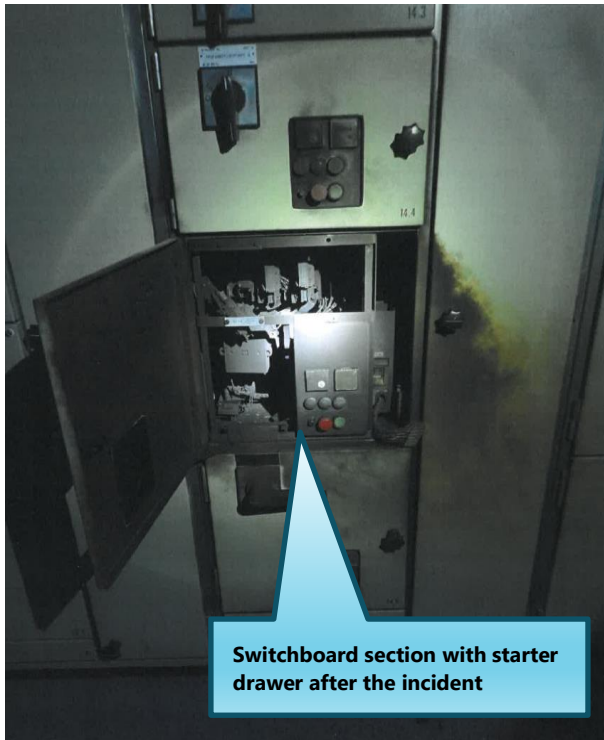
Figures 16 and 17 below show the damaged starter drawer, while clear signs of the three-phase short circuit can be seen in figures 18 and 19 over the fuse elements and on the copper busbars. The neighbouring starter drawers were also heavily exposed and damaged by the short circuits and the incident energy.

Figure 16 Switchboard section with starter drawers. Source: Equinor

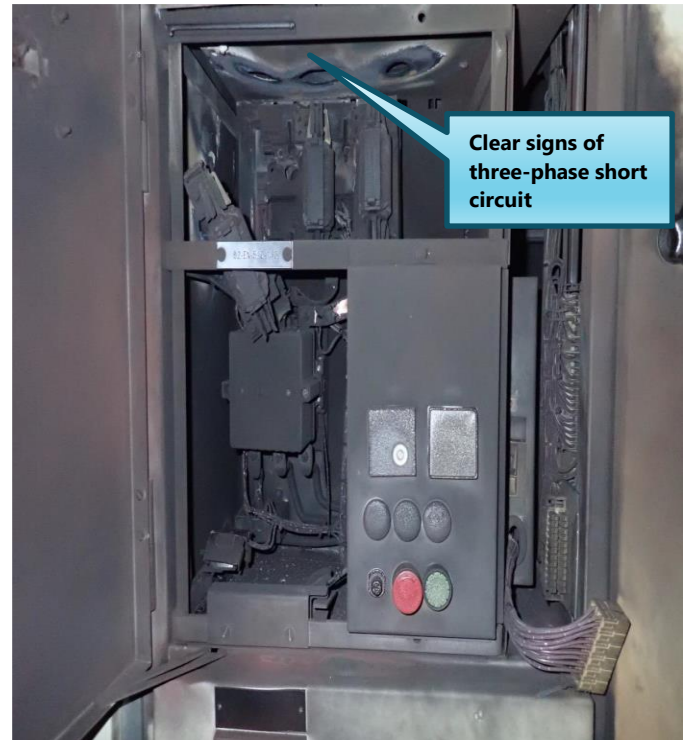
Figure 17 Starter drawer 14.5. Source: Equinor

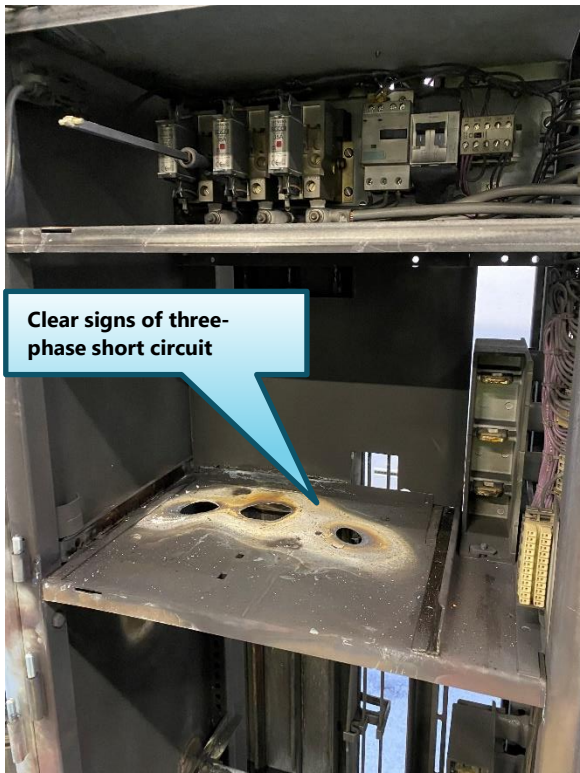
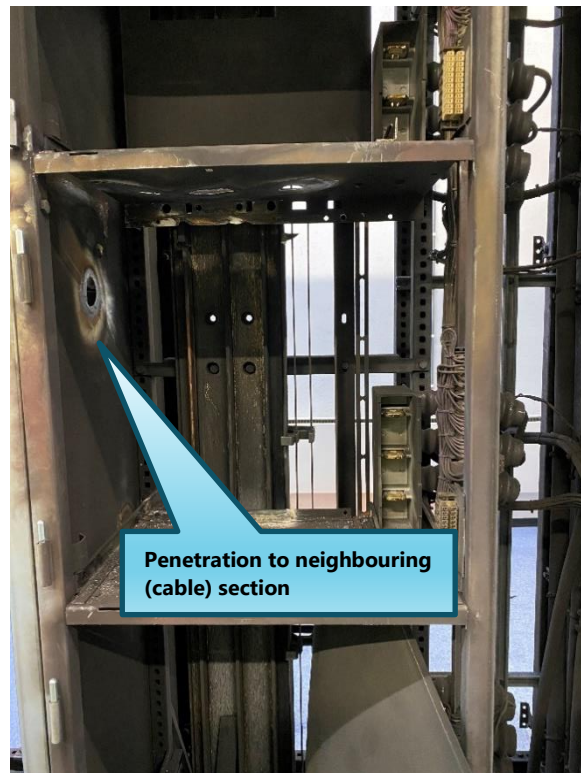
Figure 18 Frames for starter drawers and marks from short circuits. Source: Equinor

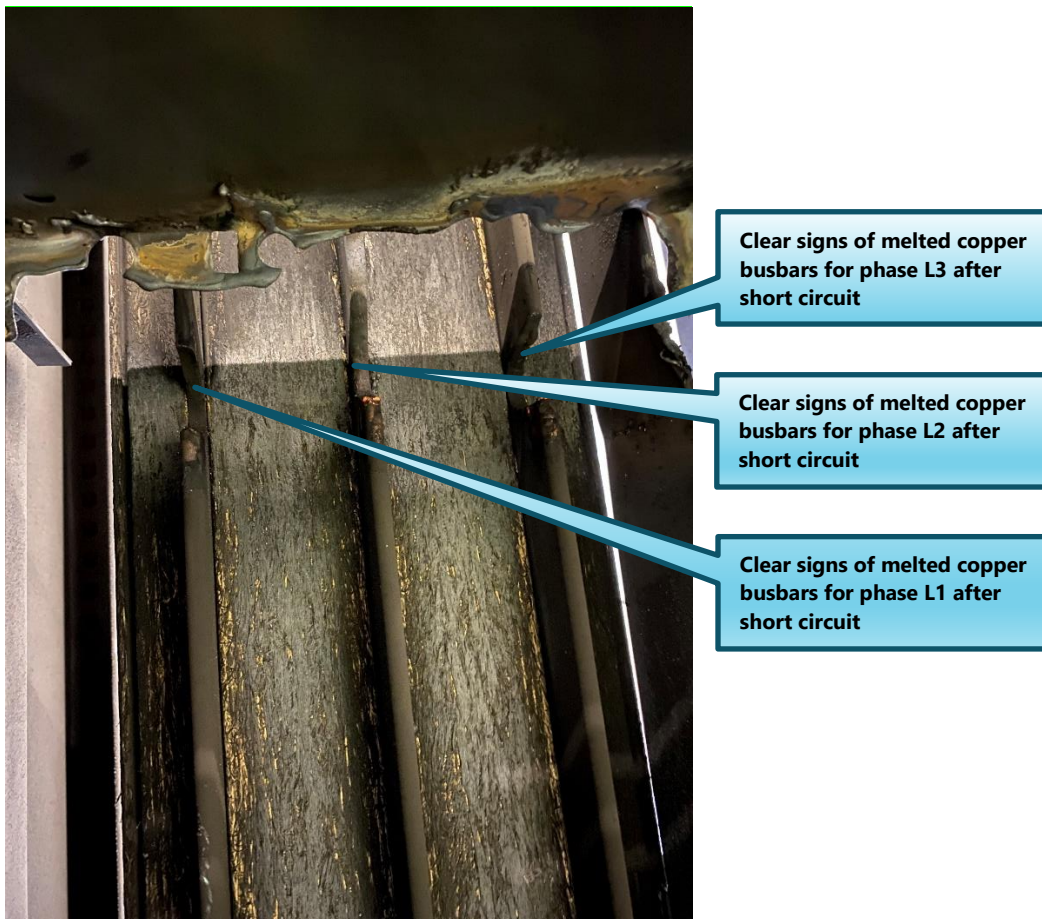
Figure 19 Clear signs left by melting of copper busbars after the short circuits.

Figure 19 above shows the switchboard's copper busbars for phases L1, L2 and L3 in the field below the damaged starter drawer. Clear signs of melted busbars as a result of the incident can be seen.

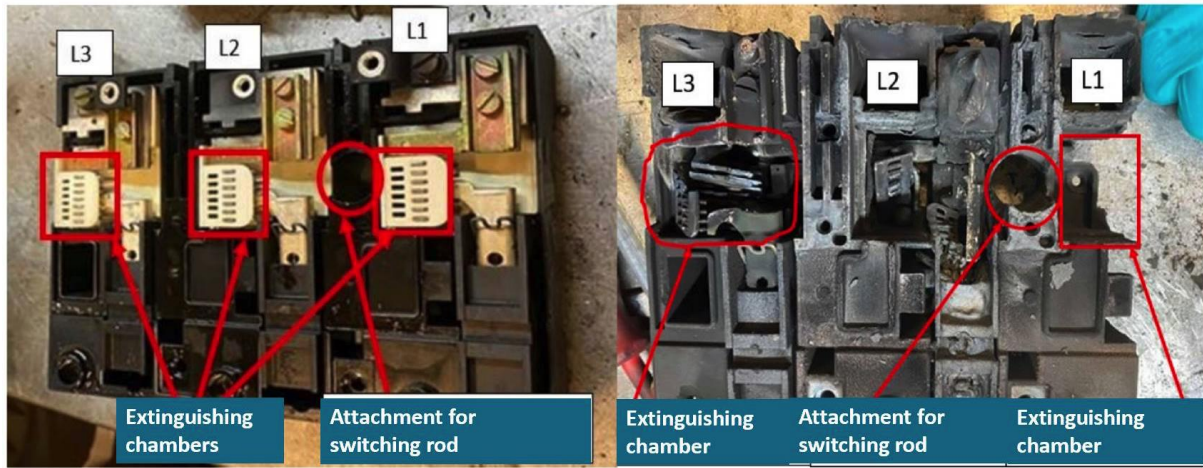
Figure 20 below, left, shows internal details of a disassembled spare circuit breaker with phases L1, L2 and L3, earthed switching rod and extinguishing chamber. Corresponding details from the damaged circuit breaker are shown on the right.

Figure 20 Comparison of disassembled spare breaker and damaged breaker. Source: Equinor

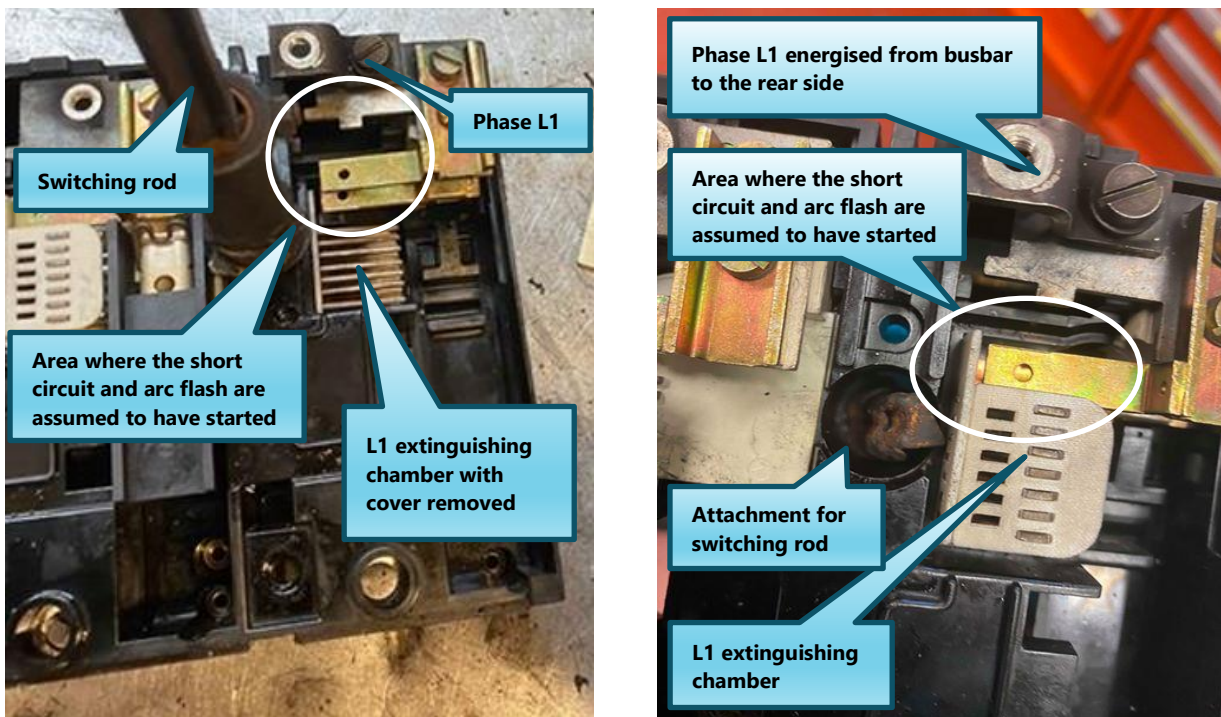
Figure 21 shows further details of the disassembled spare breaker with phase L1, earthed switching rod and extinguishing chamber. This also shows the area where the short circuit and arc flash are assumed to have occurred.

Figure 21 Information from disassembly of spare breaker.

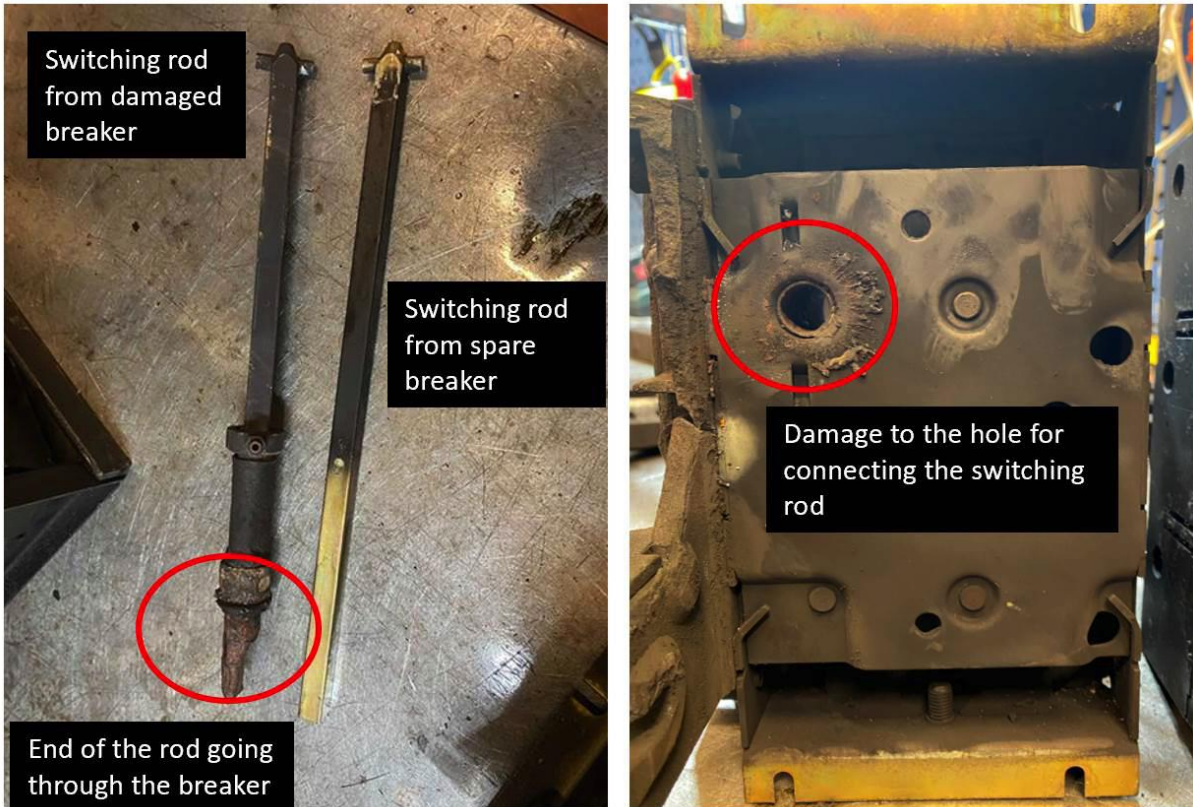
Figure 22 Switching rods and image of the rear of the damaged breaker. Source: Equinor

Figure 22 compares the switching rods for the damaged and spare circuit breakers. The one for the damaged breaker shows considerable melting at the end, just where the rod goes through the rear of the breaker. This rod had reportedly come loose and lay on the floor after the incident.

Combined with thermal stresses during operation and testing, mechanical stresses resulting from the using tools and from transporting the starter drawers between substation and electrical workshop have probably caused deterioration/material fatigue over time. These effects are regarded as the direct cause of the incident.
