# Investigation report

Report title Investigation report following a condensate leak on GjØa	Activity number 027153036
--	------------------------------

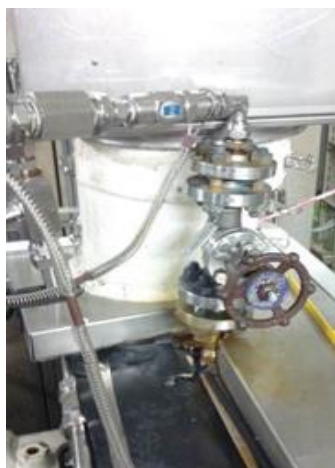
Figure 2 - Condensate pump with pipe nozzle.  
The photograph belongs to Engie E&P

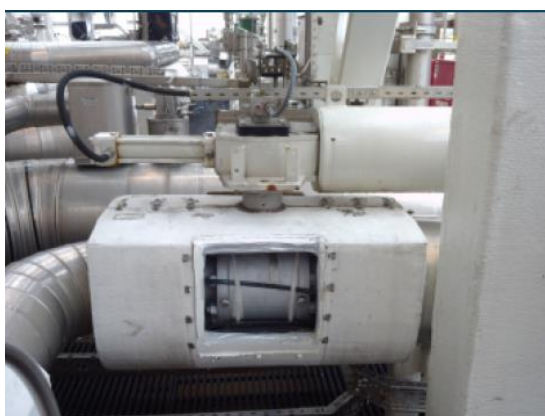
Figure 4- ESV with actuator installed.  
The photograph belongs to Engie E&P

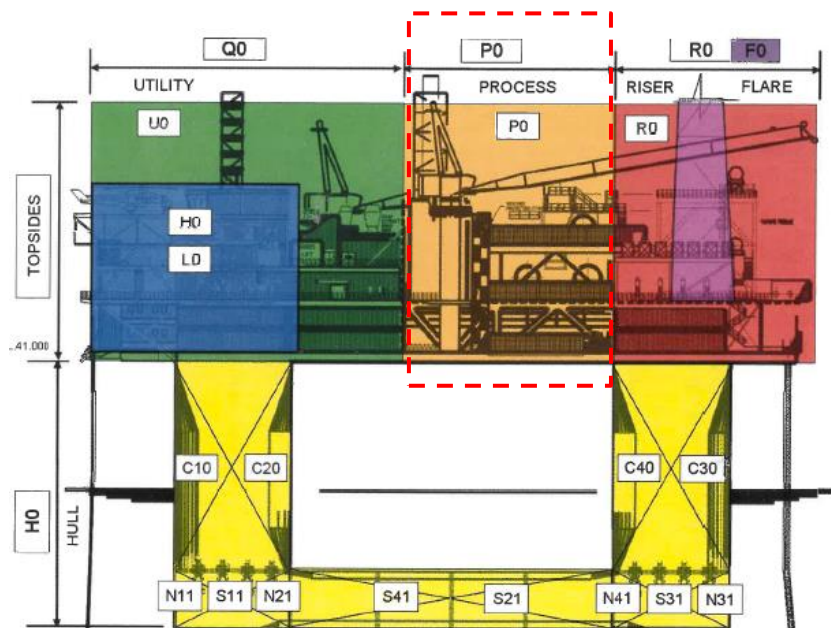
Figure 7 - The condensate leak occurred in process area P0, lower deck.  
The diagram belongs to Engie E&P

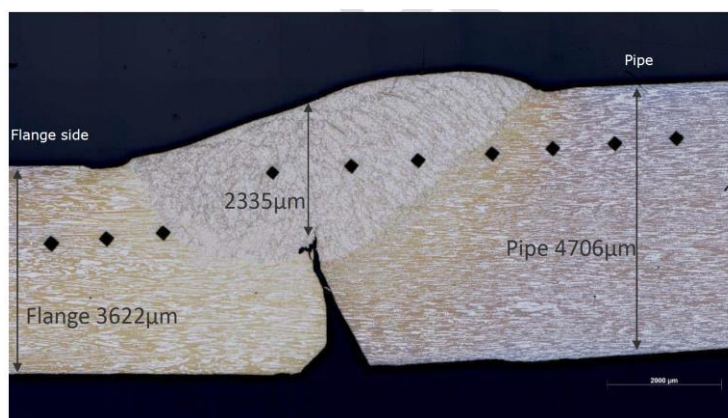
Figure 14 - Metallographic image of the fracture site on the pipe nozzle, showing lack of penetration in the weld. The photograph belongs to Engie E&P
