Report	
Report title Investigation of fractured coiled tubing on Gullfaks C	Activity number 001050090

Involved	
Team T1	Approved by/date Kjell M Auflem/12 October 2023

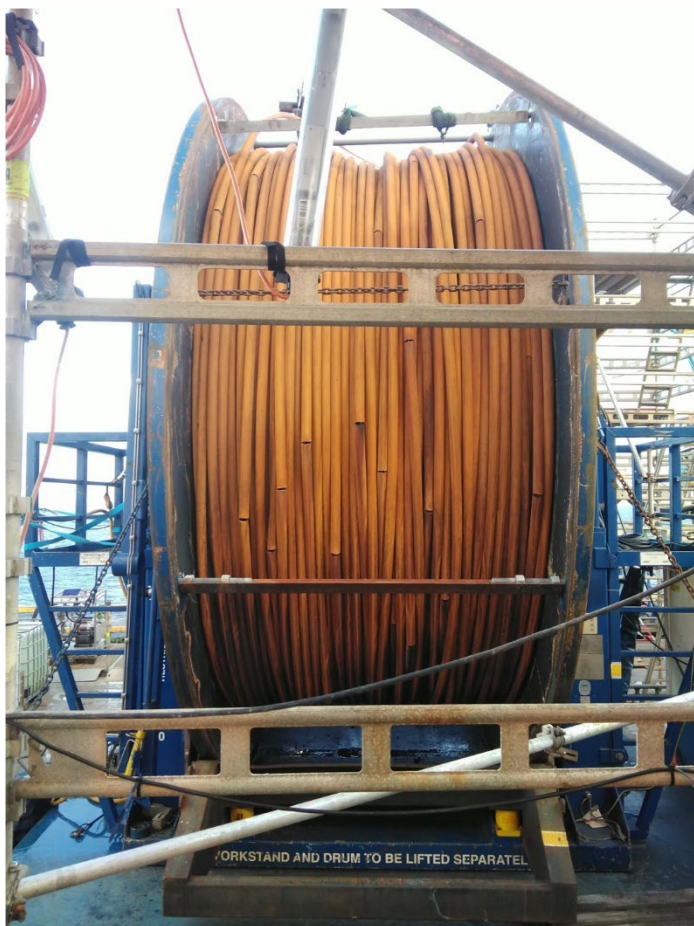
A fracture in the CT was observed at 06.56 during the hand-over between night and day shifts. The check valves in the BHA held firm against the well and the primary barrier loop was intact. During the hours which followed, six different fractures were observed in the CT on the surface.

Image 2 - CT with fractures (source: Equinor).

Intergranular brittle fracturing had developed from the internal wall of the CT and propagated outwards. Together with findings of sulphur and H₂S, this supports the view that HE is the failure mechanism. The test reports conclude that SSC, a corrosion-driven form of HE, is very likely to be the cause of the CT fractures.

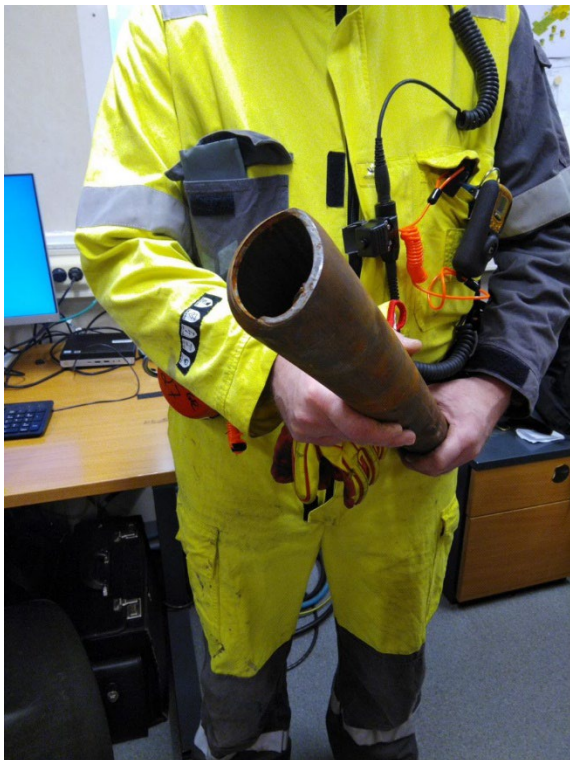
Image 4 shows the tube stump recovered from the well after normalisation. The CT BOP blind shear ram has cut it off and left it with good opportunities for continued circulation via the CT BOP kill line.

Image 4 - Tube stump after being cut by the CT BOP.
