Goliat Bonded offloading hose;
integrity management, inspection,
experience transfer & learning

Olaf Døble, 4.12.2019

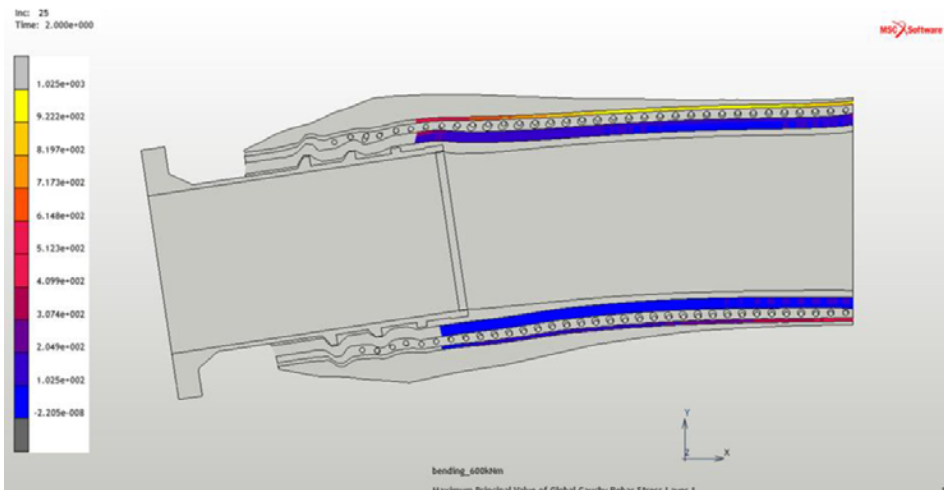
Stresses in outer steel cords at nipple end

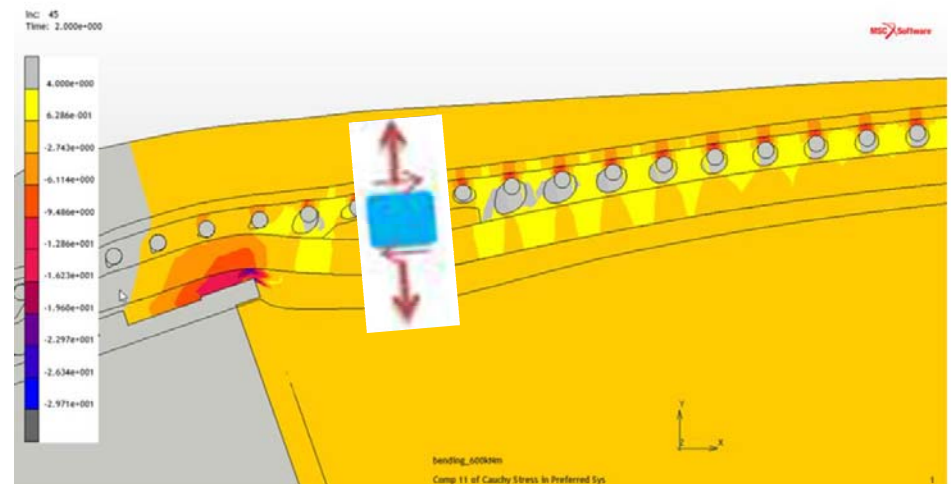
Radial stresses in rubber with beginning delamination outside nipple
