# Investigation report

Report title Investigation report – Goliat FPSO – serious personal injury 250616	Activity number 014229058
---	------------------------------

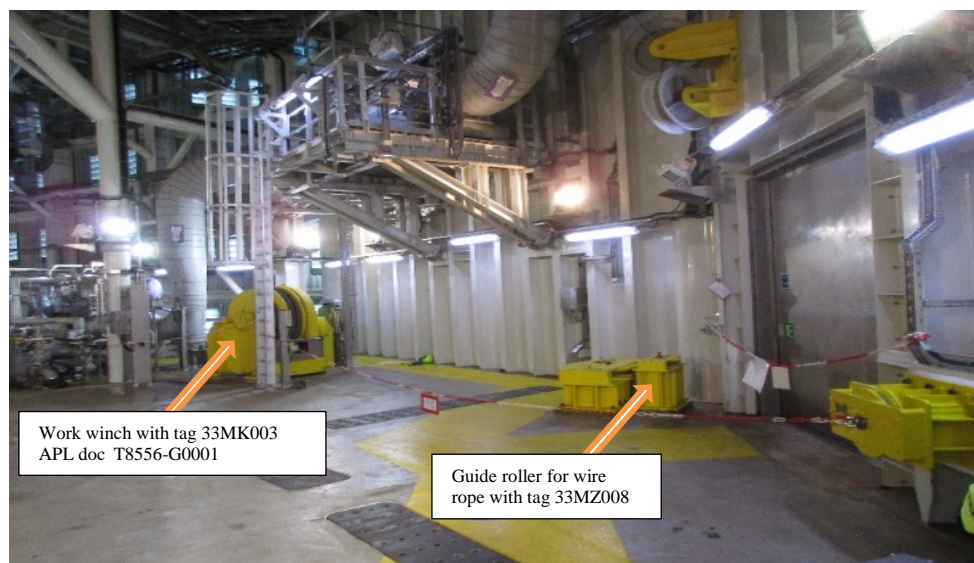
**Photograph 3:** Incident site viewed through the door from the quarters module. (Source: PSA)

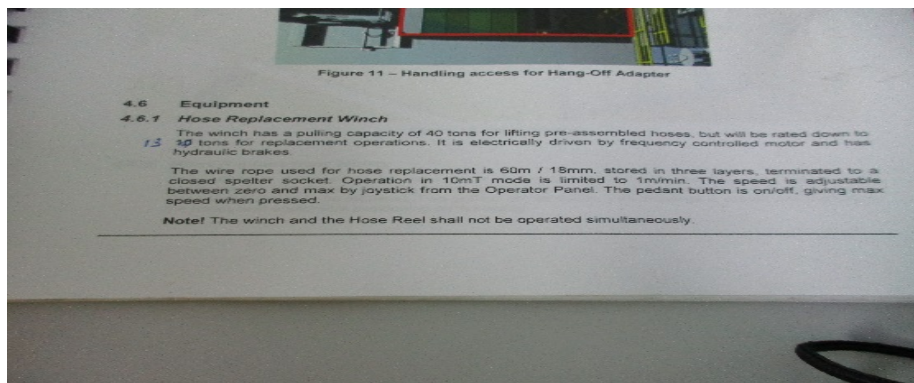
**Photograph 4:** Document 229A-APL-O-KA-001. (Source: PSA)

It emerged from conversations with personnel on board that the work winch was upgraded from 10 to 13 tonnes. It was unclear why this had been done, or by whom. Eni could not document the upgrading process. The capacity change is only shown by somebody having deleted “10 tonnes” and entered “13 tonnes”. This has been done solely on page 101 in document 229A-HHI-A-KA-6003 *Commissioning procedure for system 33*. The change was made on 16 August 2015. The other place where anything can be found on the upgrading is section 4.6.1 on the hose replacement winch in Eni document 229A-APL-O-KA-001 *Hose Replacement Procedure*, where “10 tonnes” has been deleted by a ballpoint pen and replaced with “13 tonnes”.

This procedure, where the change is depicted in photograph 4, was found in the main operation room for the main winch. Documents made available to the team so far show that the original documents have not been updated in any way.

Upgrading capacity from 10 to 13 tonnes reduces the safety factor for the wire rope from 3.15:1 to 2.42:1. Eni cannot document a risk assessment of the upgrade.

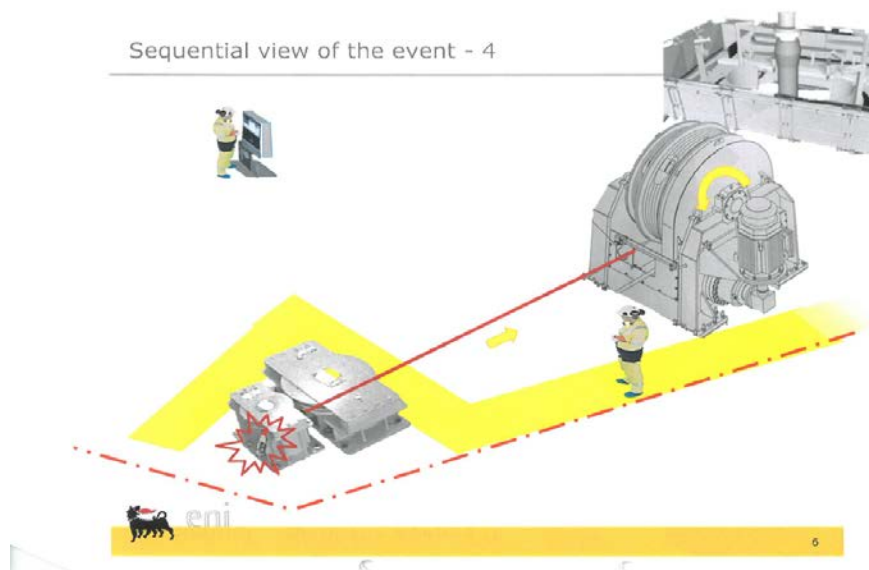
The crane operator took his place at the winch control panel, while the deck operator stood roughly in the centre of the deck. The crane operator began to reel, and the deck operator kept an eye on the rope being pulled towards the guide roller. When the rope end approached the block, the operator positioned himself with his back towards the outer bulkhead roughly midway between winch and guide roller and facing the crane operator.

Reeling continued until the crane operator realised that something was wrong. The wire rope was taut, and the operator immediately put the control lever into neutral. The deck operator moved forward – probably to check why the rope had become snagged, according to a witness. The rope then came free from the guide and flew towards the deck operator. The crane operator believes that the socket termination or the rope hit the left-hand side of his hard hat and ear protector and threw him backwards towards the bulkhead. He remained lying there, clearly confused and partly unable to explain himself.

**Figure 5:** Overview of the D10 area on deck 50000 around 11.00 on 25 June 2016. Source: Eni presentation)

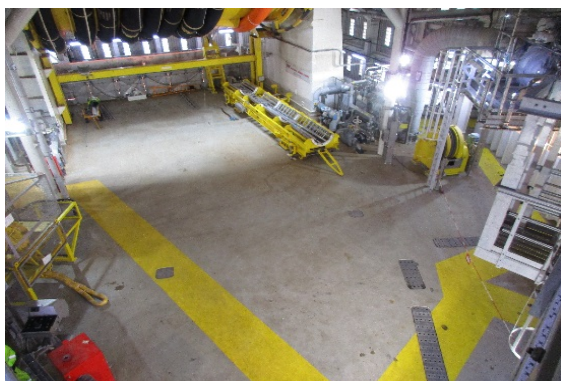
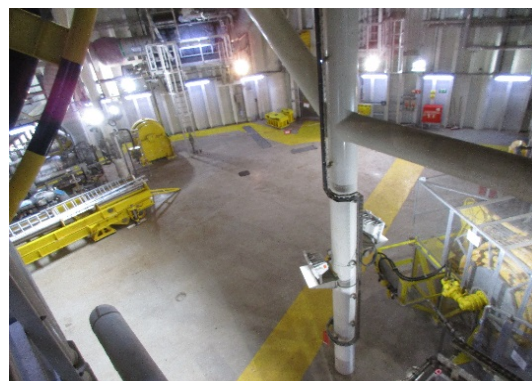
**Photographs 5 and 6:** Overview of the D10 area on deck 50000 around 11.00 on 25 June 2016. Left: view from the stairs up to the main winch. Right: view from the mezzanine deck at the rear of the main winch. (Source: PSA)

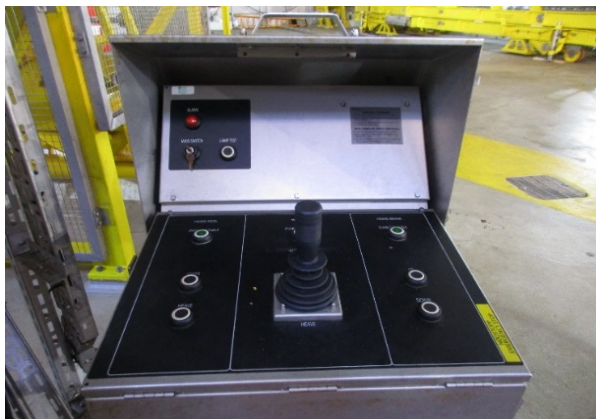
Had the work winch stopped when the lever was turned to off, the load on the wire rope is unlikely to have been as high as it was during the incident. The failure of the winch to stop immediately when the lever was put into neutral should have appeared in the user manual.

**Photograph 7:** Control panel of the work winch (tag 33MK003). (Source: PSA)

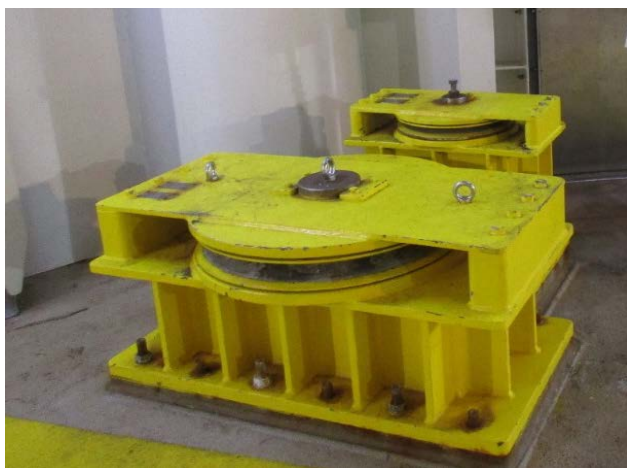
**Photograph 8:** The guide roller (tag 33MZ008). (Source: PSA)

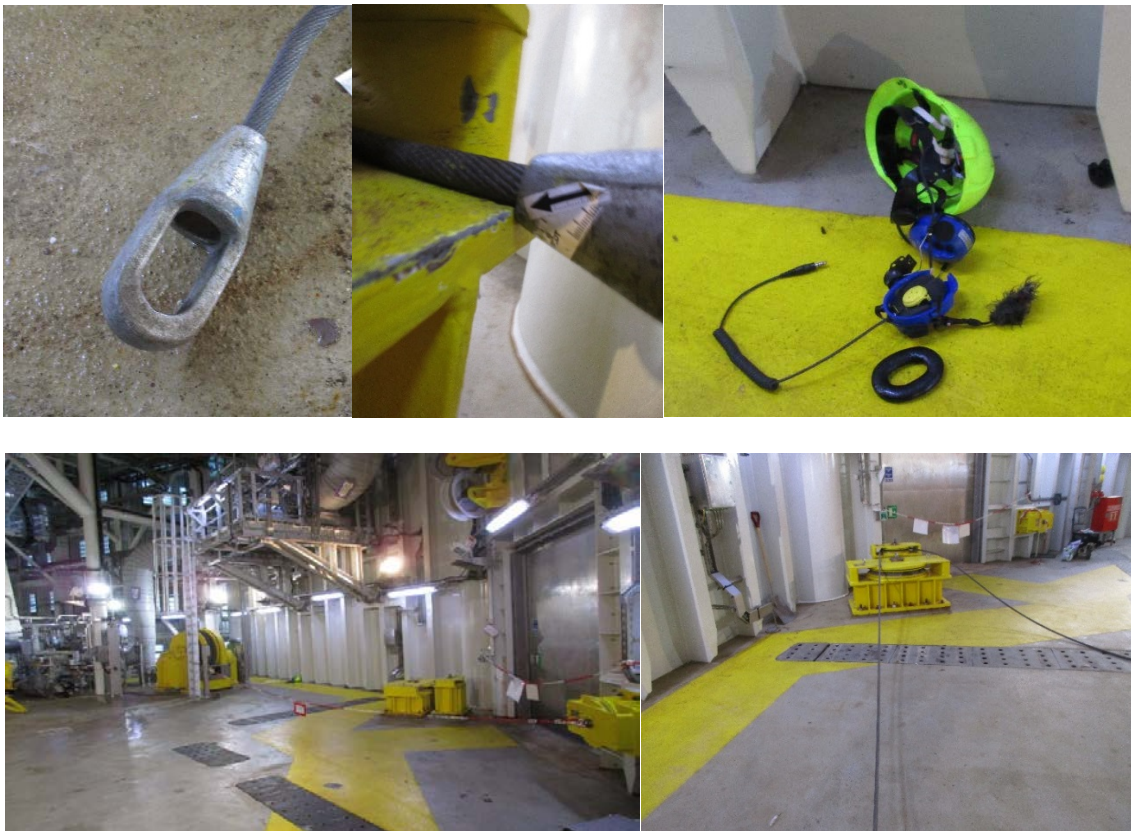
*Photograph 9: The site of the incident. (Source: PSA)*

The cast socket termination of the wire rope became caught in the guide roller, putting the rope under strain before it was suddenly released and hit the deck operator in the head area. It is unclear whether he was hit by the rope and/or the socket. The impact lifted him off his feet and threw him backwards against the bulkhead/deck. His hard hat landed some distance away, and the left-hand side of the ear protector was smashed for an unknown reason. The deck operator suffered head injuries and seemed confused when the crane operator ran to him.
