Investigation report

Report	
Report title Investigation of an arc flash and fire in a switchboard room on Statfjord B	Activity number 001037054

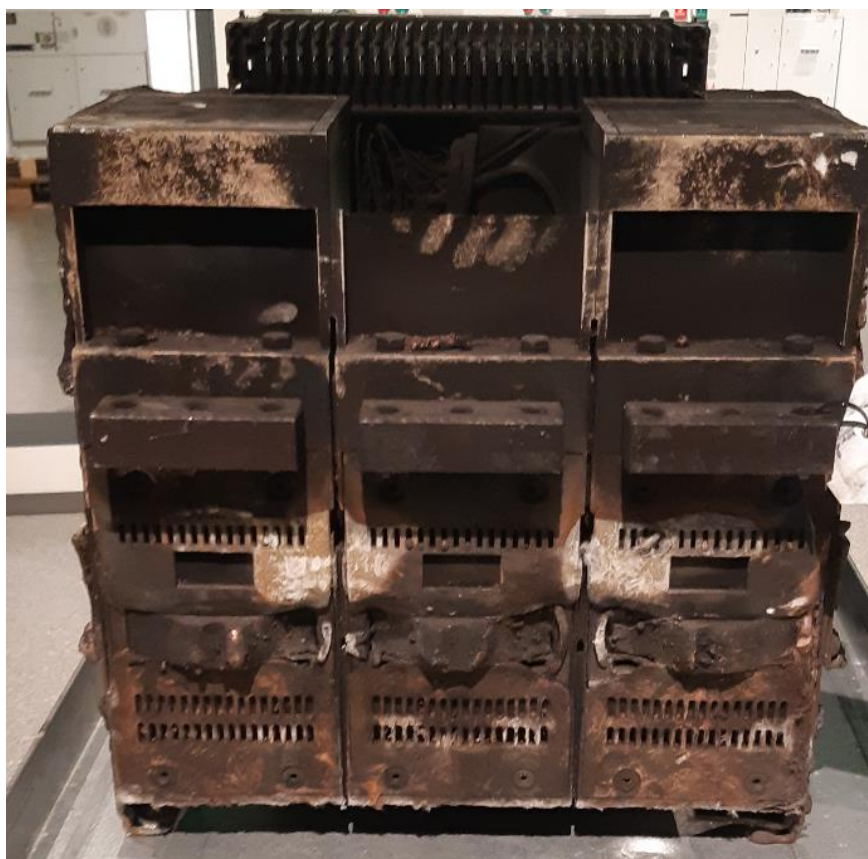
Figure 8 Damage to the lower contact set on the spare breaker.

The direct cause of the incident was very probably a conductive foreign body which contributed to a short circuit and arc flash as the electrician wound in the breaker. That has in turn ionised the air, which quickly developed into a three-phase short circuit/arc flash and fire. The lower contact set (phase conductors) melted/ vaporised, as did the actual cause of the fault (the foreign body). Nothing suggests that the actual breaker has been defective.
