Investigation report

Report	
Report title Investigation of oil spill at Njord A on 31.12.2024	Activity number 2025/9

Parties involved	
Team A1	Approved by / date Elin S. Witsø/24.09.2025
Investigation team participants [REDACTED]	Investigation leader [REDACTED]

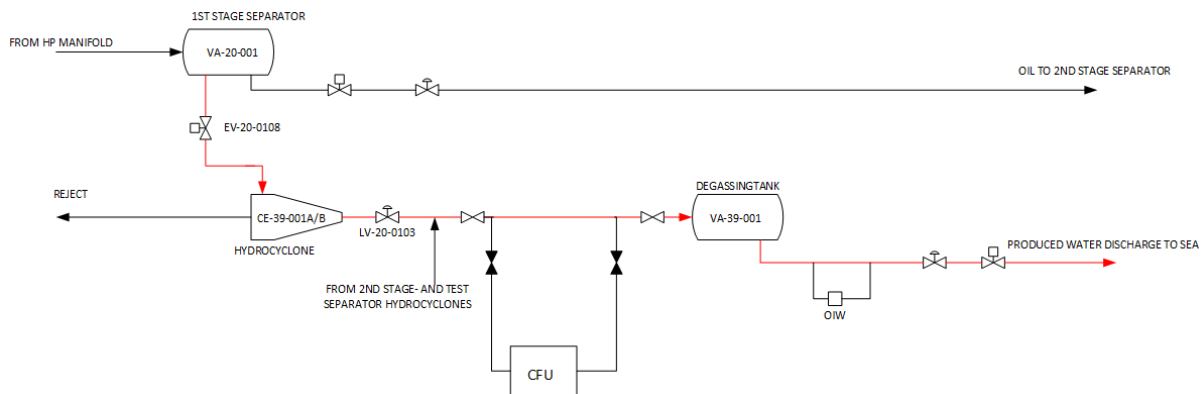
Figure 3 Simplified drawing showing the 1st stage separator and produced water system

During the project phase, calculations demonstrated that the flow volume through the new control valve in the event of gas blowby would exceed the capacity of the overpressure protection system for downstream equipment. In addition, this gas flow rate could have resulted in excessive loads on the downstream piping. To overcome this, the project decided that the valve should be equipped with a travel stop, which was both mechanical and logic-based, in order to limit the maximum opening of the valve so that downstream equipment could cope with the flow caused by gas blowby. However, this travel stop was never installed.

There were deficiencies relating to the overpressure protection of equipment downstream of the level control valve in the produced water system.

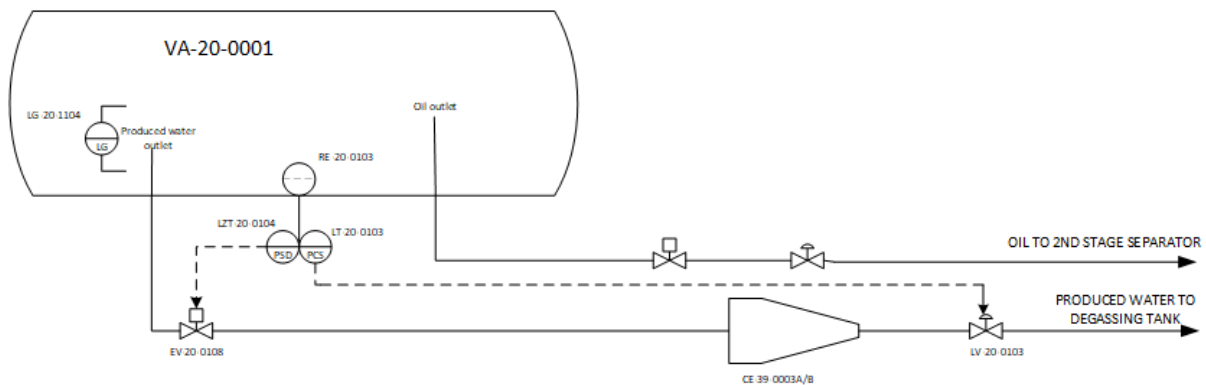
Figure 4 Simplified view of level control and safety functions for shutdown in the event of low water level

During the incident, the level transmitters for both control and process shutdown indicated the same water level. The measured level was (falsely) stable at approx. 37% throughout the entire incident, which is higher than the set limit value for both alarm level (LAL) and trip level (LALL). As a result, no alarm was sent to the CCR upon reaching the LAL level, neither was any alarm nor shutdown initiated sent upon reaching the LALL level. This caused the presence of oil in the produced water discharging to sea to go undetected.

After the incident (11.01.2025), a job was performed in order to verify the water level transmitter. During this job, it was observed that the level measurements as read in the CCR did not fall below 33% at any stage, despite the fact that the actual level had been reduced to approx. 5%. Work was then started to define how the transmitter could best be verified and calibrated. On 23.03.2025, the transmitters were recalibrated by checking and correcting points throughout the measurement range against supplier data (normalised points / % value). After the calibration had been completed, the read and measured levels corresponded for all measurement points, indicating that the transmitter was functioning and that the cause of the previous failure was miscalibration.

In connection with calibration and determination of the trip level for the water level transmitters, insufficient consideration was given to conditions which impact on the measurement results. Thus, the level transmitter, and the trip level for low water level in the separator, did not provide the necessary protection.

The method of calibrating the level transmitters for water level in the separator will cause any miscalibration to affect both the trip function and the control function. An oil spill could occur as a consequence of such miscalibration.

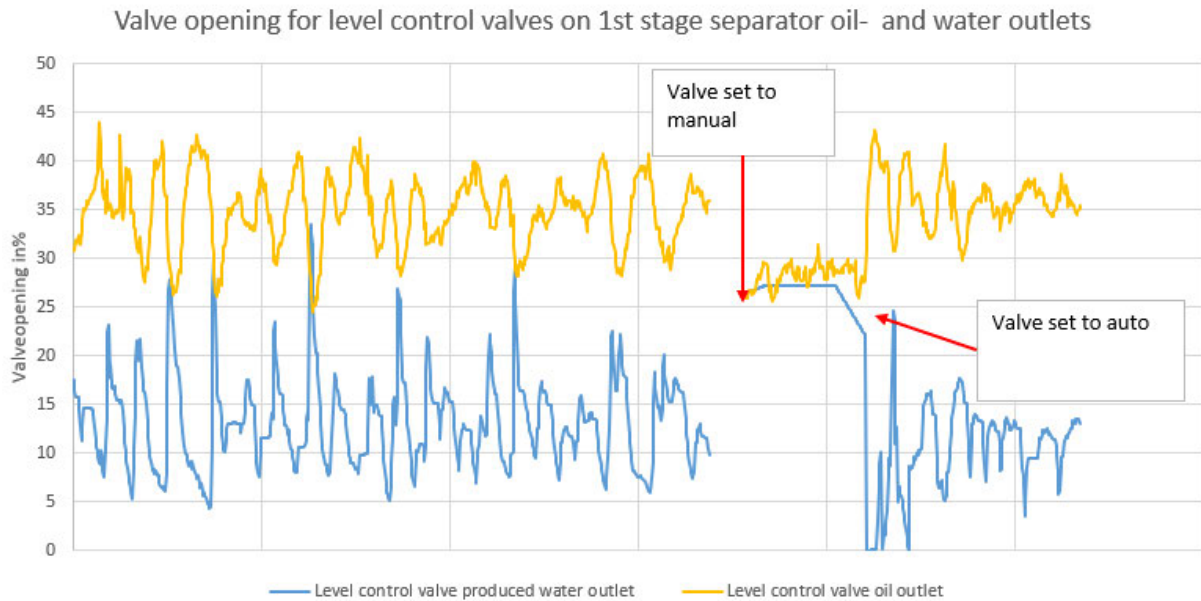
Figure 5 Plot showing valve opening for the level control valves for water and oil respectively

The data concerning valve opening received for the level control valves on the oil and water outlets from the 1st stage separator for 31.12.2024 is shown in Figure 5 below. Data is missing for the period from 11:00 to 18:00 on the day of the incident, which is illustrated by breaks in the curves.

The figure shows that, during the period when the water level control valve was set to auto, the valve openings fluctuate considerably, and that the control valve for oil level then responded in order to compensate for changes in the liquid level. It is also apparent that the fluctuations in valve opening on the oil outlet was dampened during the period when the level control valve on the water outlet was set to manual. It is likely that the erosion damage caused to the water level control valve, combined with the fact that the valve was dimensioned for a higher water flow rate, prevented the level control from operating optimally. This resulted in fluctuations both in the levels in the separator and in the volume of water exiting it.
