# Investigation report

Report	
Report title Investigation of the unintentional disconnection of the LMRP on <i>West Mira</i>	Activity number 404010004

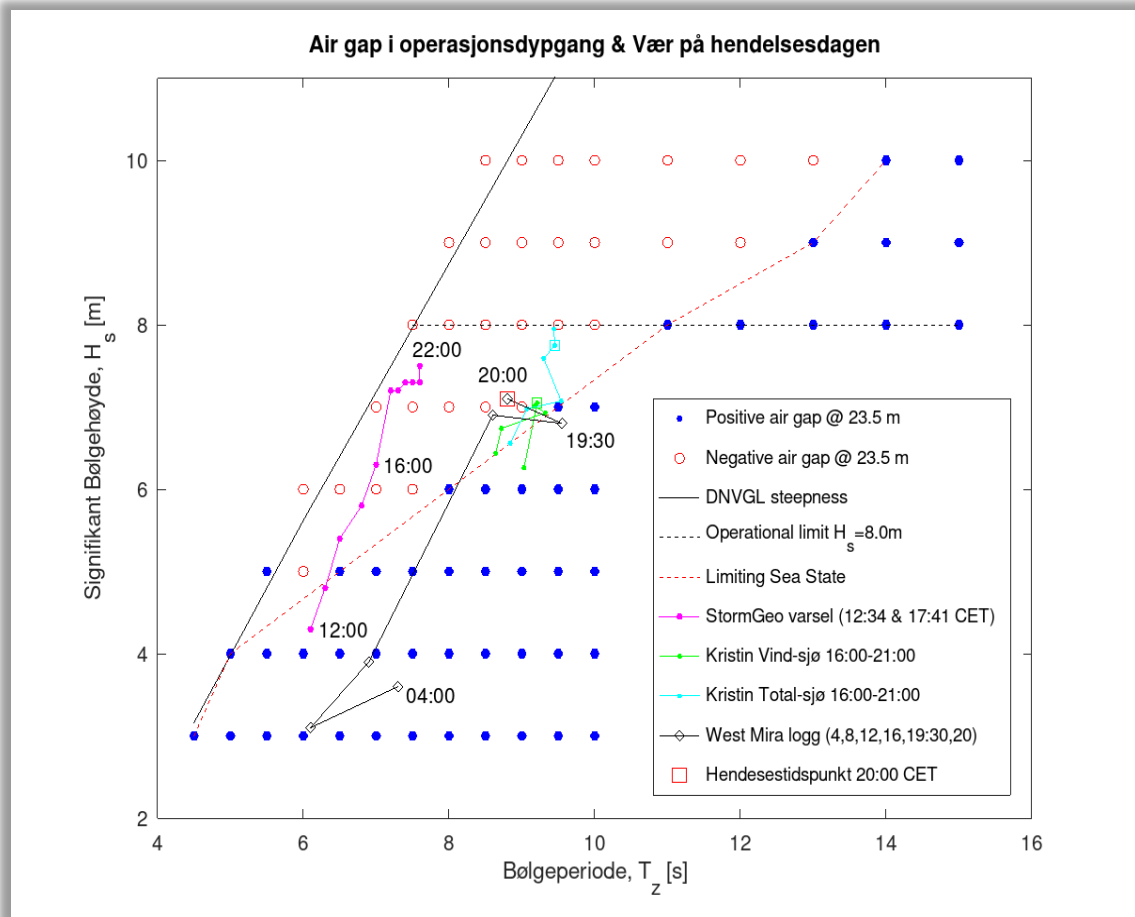
Figure 18 presents the air gap limits for the facility. This graph also shows how the two weather reports from StormGeo at 12.34 and 17.41 predicted developments. The 12.34 forecast shows a predicted trend with very steep waves and rapidly rising Hs, with the latter increasing from about 4m before 12.00 to more than 7m by the end of the day. The updated forecast at 17.41 showed a rise in expected maximum Hs to 7.5m at about 22.00. Furthermore, Hs of 7m was expected from 17.00. As can be seen from figure 18, where the weather forecast is plotted by hourly points, the limiting sea state curve was expected to be exceeded between 13.00-14.00 on 14 March. This curve indicates the boundary between conditions with positive and negative air gap at operating draught. A negative air gap means that waves can be expected to hit the base of the topsides (box bottom) on the facility.

Log entries for registered weather on *West Mira* are also plotted in figure 18. The log is updated every four hours and shows developments from 04.00 until the incident. These data give the impression that observed sea states had a wave period about one second longer than the forecast condition. There are also signs that *West Mira's* limiting sea state was exceeded a little later in the day. According to the logged data, the transition to sea states with a negative air gap occurred between 12.00 and 16.00, and possibly closer to 16.00. In addition to weather recordings every four hours, the times 19.00.00/30 are specified – and then with a very long wave period.

Figure 18: Graph from the appendix to the West Mira class certificate showing the limit values for a positive air gap at operating draught. Weather forecasts from StormGeo, log registrations from West Mira and weather measurements from the Kristin field have been plotted. (Source: PSA) Key: Significant wave height; Wave period.

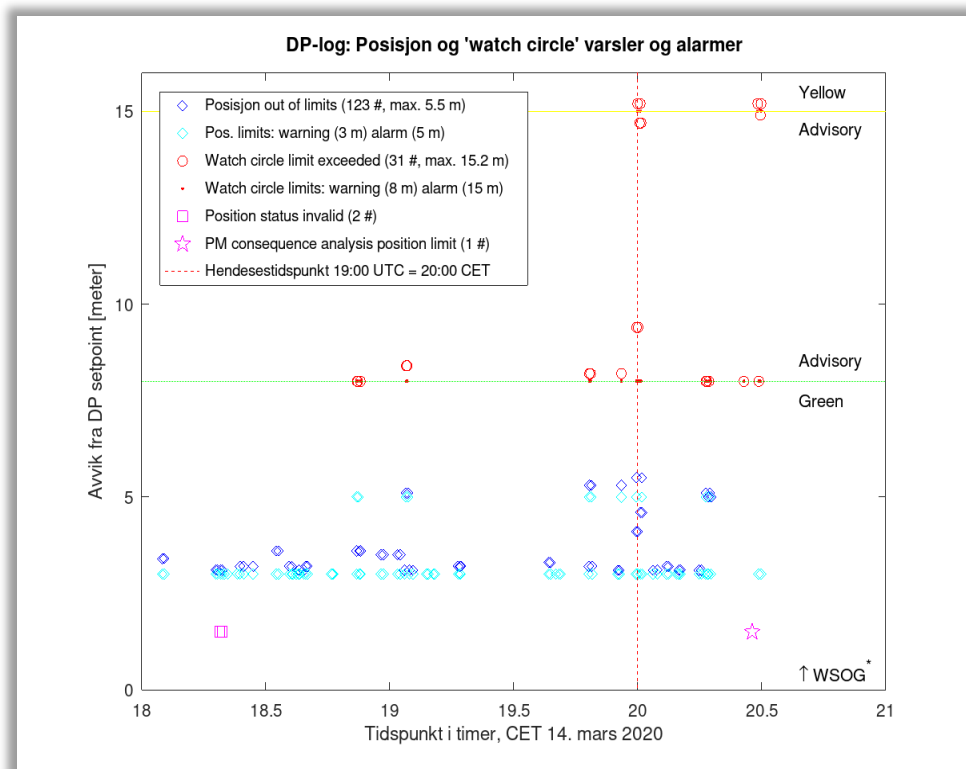
Figure 20 shows position-related warnings and alarms from the DP system between about 18.00 and 20.30. Many position warnings reported that the 3m limit was being exceeded. Since the DP set point had been manually moved by 3m, the real distance from the well location was closer to 6m at the times when the DP system was warning of 3m drift-off.

Figure 20: Graph of position-related warnings and alarms from the DP system's data log.

Note that points on the right of the graph above WSOG\* show the WSOG limits which would normally coincide with the distance from the DP set point. During the hours shown in the graph (post-17.30), the latter had been manually set to 3m from the well centre in the direction of the waves (produced by the PSA). Key: Deviation from DP set point (m); Time in hours.

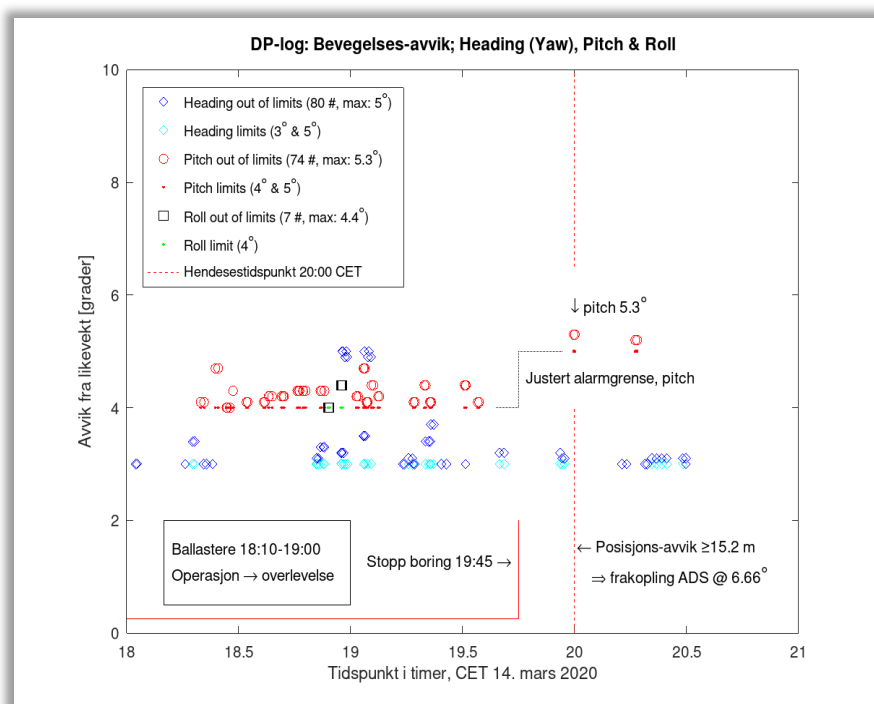
In addition, the facility experienced a pitch of roughly 5.3 degrees at the same time as the incident. This motion could have affected the riser and had an effect on the angle of the LFJ, where the ADS mechanism was triggered.

Figure 21 illustrates motion warnings and alarms graphically. Note that a shift occurs in the limit value for pitch, which indicates that a (manual) adjustment was made to the value in the DP system from four degrees (in accordance with the WSOG) to five degrees. Carried out between 19.34.24 and 19.49.43, this was not logged and has not been mentioned in interviews during the investigation.

Figure 21: Graph of alarms from the DP system for dynamic motions of the *West Mira* facility (produced by the PSA on the basis of the alarm log in the DPM system). Key: Deviation from equilibrium [degrees]; Time in hours.

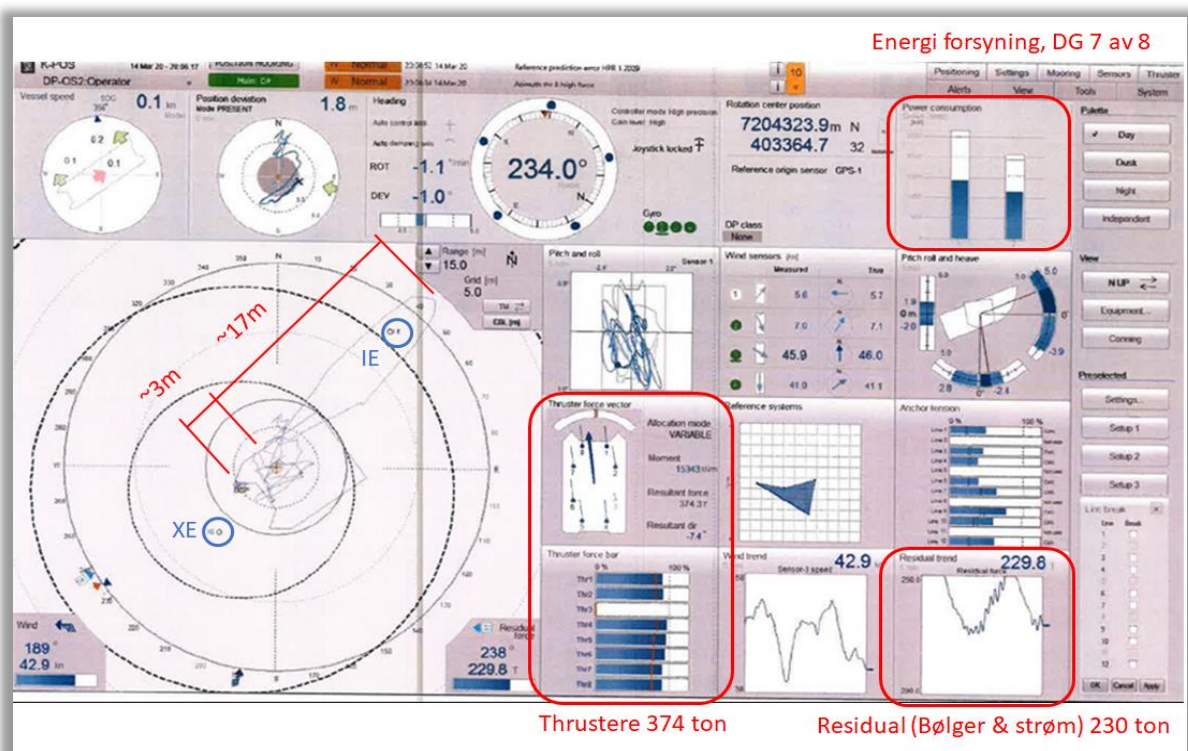
Figure 22: The DP console immediately after the incident on 14 March at about 20.00 CET (local time), 19.00 UTC. The excursion trace is shown to the left, where the silhouette of West Mira can also be seen. The DP set point below the drilling centre is marked in orange as the target, and the well centre is forward of the starboard pontoon. Two marked points can also be seen, one forward of West Mira (XE below left), which is where the facility would locate itself with active mooring and thrusters if all weather forces disappeared. The IE point more than a vessel's length aft of West Mira is the one which the facility would move around if all thruster power disappeared and the mooring system alone was left to withstand the natural forces.

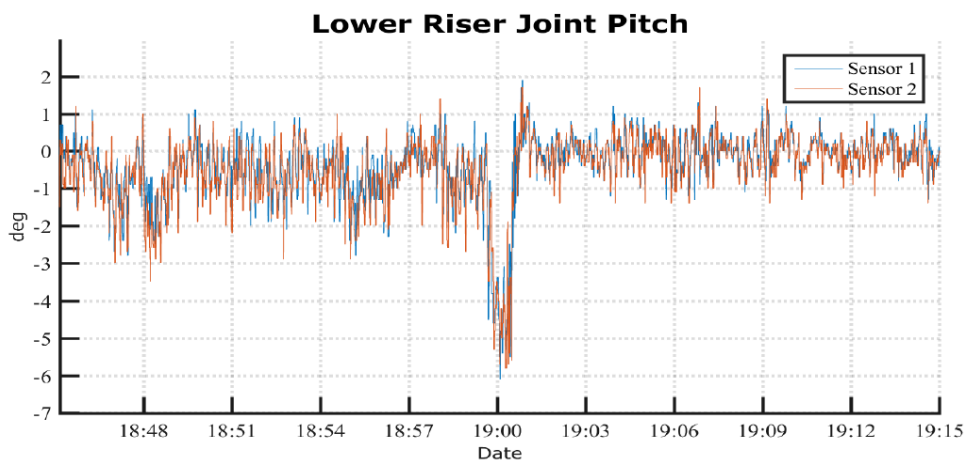
The direct cause of the incident is a combination of several factors. It occurred when the facility lost position because of dynamic weather forces. The drilling contractor concluded that the drift-off activated the ADS. A combination of sub-optimal mooring lines and extensive use of thruster capacity to maintain position meant thruster power was insufficient to withstand the dynamic forces at the time of the incident. The disconnection signal was given after the ADS exceeded the five-degree activation point, which in turn automatically cut the string and shut in the well.

Figure 23: The angle attained by the LfJ at the time of the incident.
