Investigation report

Report from the investigation of a hydrocarbon leak on Heimdal, 26 May 2012

Activity number
001036006

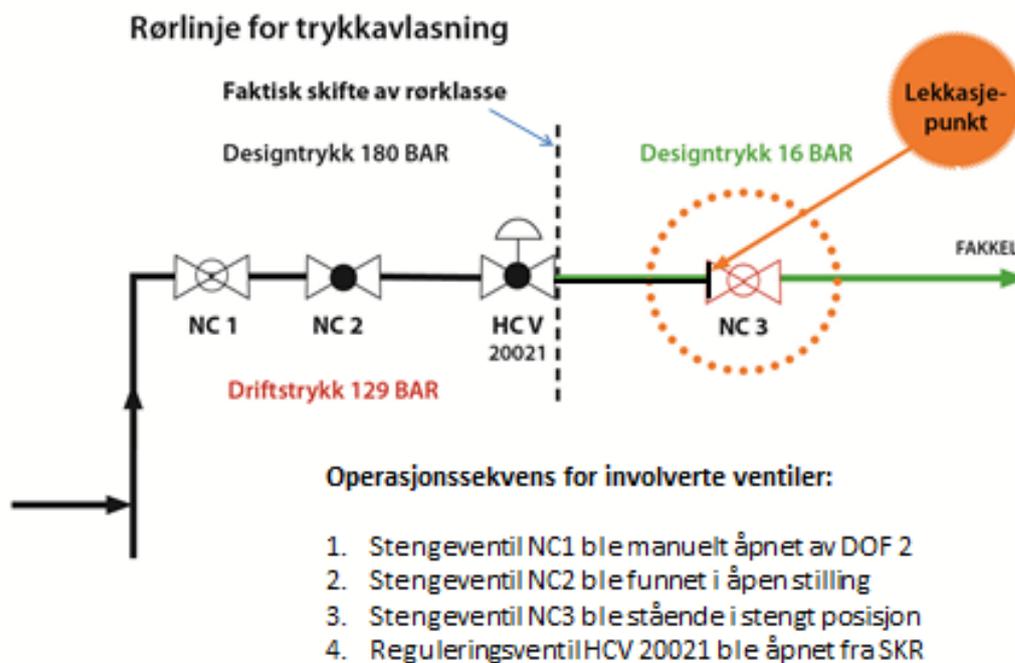
Figure 1: The pipeline for blowdown and a description of the operational sequence performed by the operator in the field, hereafter designated DOF2.

The NC3 valve which functioned as the final barrier to the flare was closed. When blowdown was initiated by opening the HCV, NC3 was exposed to a pressure of 129 bar. As a result, the gasket, insulation and enclosure around the flange were blown off. The gas pressure twisted the metal plates out of place, pieces of the aluminium enclosure and the insulation were blown off, and gas leaked out into the Module 40 (M40) area.

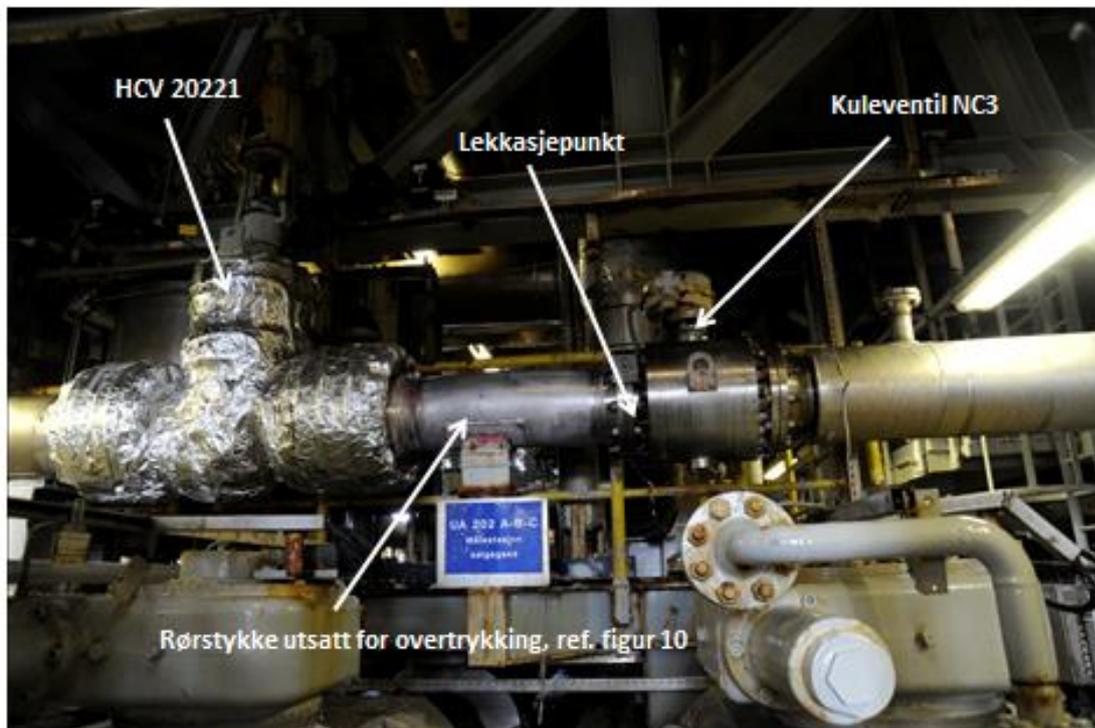
Figure 2: The pipe section between HCV 20021 and the NC3 manual shut-off valve.

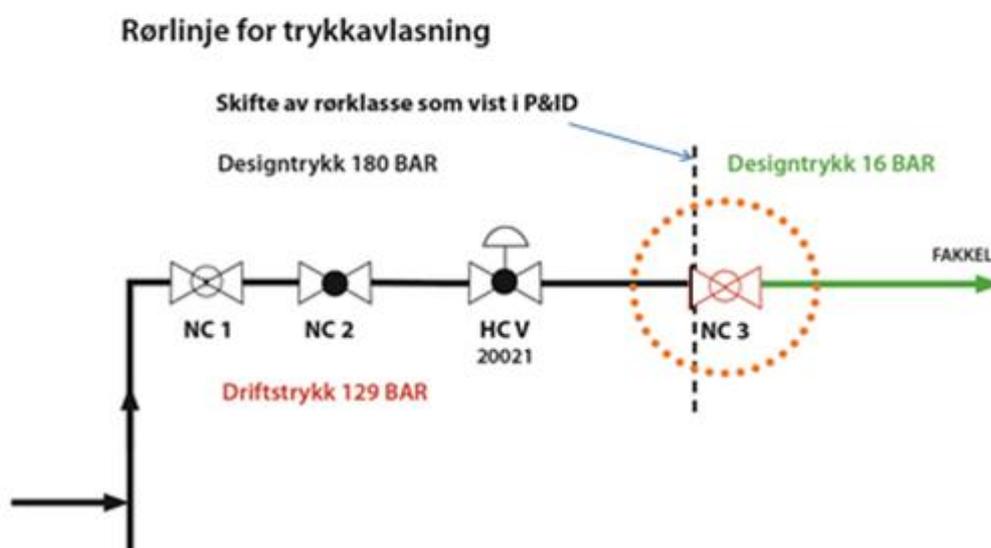
Figure 5: The pipeline for blowdown illustrates the change of pressure rating as shown in the P&ID.

The applicable standard, Norsok P-001 2006, recommends (see figure A.7 – *Manual blow down for maintenance purposes*) that a change of pressure rating must always follow the final block valve before the flare. In addition, this valve must be open. The purpose is to establish a robust design which ensures that a leak does not occur because of excessive pressure on valve or pipe. The applicable regulations when the HRP was designed and built (1980) state that “Equipment must be safeguarded in accordance with API RP 14 C” and that the gas blowdown system must be dimensioned in accordance with API RP 521. The chosen design solution breaches the basic protection principles in these standards, and the safety functions are not robust.

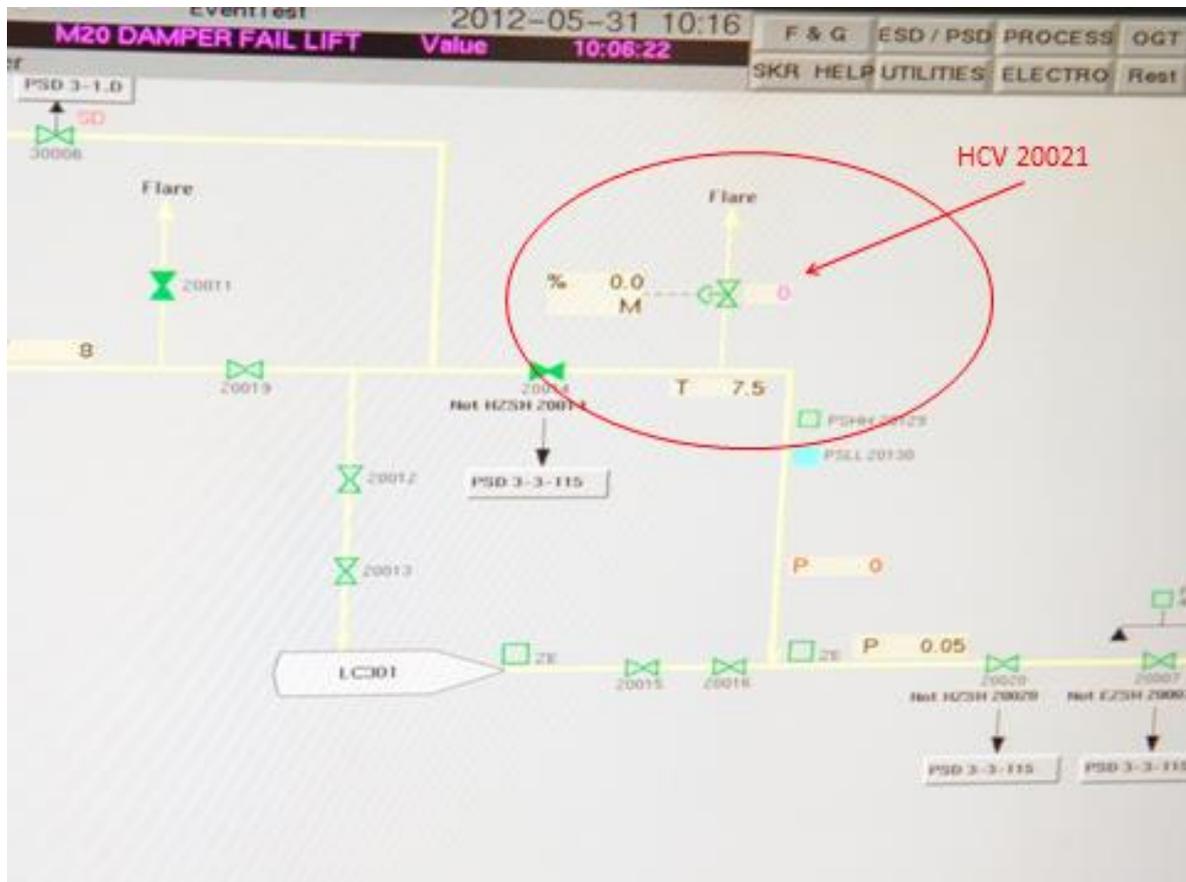
Figure 6: The CCR operator had a limited overview of the valve configuration.

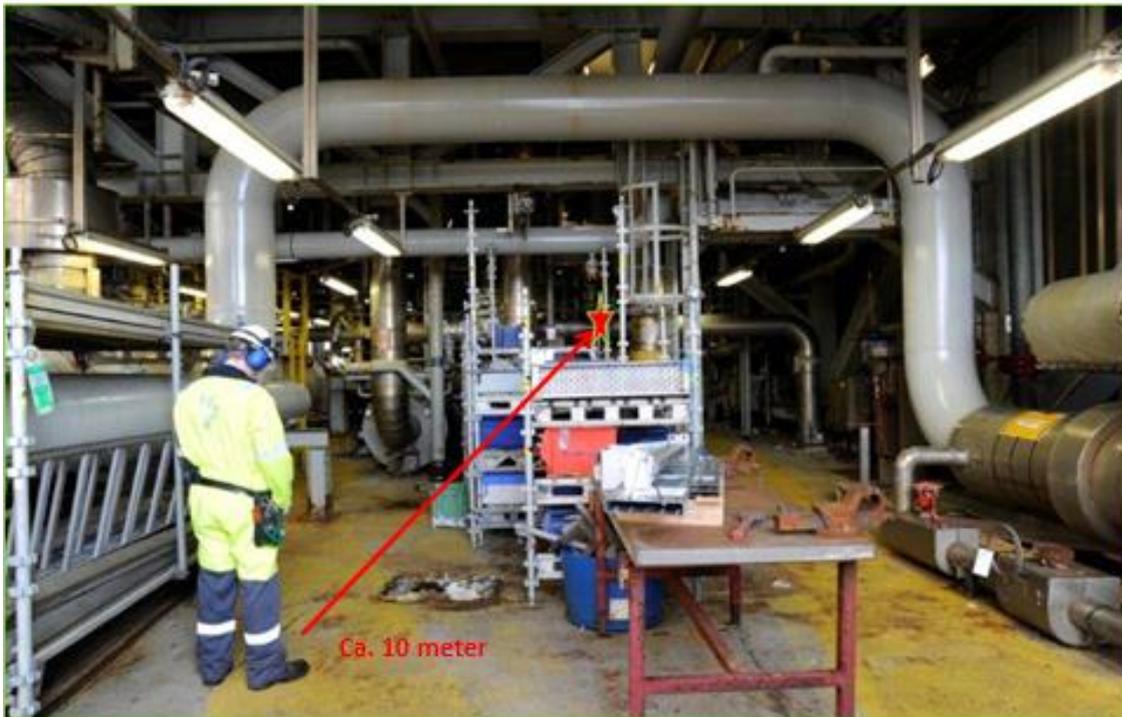
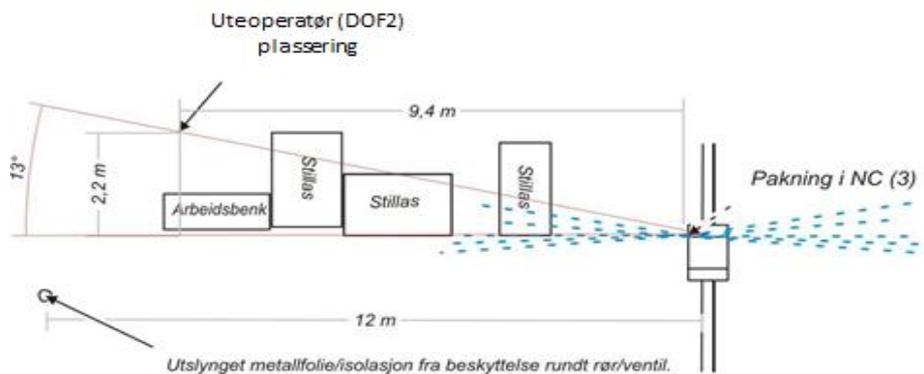
Figure 7: The operator’s position and distance from the leak site (source: police).

Figure 8: Operator’s position in the area near the leak site (source: police).

An operator stood about 10 metres from the leak site (see figures 7 and 8) and, according to information from interviews, was exposed to the gas cloud. The extent of this exposure has not been clarified. The operator was not subject to obvious immediate injury from the gas or fragments of gasket and insulation blown off from NC3 in the incident. The operator was investigated by health personnel on the installation and followed up subsequently to identify possible delayed effects.

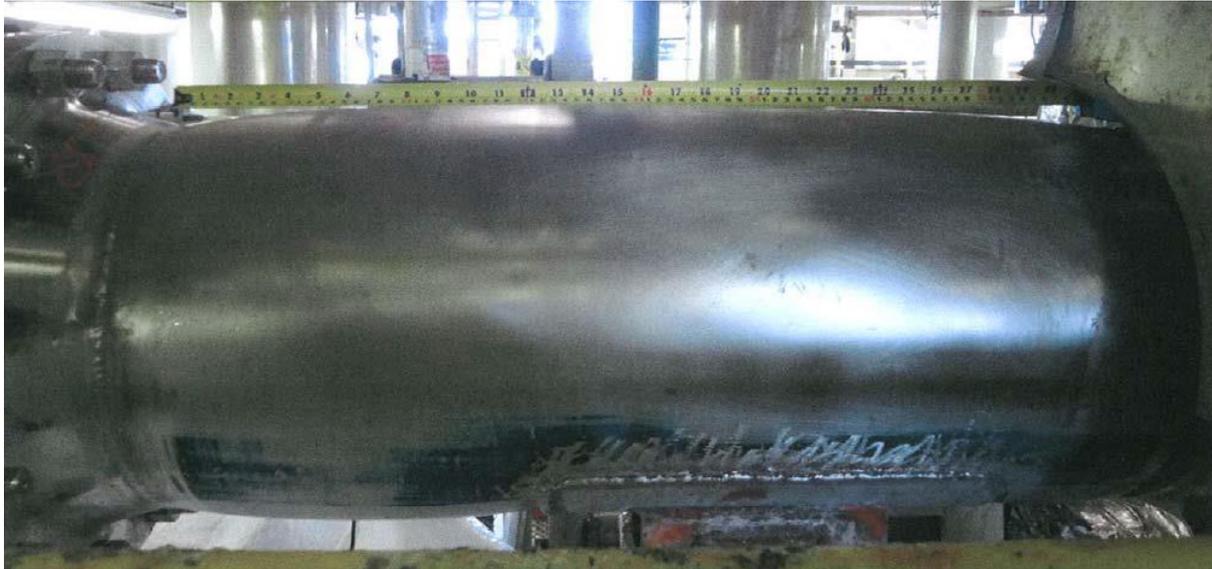
Statoil has reported that the gasket which failed in NC3’s upstream flange was a fibre type, and should have been replaced in line with Statoil’s own requirements by a spiral wound gasket with a steel facing. It emerges from Statoil’s investigation report that a spiral wound gasket would probably not have failed under the relevant pressure. The pipe section was deformed (see figure 8), and would probably have fractured longitudinally had the gasket not failed first. This would in all likelihood have meant that the whole gas volume of 7 000 kg escaped before HCV 20021 managed to close.

Figure 11: Deformed pipe section between HCV 20021 and the leak site. (Source: Statoil's investigation report)

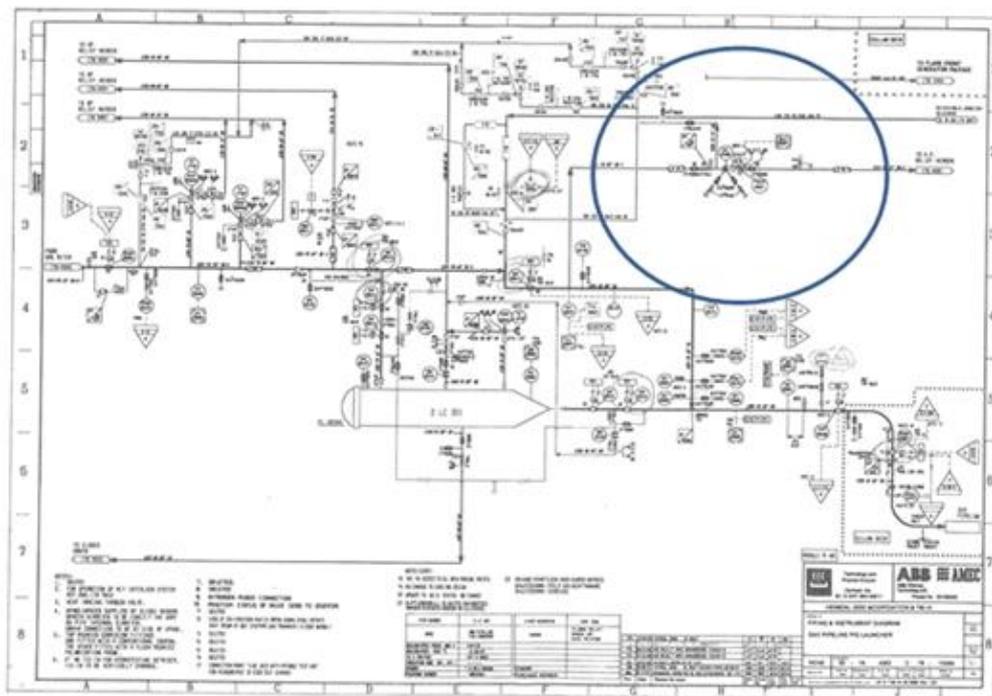
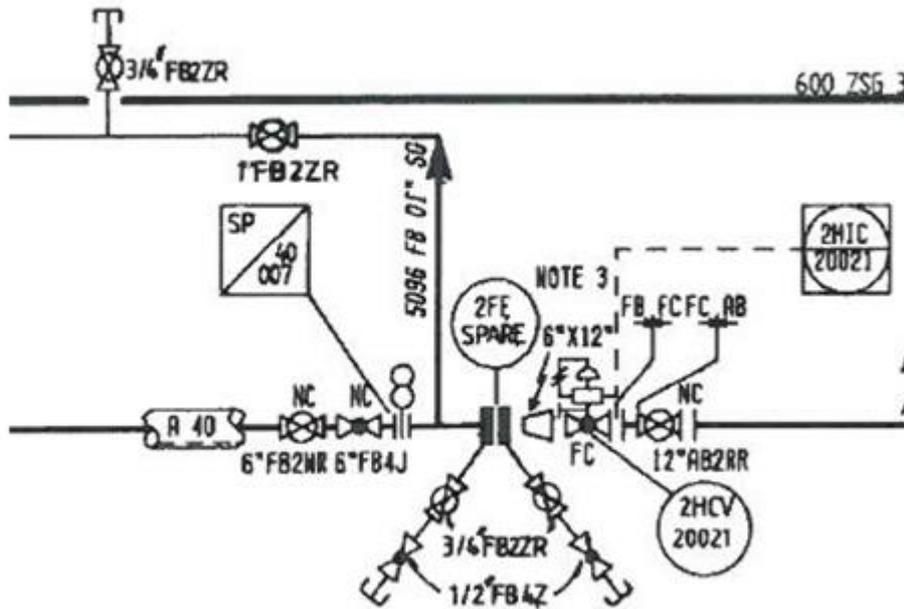
The P&ID must show the correct design of the process plant, and represents a key element in the ability to operate the facility safely. In the procedure submitted, the P&ID appears in A4 format on the reverse of the procedure. Some of the symbols and texts in the P&ID are indistinct. This means it is not possible to read the change of pressure rating on the pipeline. The position of the valves is also hard to discern. In addition, several errors appear on the P&ID, including ones related to the pipeline involved. See nonconformity 7.1.1.

Figure 14: The P&ID (in A4 format) on the reverse of the test procedure, with the relevant pipeline circled.

Figure 15: The relevant pipeline in detail.

The NC2 control valve was found in the open position by DOF2. This valve was marked NC (normally closed) on the P&ID. There was no extra notation on NC2 or in the P&ID that this valve was open. It also emerged during the interviews that NC2 was difficult to operate at times, and was described as “stiff”, “crooked” and “rusty”. The real status of the pipeline and the information on the P&ID do not correspond, which could indicate a failure to spot such lack of correspondence and/or update the test procedure the last time it was implemented.

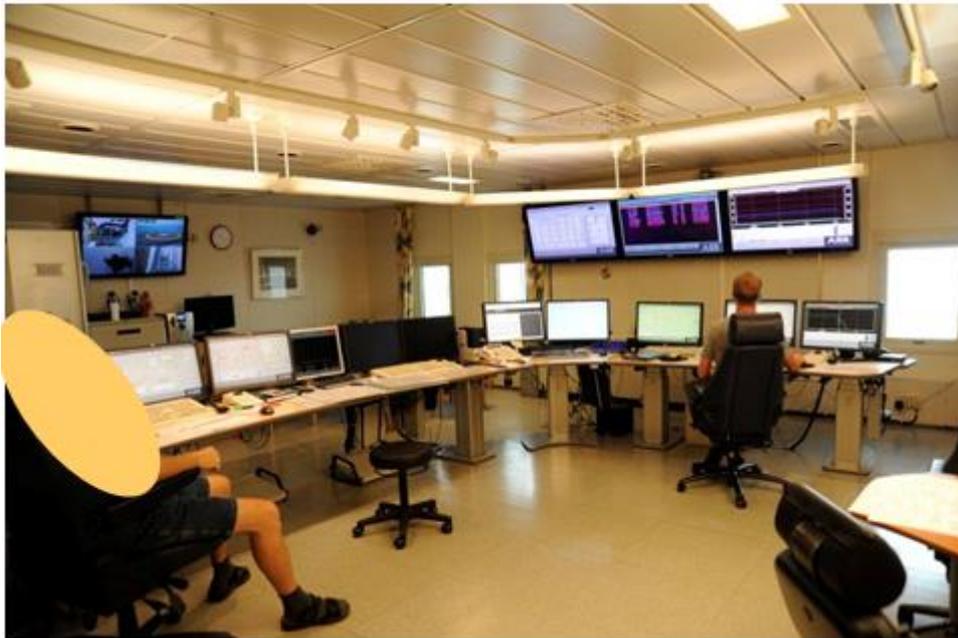
- *sat with his back to the KOS and the flare*
- *could not see the flare because of fog*
- *thought the leak was in the flare system*
- *working conditions in the CCR were a great disadvantage*
- *the job was made a little harder*
- *the phone was out of reach*
- *extremely irritating*

Figure 16: Shows the CCR operator at the temporary workstation as during the incident. The dedicated but inoperative workstation is to the left with a dark display.
