# Investigation report

Report	
Report title Investigation of lifeboat incident of 14 January 2015 on <i>Mærsk Giant</i>	Activity number 400003004

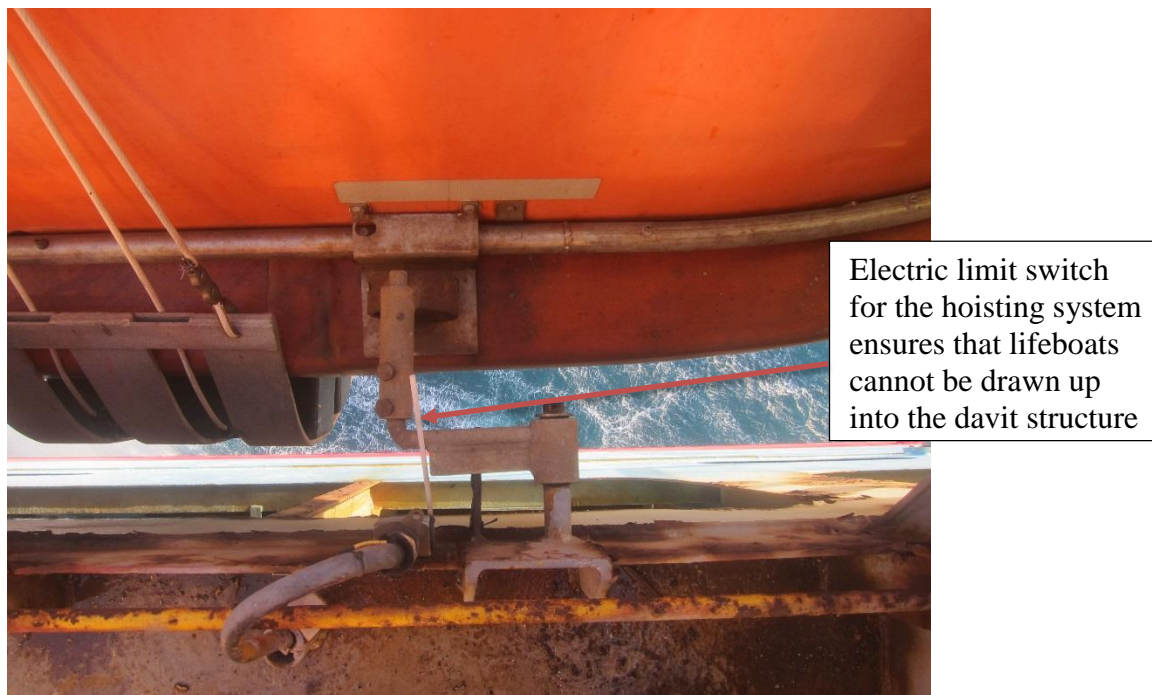
When the lifeboat is hoisted back into place, two limit switches turn off the electric motor when the lifeboat reaches its normal position to prevent it being drawn into the davit structure.

Figure 3: Electric limit switch.

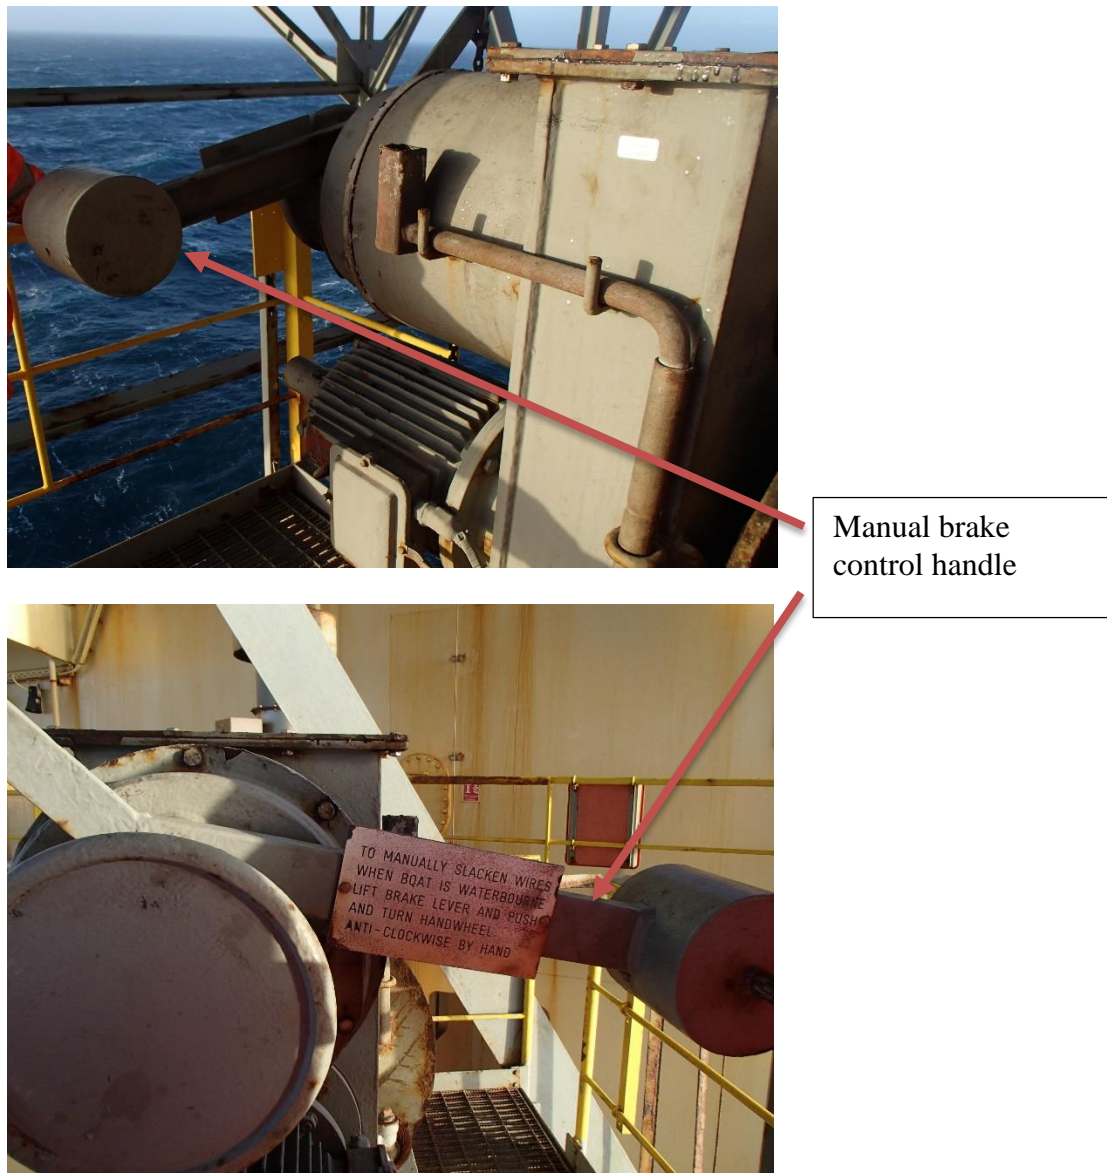
The manual brake on davit number 2 was in the position shown in figure 3, with the manual brake control handle tilted down.

Figure 4: Two photos showing the manual brake control handle for lifeboat 2 after the incident.

The user manual for the davit specifies that the manual brake control handle must either be in a horizontal position or adjusted to a raised angle of 10-15 degrees to ensure a fully functional brake.

When the control handle is tilted down, the chain which should be tautened to lower the lifeboat will already be taut. This means in turn that the braking effect of the manual brake will be reduced because the weight on the end of the handle cannot exert sufficient moment on the braking mechanism.

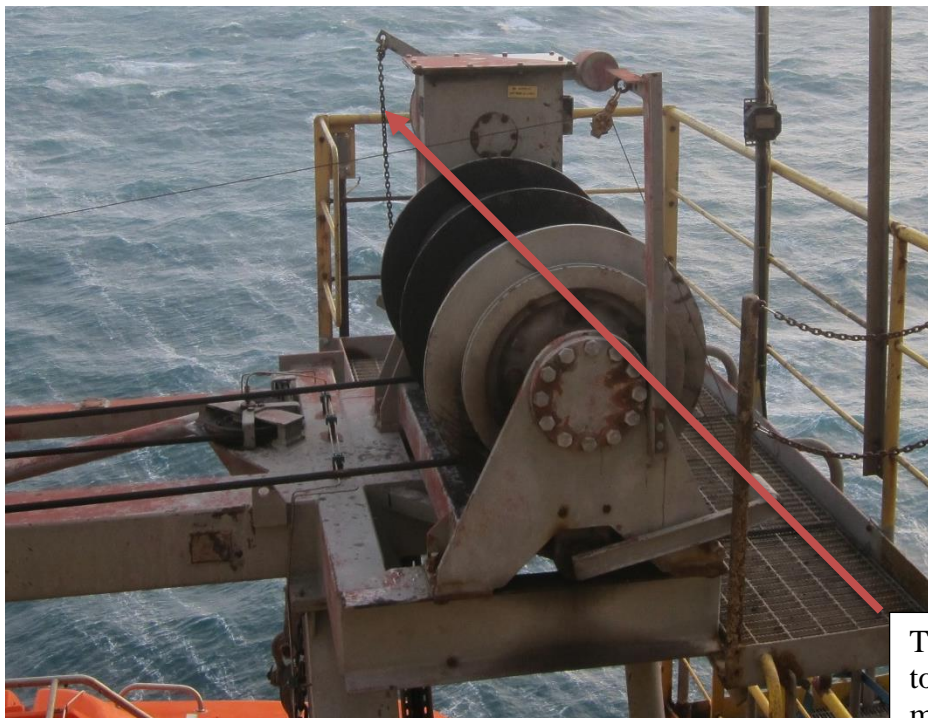
Figure 3: Overview of the winch system on the corresponding port-side davit.

The chain connected to the lowering mechanism in the lifeboat. This must be slack for the weighted handle to be effective. The functionality of the manual brake is reduced if the chain is taut and prevents full activation of the weight on the manual brake handle.

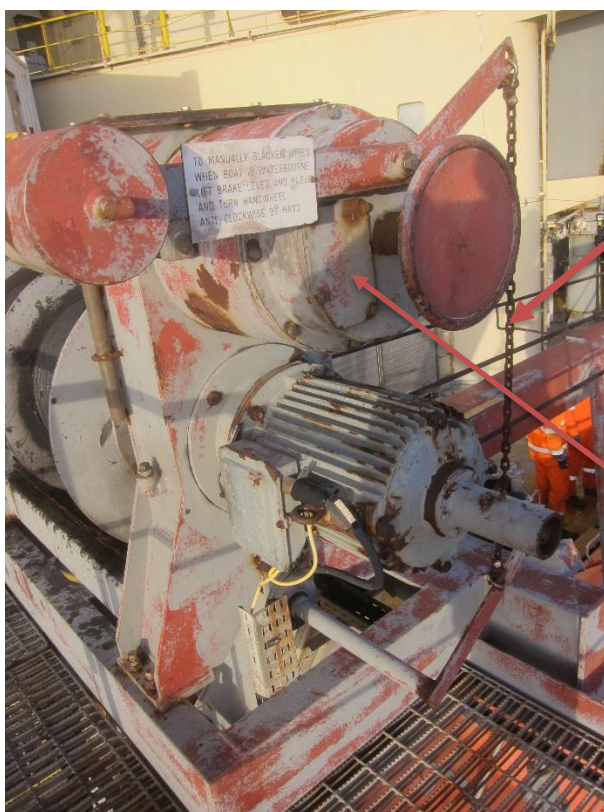
Figure 4: The corresponding port-side davit with the manual brake control handle and chain connected to the lowering mechanism.

The precision adjustment nut is beneath this cover.

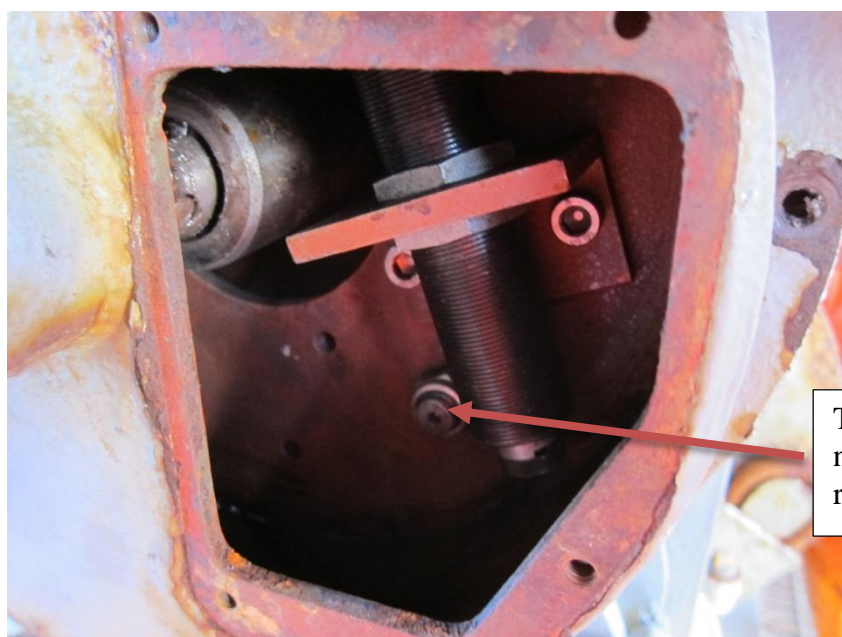
The precision adjustment nut is accessible after removing a cover.

Figure 8: The precision adjustment nut.

We find it highly probable that the brake has not been adjusted with the aid of the precision adjustment nut since its most recent annual maintenance by Survival Craft Inspectorate Norge AS on *Mærsk Giant* in August 2014, and that full braking effect has therefore been absent.
