REVIEW OF AVAILABLE MATERIAL ON USABILITY AND SUITABILITY OF  
HIGH-STRENGTH MOORING CHAIN (PSA)

# Usability and suitability of high strength mooring chains

Petroleum Safety Authority Norway

**Report No.:** P261.1C-54693, Rev. 1

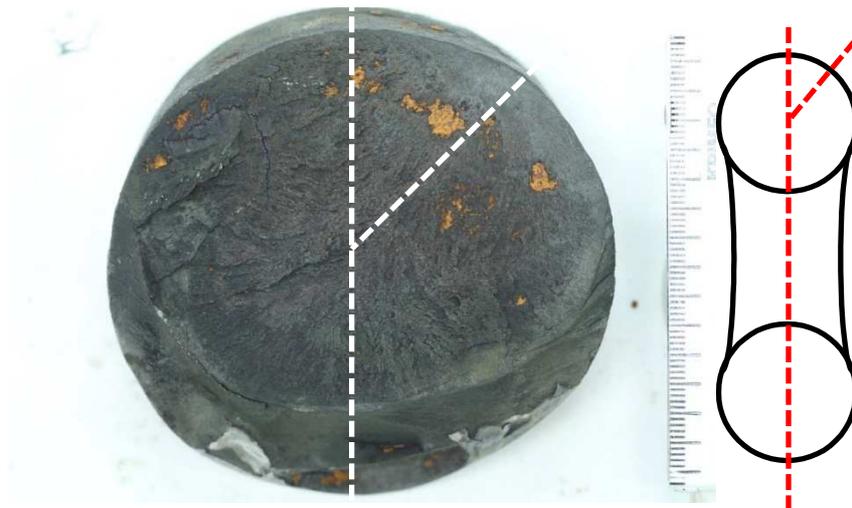
Such observations allow to conclude that crack initiation in straight area of the links result from the presence of untempered martensite or highly hardened material caused by high contact loads or drag wear.

Figure 7-9 Example of straight part crack. Initiation at 1-2 o'clock position and single brittle crack surface

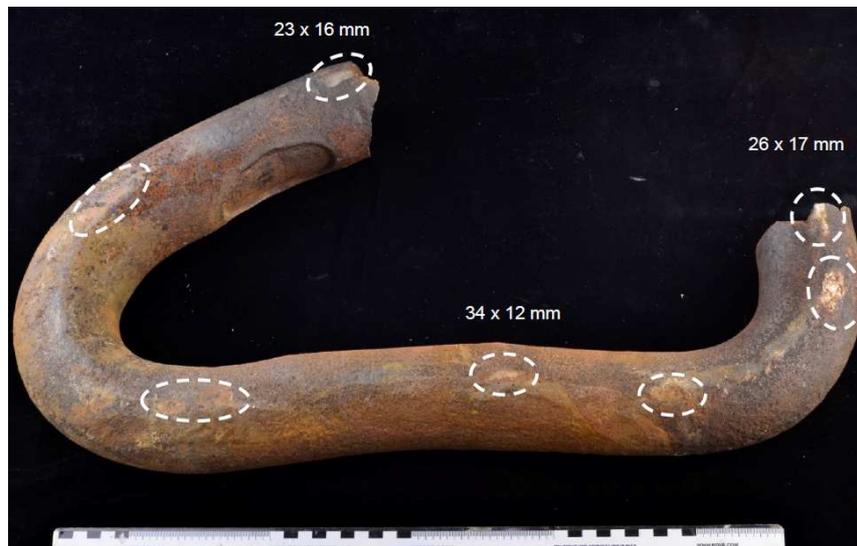
Figure 7-10 Example of contact and drag marks location.

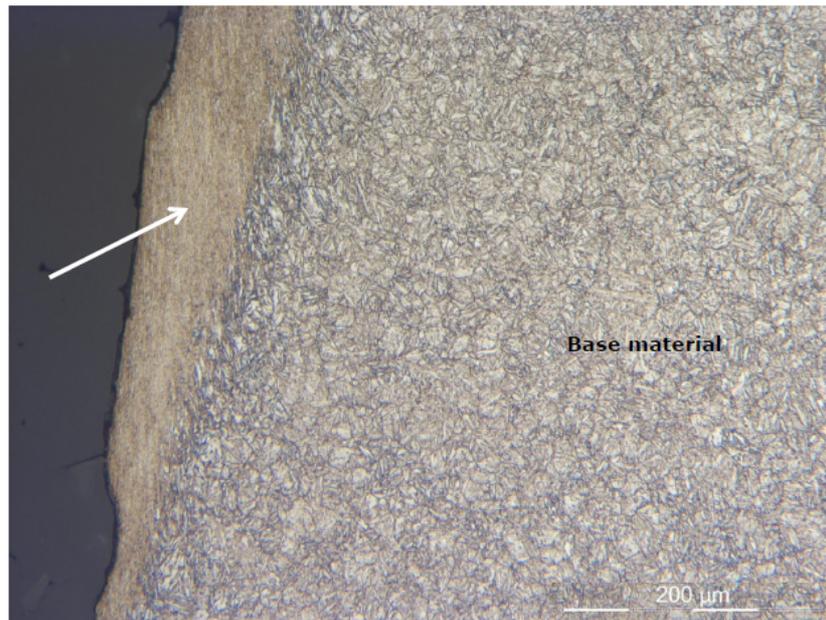
**Figure 7-11** Example of untempered martensite layer observed in the vicinity of a crack initiation on the straight part of the link.

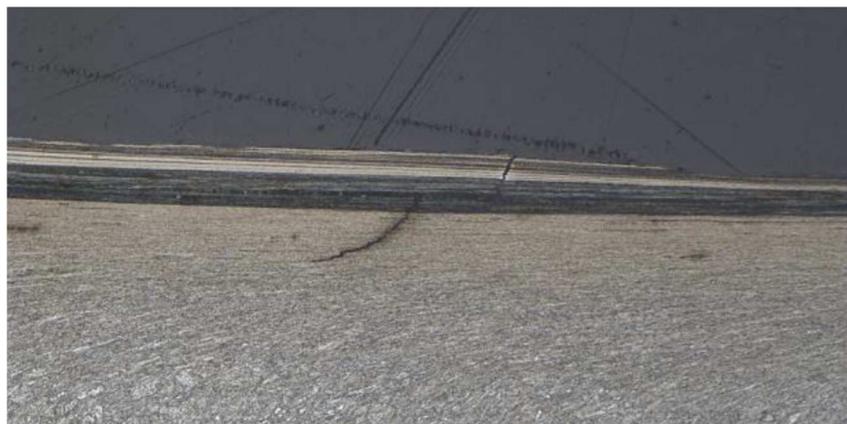
**Figure 7-12** Example of slanted micro cracks observed in the untempered martensite layer. This type of surface microstructure was not observed in sections take outside the areas with dents or wear marks.

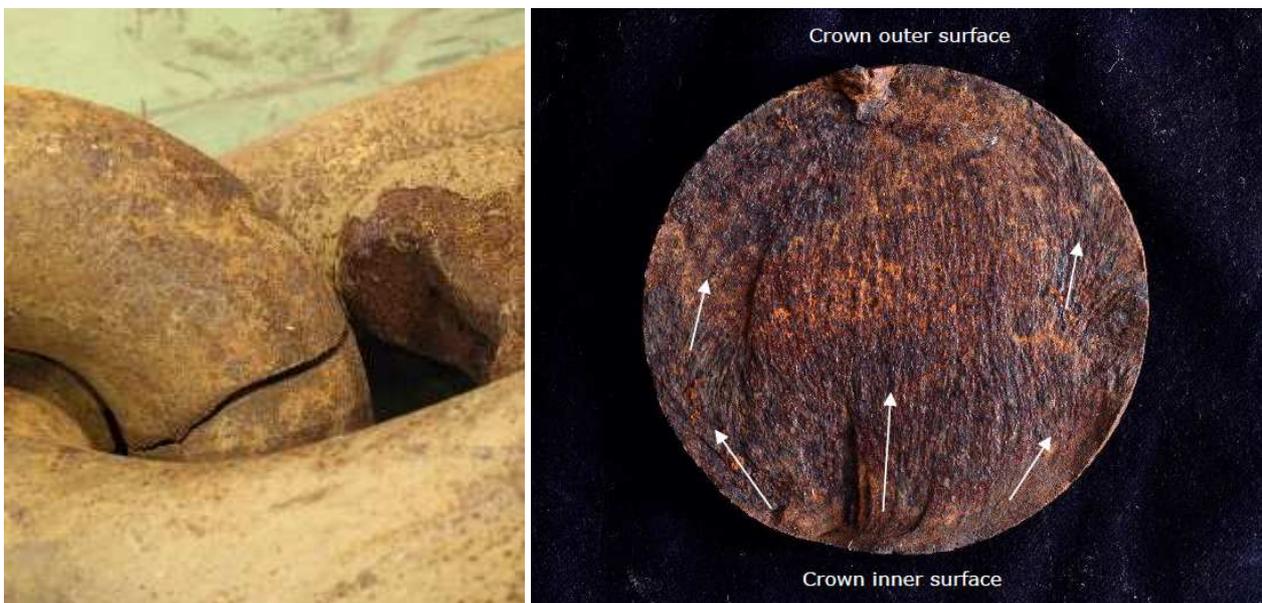
**Figure 7-13 Typical location of a crown crack and initiation area**

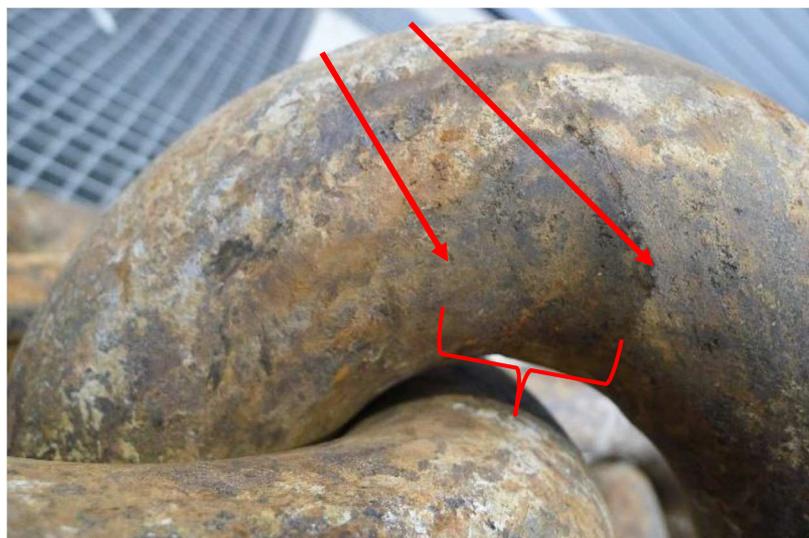
**Figure 7-14 High contact/wear marks in the crown area**

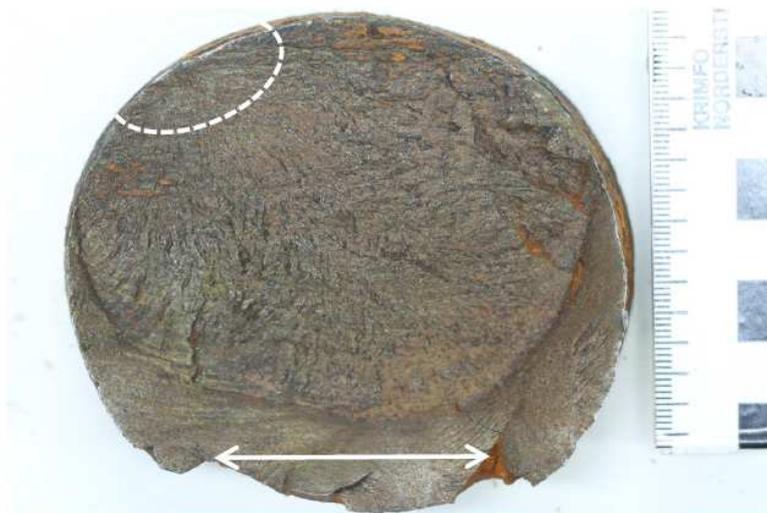
**Figure 7-15 Most common type of crack surface with single brittle growth and final shear lip.**

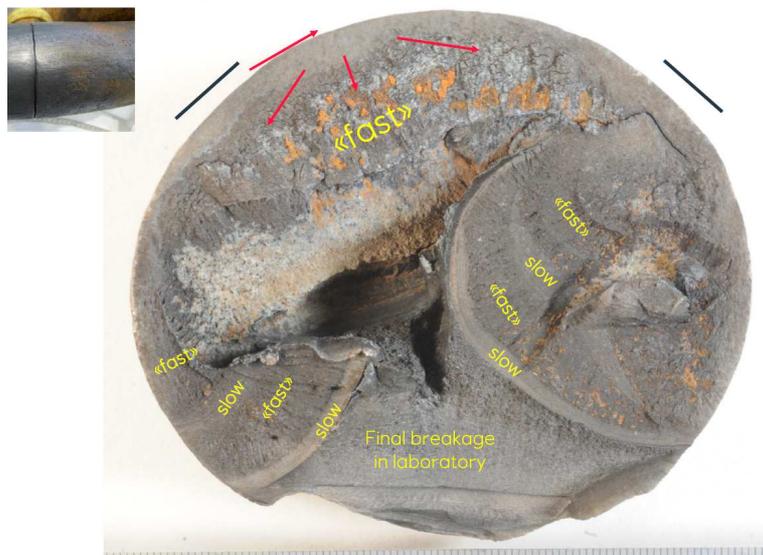
**Figure 7-16 Example of breakage surface showing several events of fast/brittle fracture and slow/fatigue growth periods.**

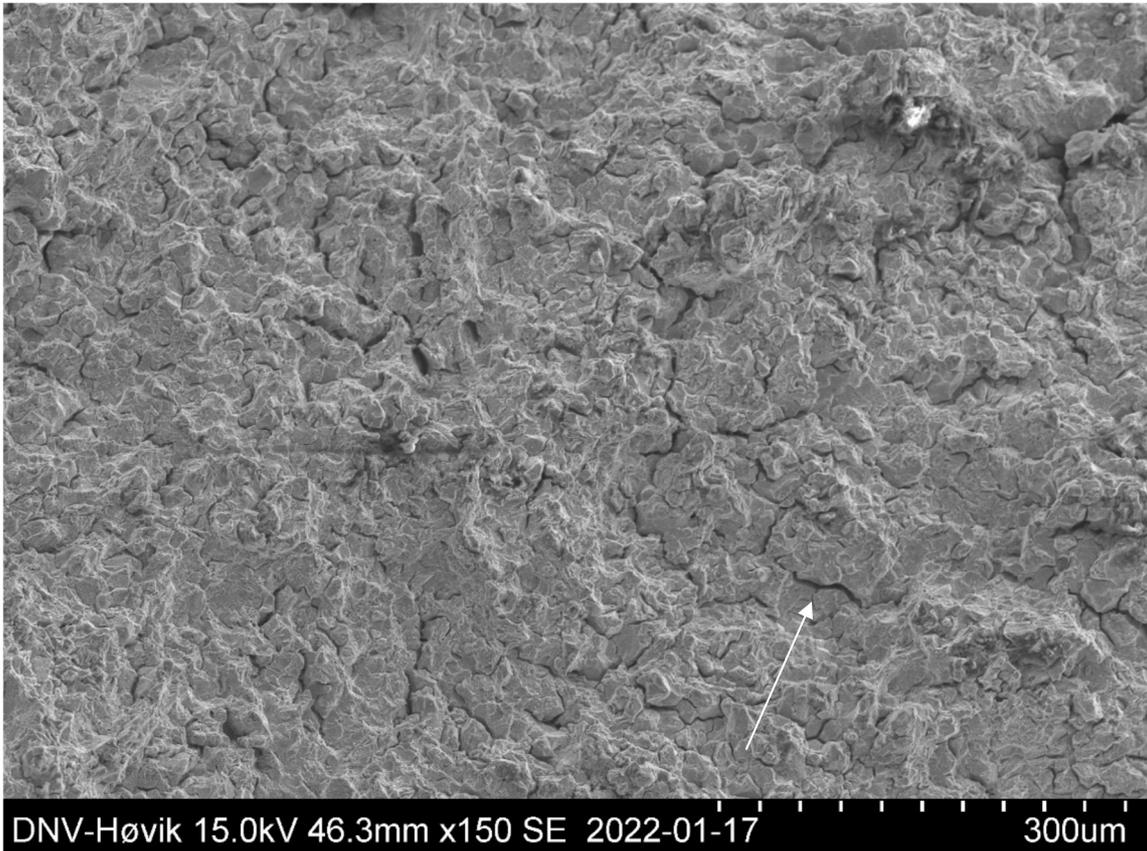
Figure 7-17 SEM image of fracture surface showing intergranular cracking- as per the surface topology corresponding to the grain boundaries. Secondary cracking is also observed- example pointed by white arrow.

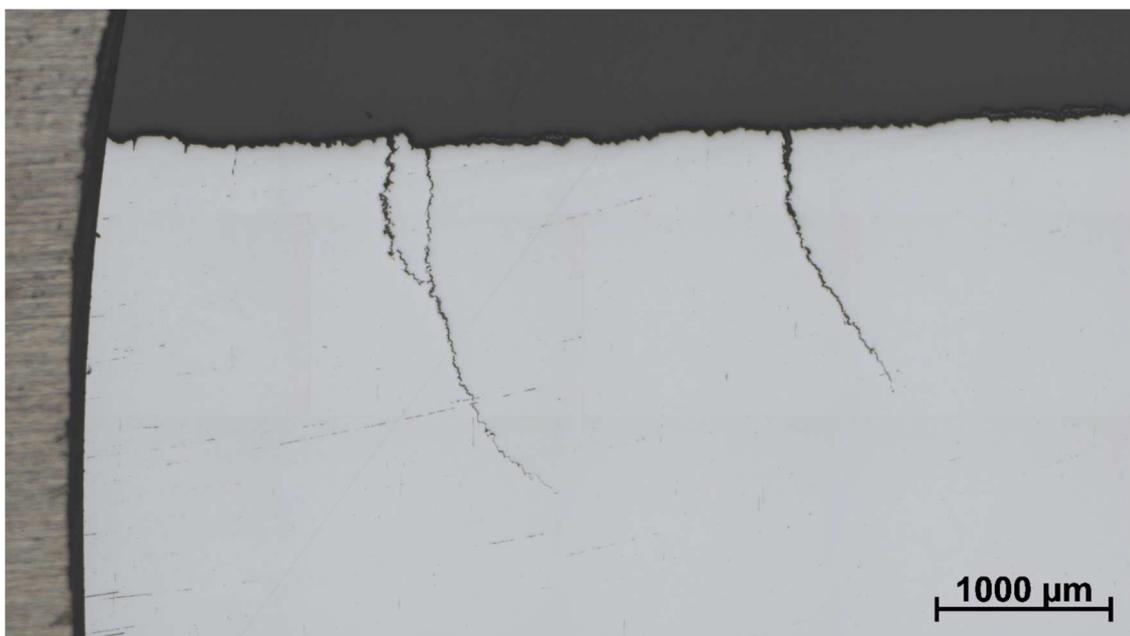
Secondary cracking was also observed in most reports (Figure 7-18) further supporting the theory that the crack growth is HISC driven.

Figure 7-18 Secondary cracking observed along the main fracture surface.

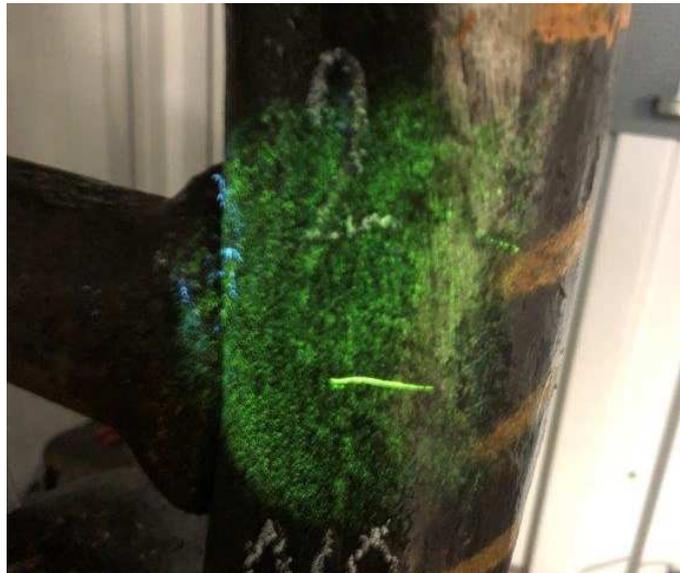
**Figure 8-4 Indication found with MPI**

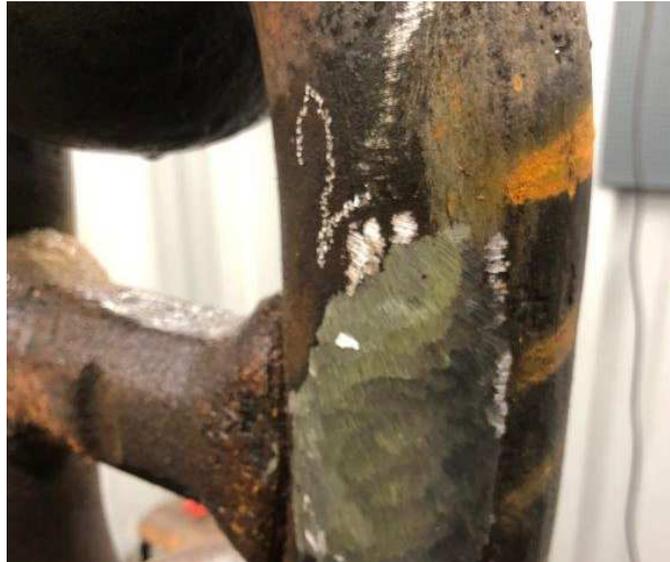
**Figure 8-5 Grinding of defect**

Changes to inspection procedures after manufacturing are expected to have reduced these events for future production, reference DNV-OS-E302 Ch.2 Sec.2 [2.10].

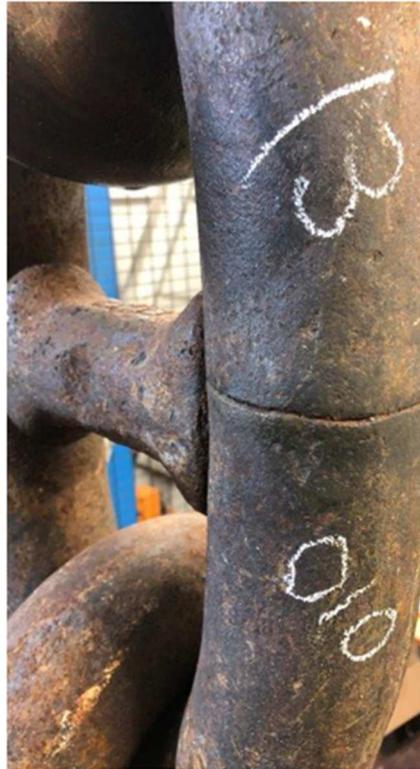
One theory for the source of these groves, is that they are generated by galvanic corrosion. This can occur if the material properties in the weld are different from those in the base material. A specific investigation was performed by DNV as presented in section 8.1 and confirmed the existence of the base conditions for this to occur.

**Figure 8-6 Corrosion in weld**

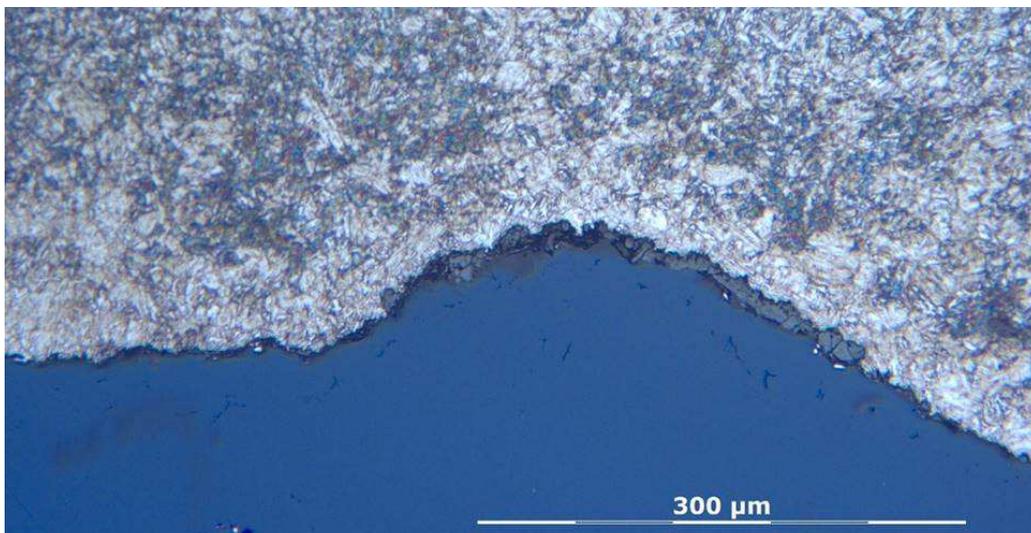
**Figure 8-7 Cross section of weld groove.**

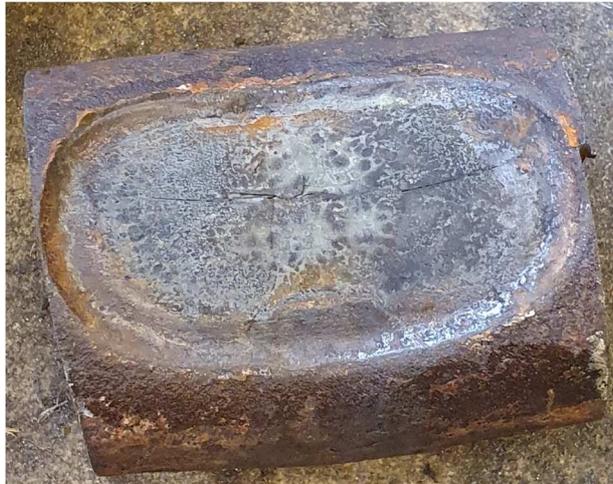
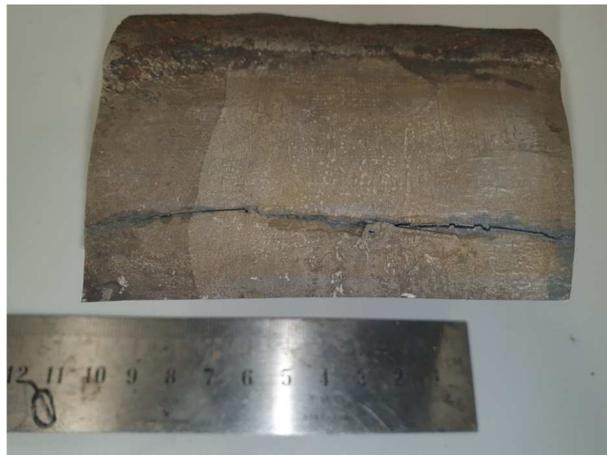
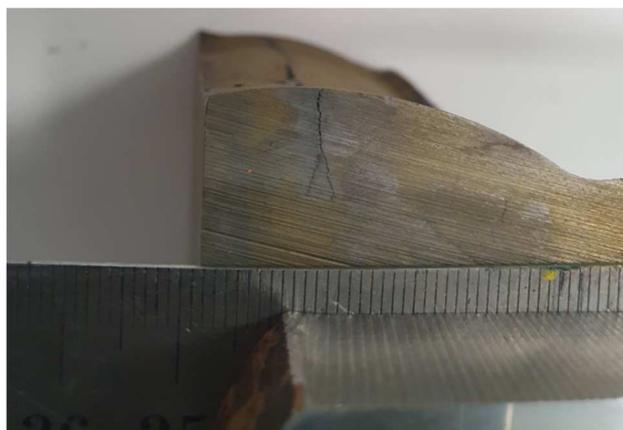
During investigation of a failed link in the laboratory environment, when removing the stud in one of the links, cracks in the stud imprint were discovered, see Figure 8-8 to Figure 8-10.

**Figure 8-8 Crack in stud imprint**

**Figure 8-9 Crack in stud imprint after cleaning**

**Figure 8-10 Depth of crack in stud imprint**

The cracks shown in Figure 8-8 to Figure 8-11 are in the longitudinal direction, and as such do not affect the ultimate strength of the chain link. The fatigue life impact was studied as presented in section 8.4.3.1 and 8.4.3.2, and all indications point to be negligible.

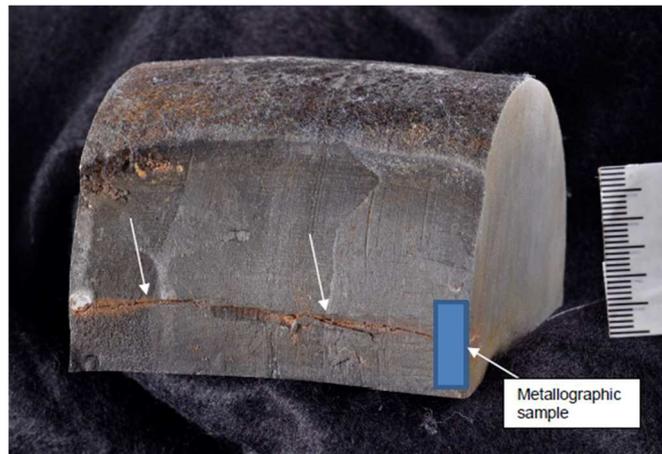
The main concern relating to this degrading mechanism is if the cracks are growing in a fatigue like manner during cyclic loading. It was therefore decided to open one of the cracks in the chain and investigate the crack surface, see Figure 8-11 and Figure 8-12.

**Figure 8-11 Longitudinal crack in the stud imprint**

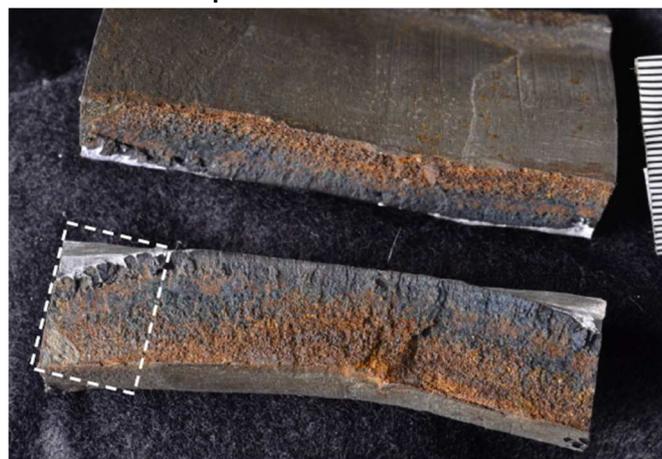
**Figure 8-12 Mechanically forced open fracture surface**

Both the investigations of both chain links concluded that the fracture surfaces do not have visual signs of fatigue crack growth.

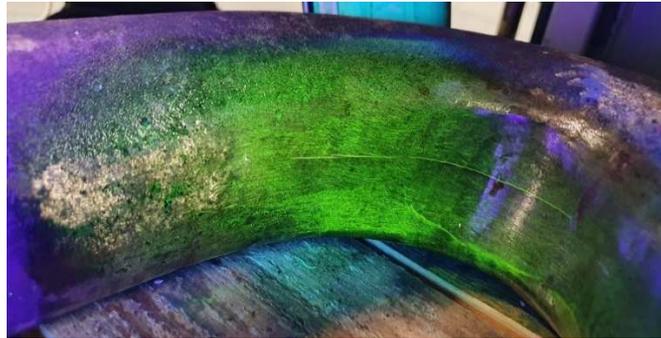
In addition to the first chain referred to in section 8.4.3, longitudinal cracks were found using MPI on chain links from another chain rental company during inspections. These cracks were located in the inner chain bend and were surface

**Figure 8-13 Longitudinal crack in the chain bend (DSM chain)**

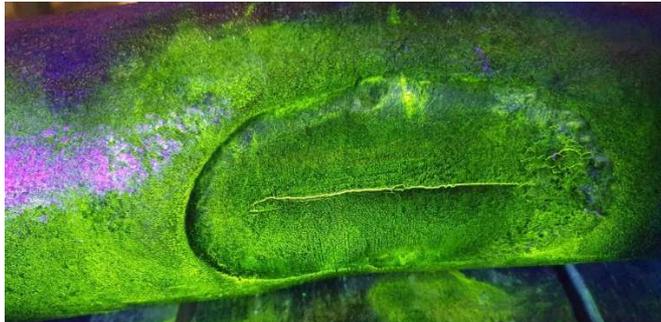
**Figure 8-14 Longitudinal crack in stud imprint (DSM chain)**
