Investigation report

1	Summary.....	4
2	Introduction.....	4
3	Technical descriptions	6
	3.1 The system where the incident occurred	6
	3.2 Description of the equipment involved in the incident	8

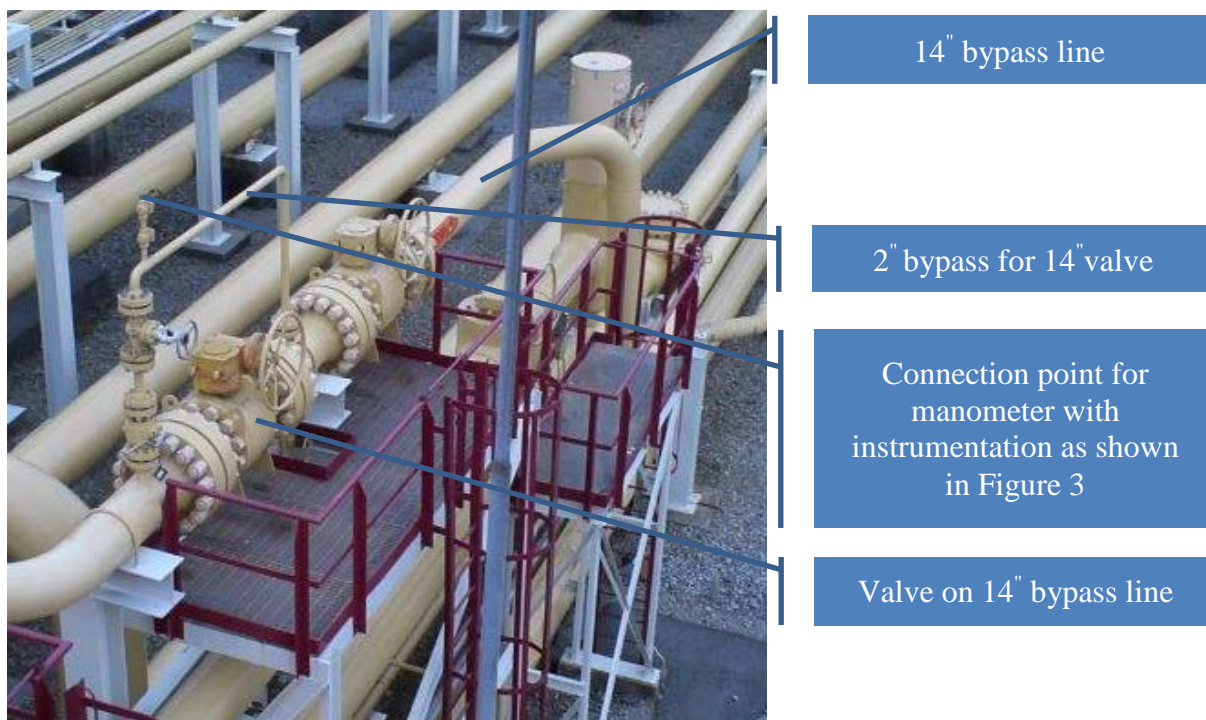
Figure 1 The area where the manometer was fitted and the leak occurred

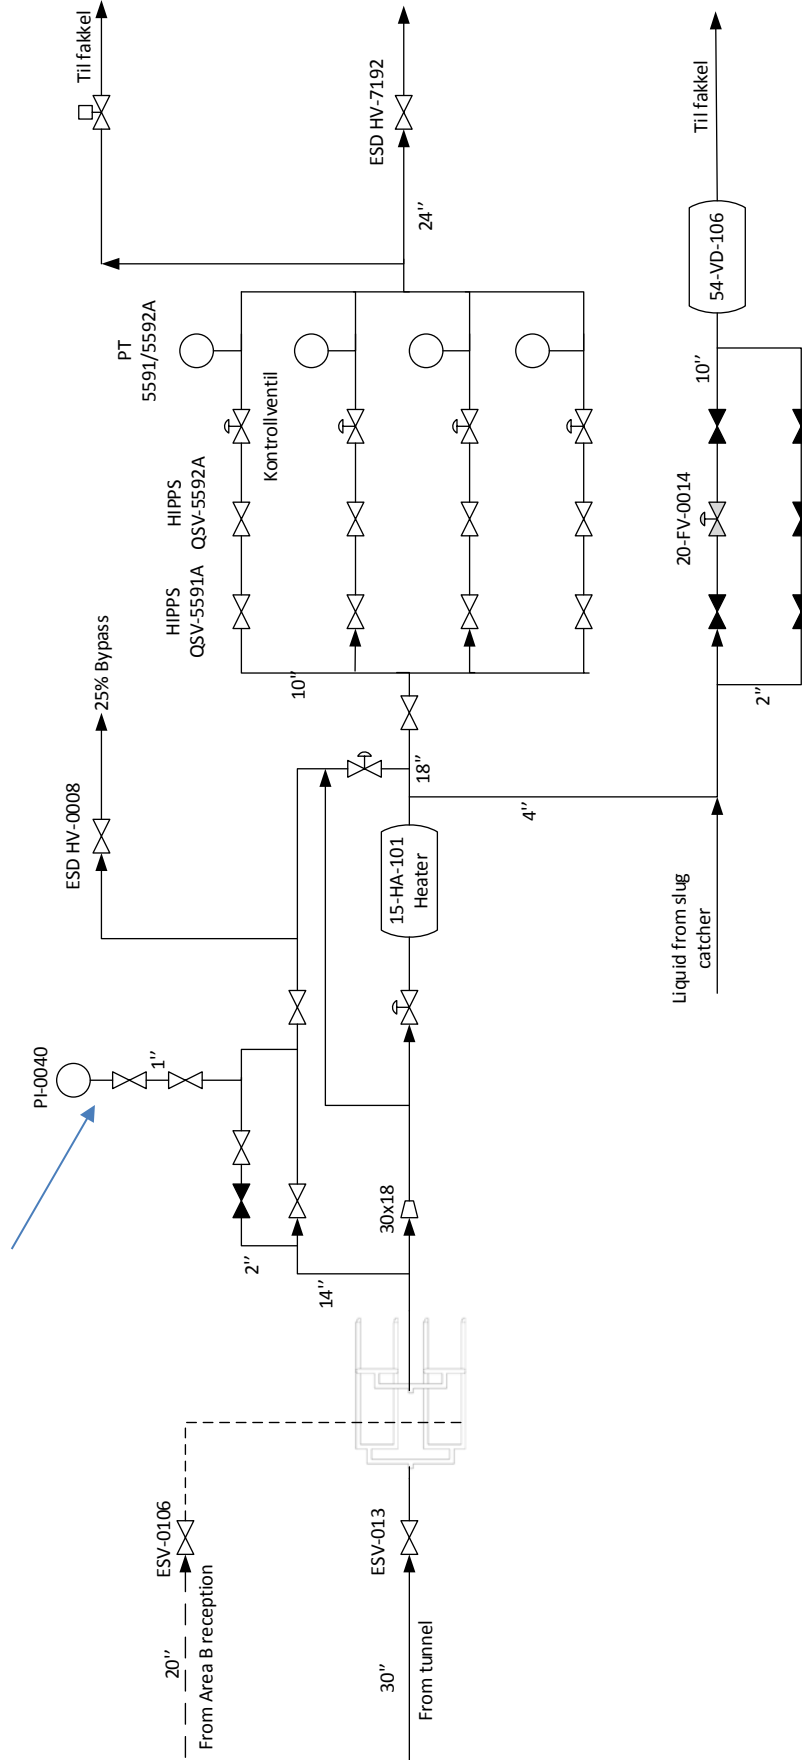
Figure 2 Simplified process flow diagram for the Statpipe rich gas receiving area; the blue arrow shows the site of the leak

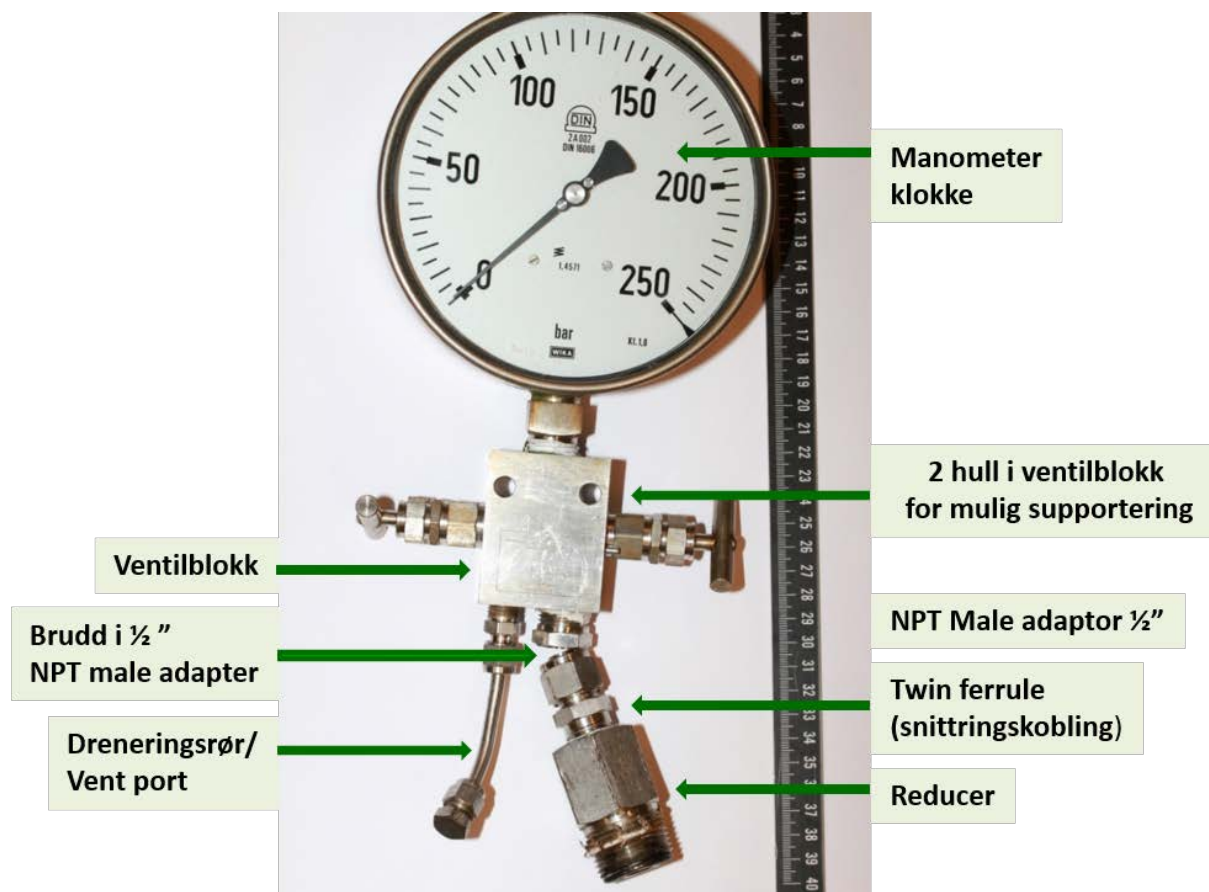
Figure 3 Manometer with associated instrumentation

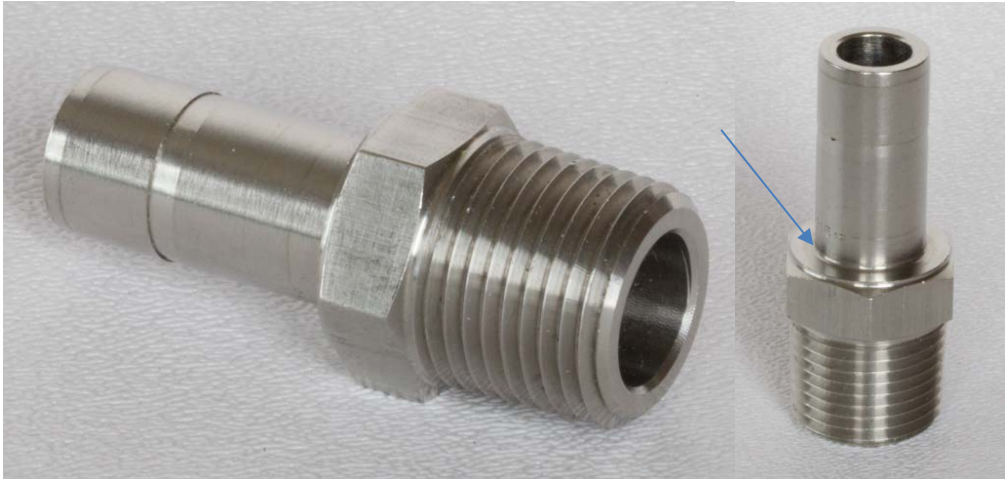
Figure 4 Example of 3/8" NPT Male adapter. The arrow shows where on this component the fatigue fracture occurred

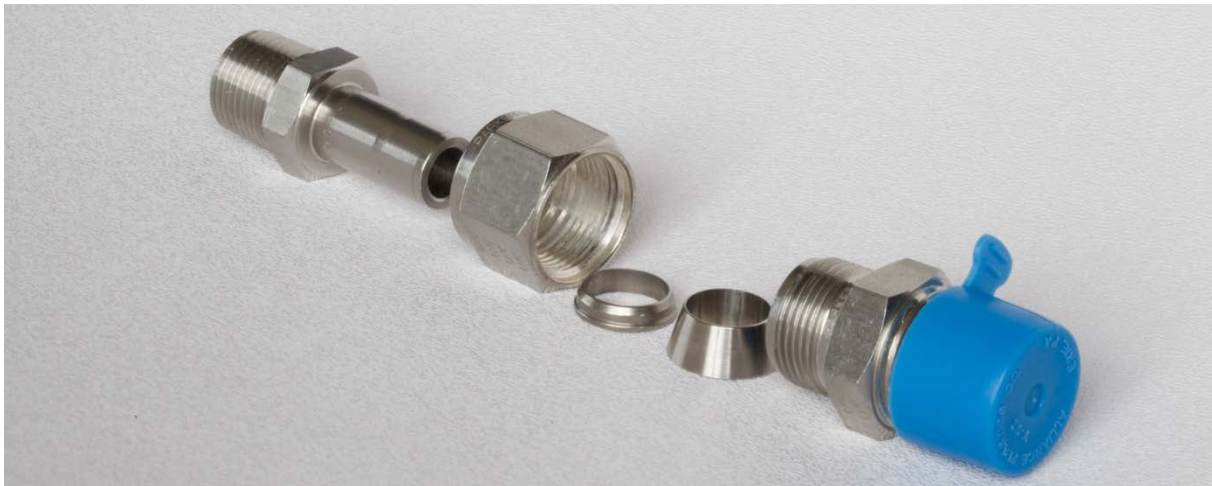
Figure 5 Example of an NPT Male adapter and components in the ferrule connector (Parker A-LOK®)
