# Investigation report

Report	
Report title Investigation of collision between <i>Sjoborg</i> supply ship and Statfjord A on 7 June 2019	Activity number 001037045

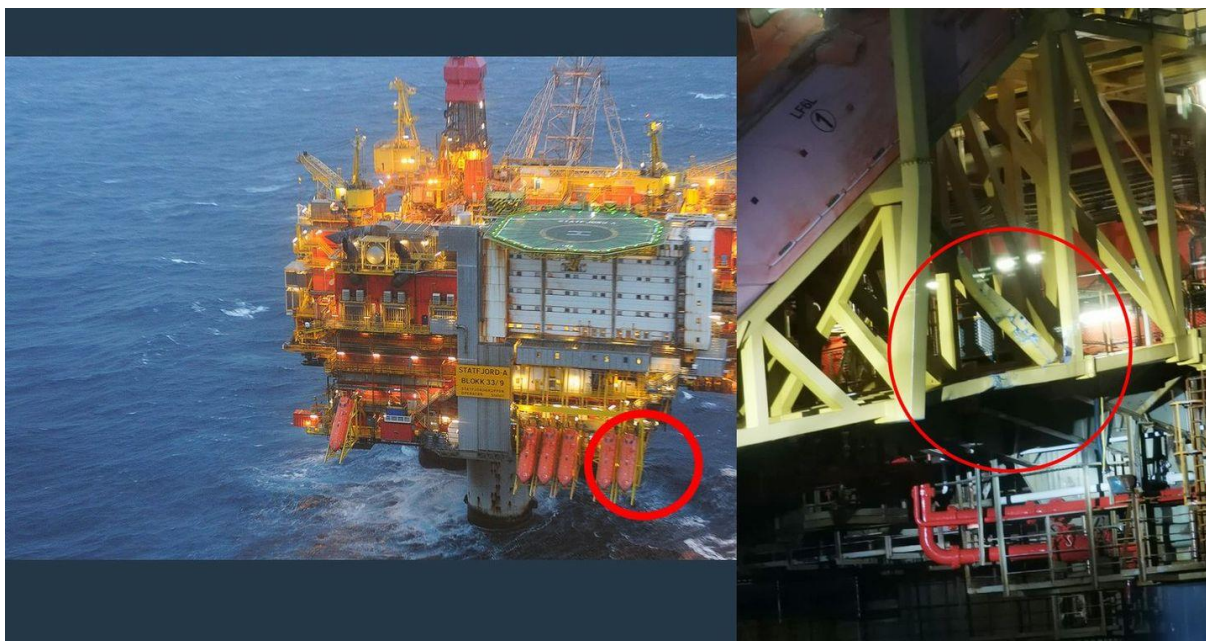
Statfjord A was undergoing a turnaround, with 276 people on board when the collision occurred. Damage to a lifeboat station, with consequent reduced lifeboat capacity, meant that

Photo: Statfjord A lifeboat station (source: Equinor).

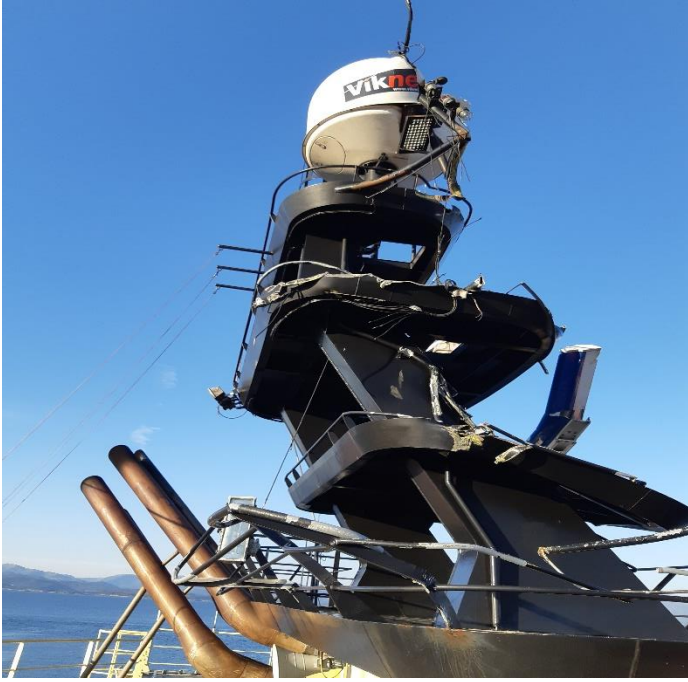
Deformation of mast and equipment above the bridge, mainly on the starboard side, which included railings, monkey island, antennas, and navigation equipment and lights.

Photo: Mast over the bridge.

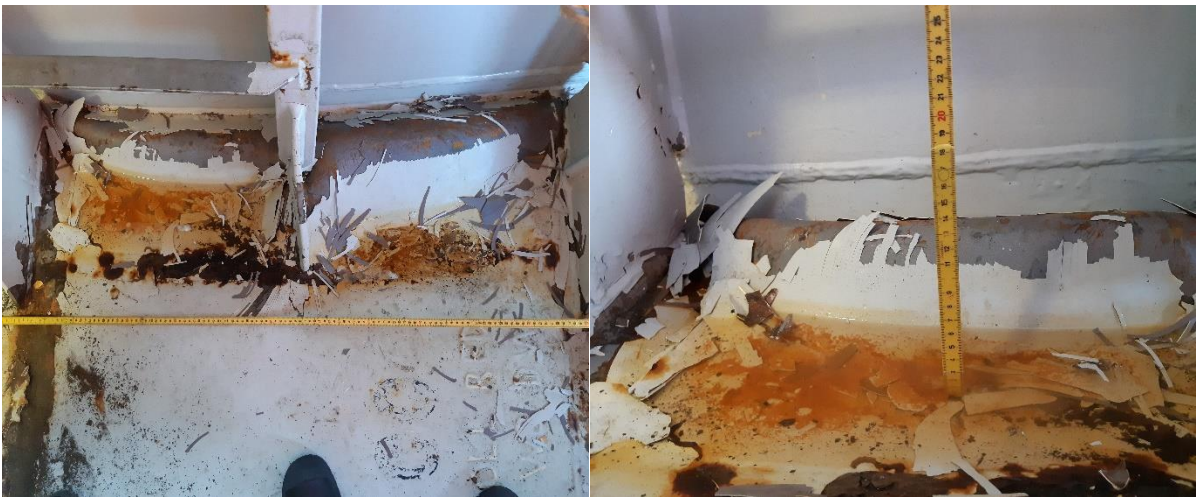
Bulging of deck plates between frames 3 and 6 aft on the starboard side, extending about 1 800 x 600 x 40 millimetres.

Photo: Bulged deck plate.

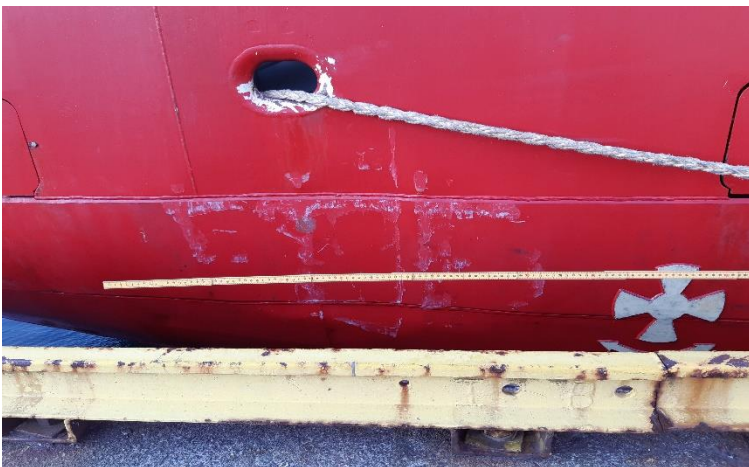
Denting of deck plates between frames 3 and 6 aft on the starboard side, extending about 1 800 x 1 500 x 50 millimetres.

Photo: Dented deck plate.

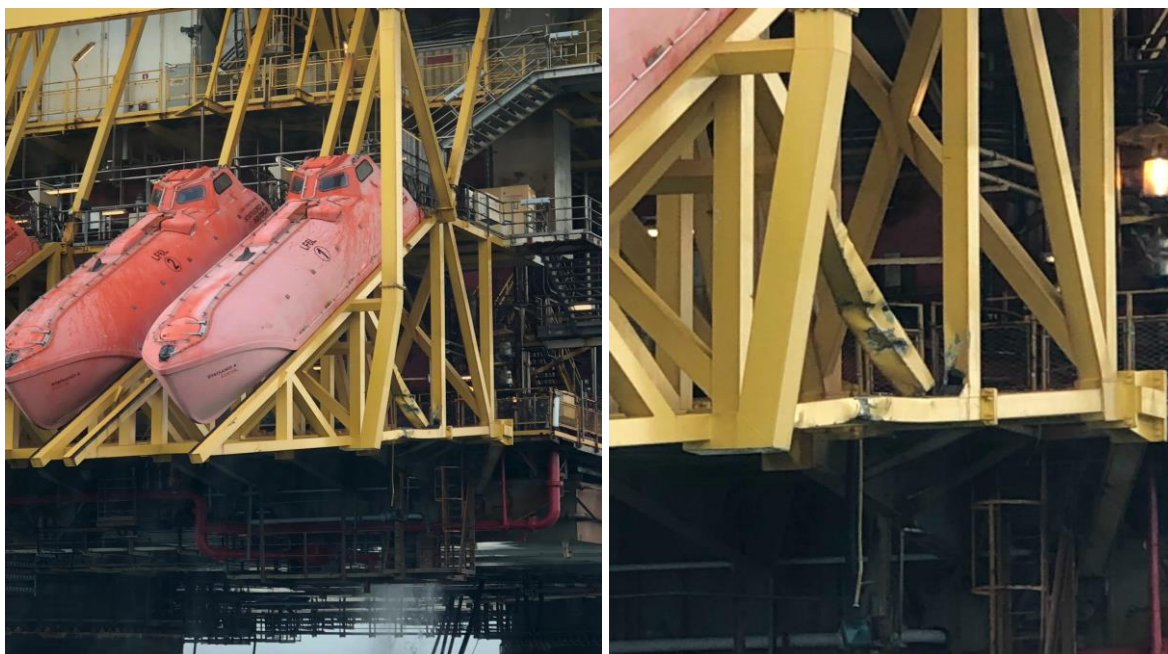
The mast over the bridge hit a lifeboat station, which was substantially deformed. The skids for lifeboats 1 and 2 were deformed in a way which indicates lateral displacement. A fracture was observed in a bracing at the station's southern end. The scope of the damage to the load-bearing structure reduced its strength and meant lifeboats could become stuck during launch. Lifeboats 1 and 2 were therefore judged to be inoperative.

The load-bearing structure for lifeboats 3, 4 and 5 was not deformed or weakened by the collision. On that basis, Equinor assessed these lifeboats to be operative on 9 June.

Further assessments by the lifeboat manufacturer and Equinor related to structural capacity and tolerances for lifeboat 2's skid documented that the lifeboat could be used until August, providing two bolted connections between lifeboats 1 and 2 were disconnected. Equinor presented the result of the assessment to the PSA in a video meeting on 4 July.

Photo: The damage site at lifeboats 1 and 2 (source: Equinor).

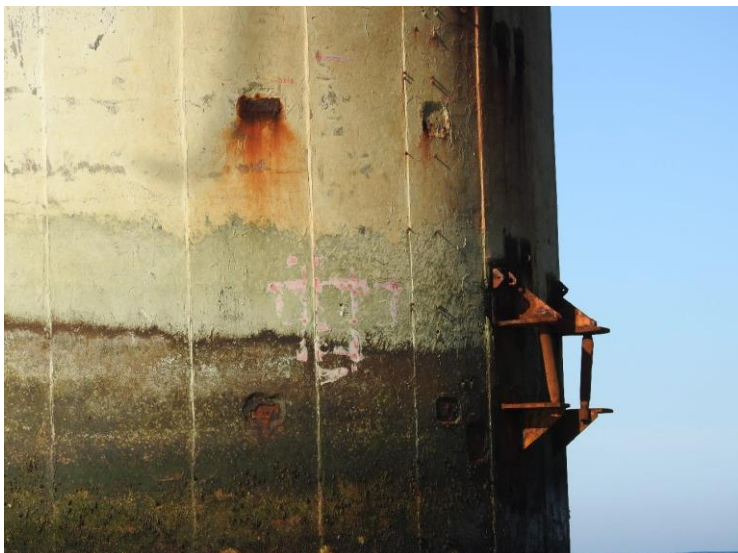
The southern side of drilling shaft south was hit about three metres above MSL. The damaged area on the shaft has been defined as about two square metres and is characterised as scraping of the concrete surface. Paint from the vessel has been transferred to the concrete wall. Close visual inspection failed to observe any damage other than scraping of the concrete surface. The area was measured to be 1.9 x 1.4 metres.

Photo: Damage site at drilling shaft south (source: Equinor).

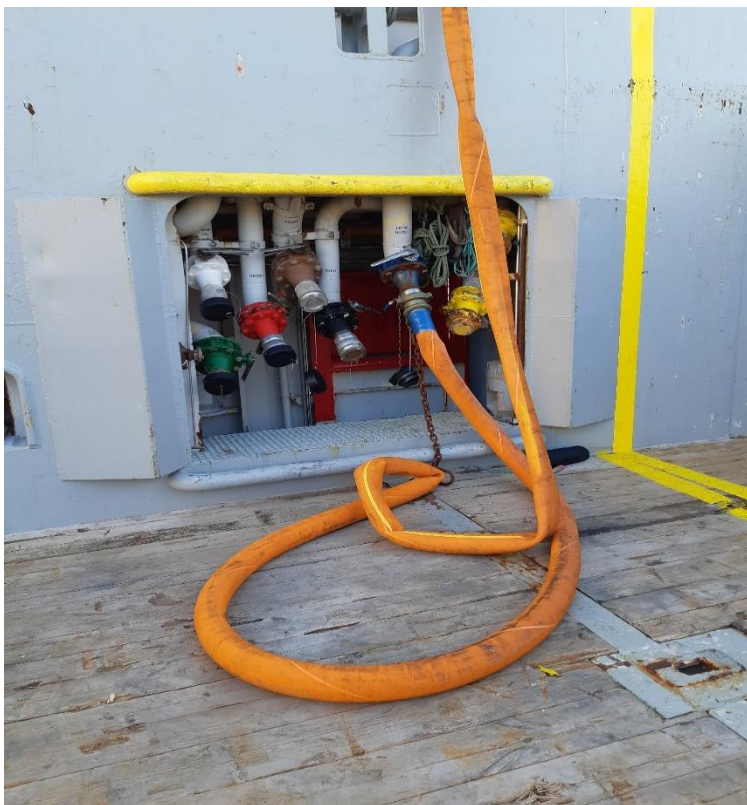
The diesel hose which hit the deck hand in the face had the potential to cause personal injury. The person concerned was knocked down and could have been injured in the fall. Under slightly different circumstances, he could have been hit by the connector with a possible fatal outcome.

Photo: Hose station on *Sjoborg*.

Equinor's investigation report does not discuss whether bulk hoses were handled in accordance with the recommended best practice in the G-OMO. This is to retrieve bulk hoses to the facility as soon as discharging is completed. Complying with best practice could have avoided the diesel hose posing a threat to deck personnel.
