## Investigation report

| Report | |
|---|---|
| Report title<br>Revised investigation report following fire on Sleipner B on 22.10.2024 | Activity number<br>001046030 |

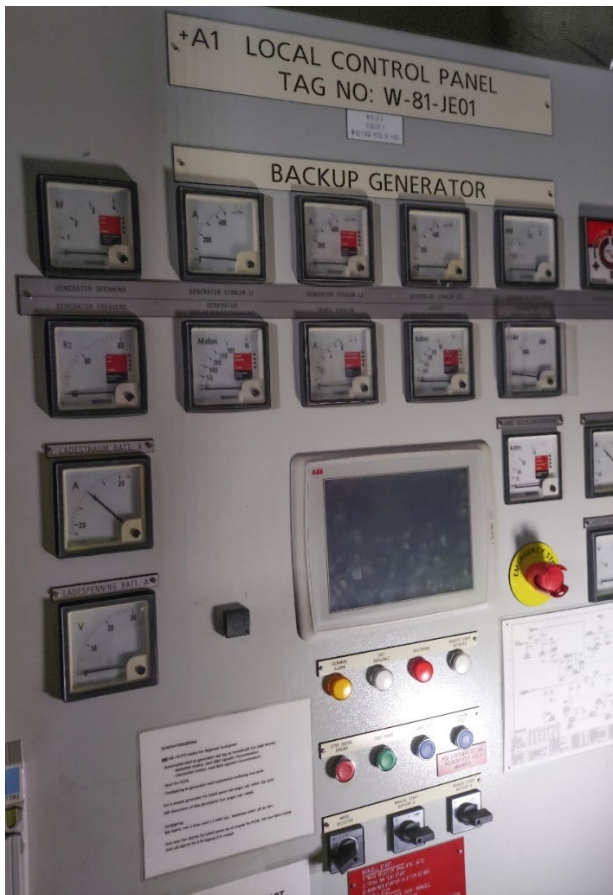
The back-up generator did not start up during the incident. We have been informed that the personnel who arrived on SLB during the incident observed that the back-up generator was in "auto mode" and that alarms were displayed on the control panel. The alarm was interpreted as an undervoltage alarm by the response personnel.

*Figure 2 Local control panel for the back-up generator on SLB. The photograph was taken during Havtil's inspection after the fire. The 'Mode selector' in the bottom centre of the photograph is in Auto mode. We have unsuccessfully attempted to gain access to any alarms from the alarm panel. (Source: Havtil)*

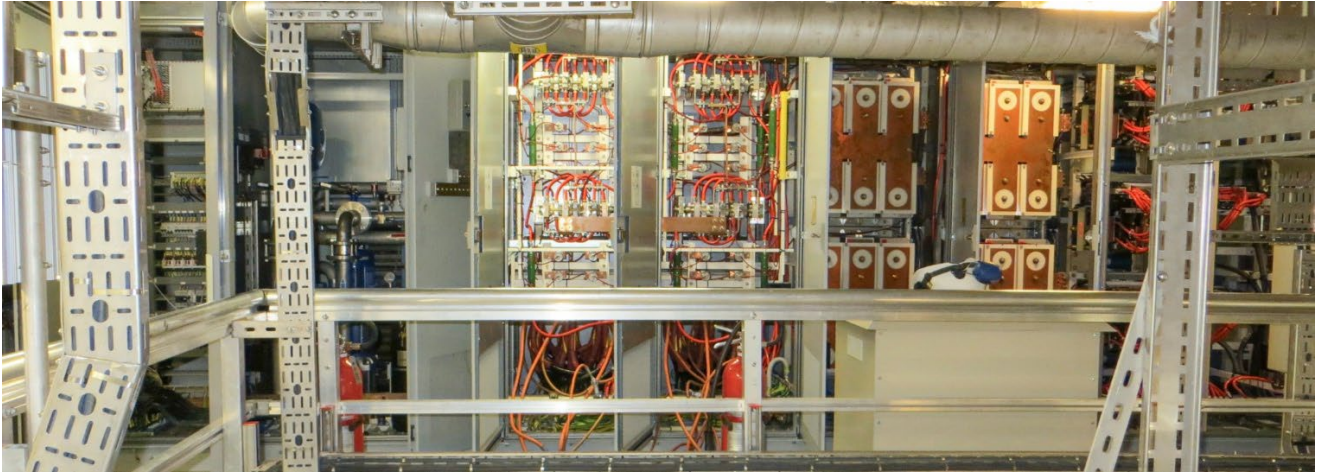
Figure 9 Photograph of the VSD with the cabinet doors open before the fire. The photograph shows what is behind cabinet doors 0 to 7 inclusive. This photograph was taken in March 2019 in connection with an fire-related incident in the rectifier section of the VSD. (Source: Equinor)

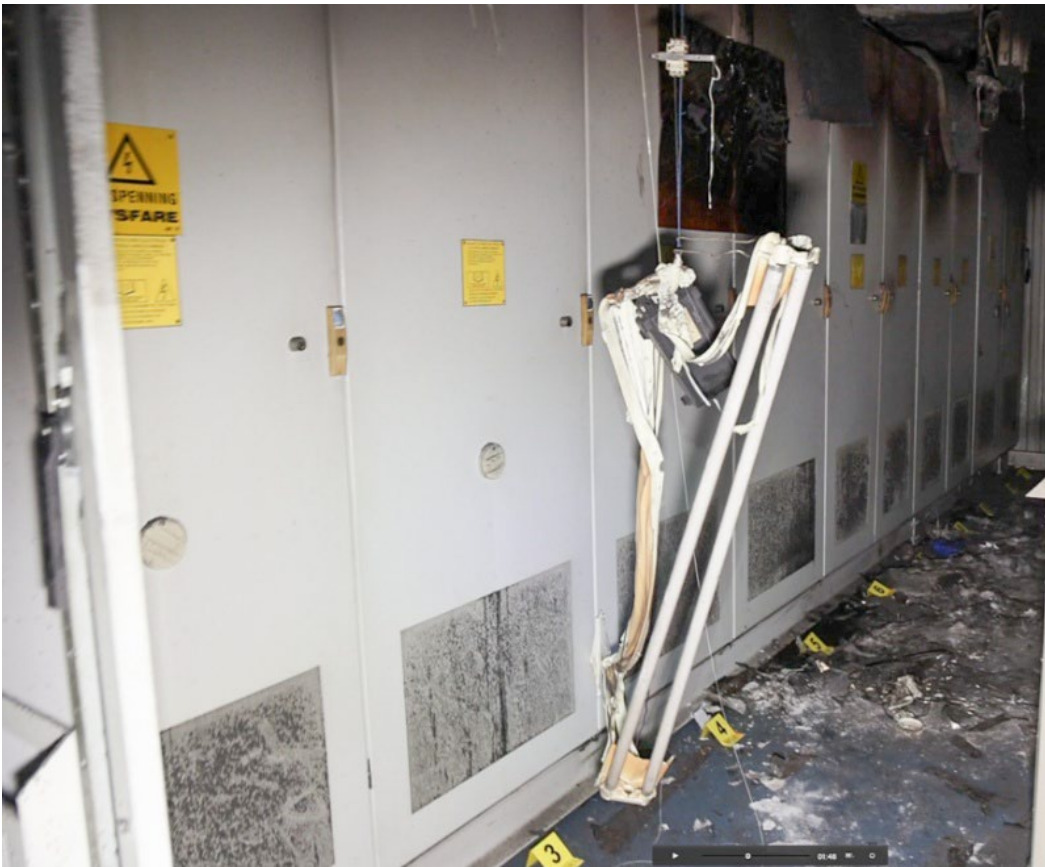
The VSD consists of several cabinets containing various components. It was the inverter part of the VSD that caught fire, but our investigation did not reveal the direct cause of the fire in the VSD.

Figure 10 Photograph of the VSD after the fire. The photograph shows cabinet doors 2 to 11. (Source: Norwegian Police)

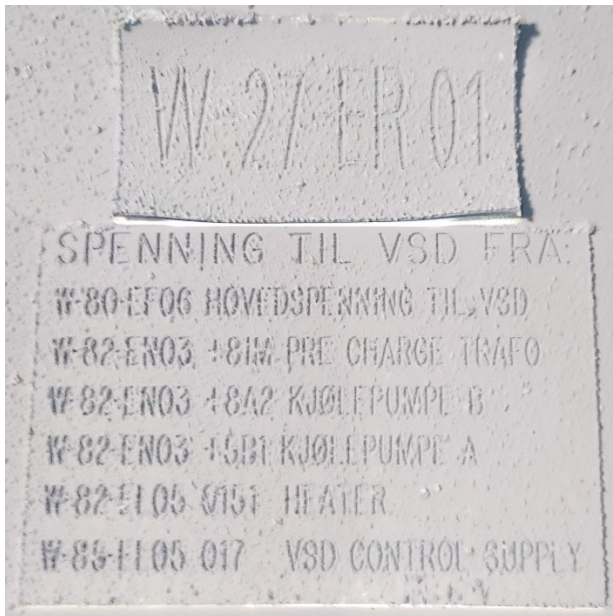
- The power supply to the VSD control supply comes from UPS subdistribution board W-85-EL05. This subdistribution board supplied the VSD with power until approximately 07:53. At this time, the emergency lighting circuits in W-85-EL05 were isolated, and it is also apparent that the last alarm was recorded on the LOP panel at 07:53. In addition, there was an alarm on the LOP panel with the text "Fan Supply OFF Alm" at 07:43. These exhaust fans, which are mounted on the top of each cabinet, are supplied from this UPS subdistribution board.

Figure 11 Sign showing the source of the power supply to the VSD (Source: Havtil)

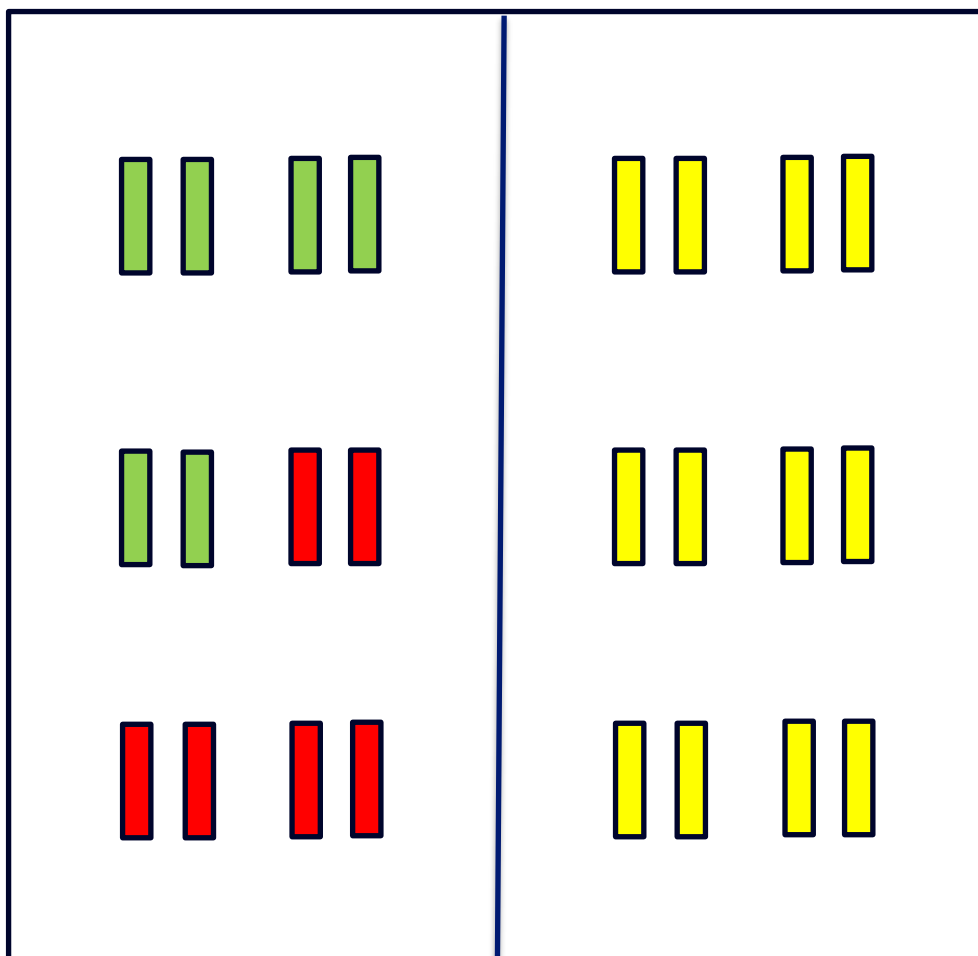
It is apparent from this illustration that all the IGBTs in cabinet 6 (red and green) had triggered an alarm at the time when water was observed on the floor in front of the same cabinet.

Figure 12 IGBTs in inverter with colour indicating the timing of the associated alarm (cabinets 6 and 7)

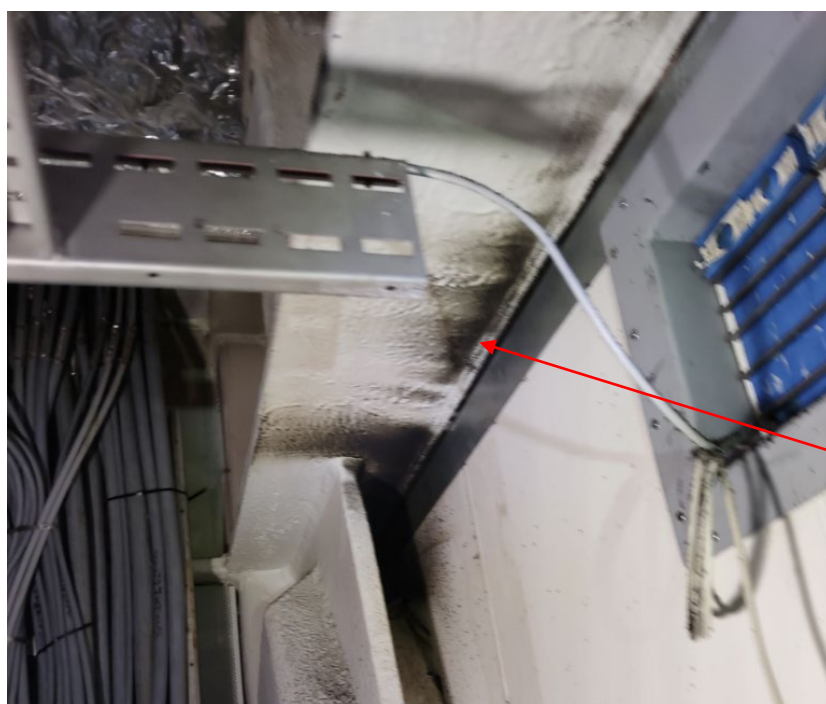
As Figure 15 shows, there is a fire division with fire rating A-60 between the high voltage room and the local instrument room (LIR room). Fire divisions with a rating of A-60 are intended to prevent the spreading of smoke for at least one hour. A smoke detector located in LIR triggered an alarm indicating smoke 25 minutes after the first smoke detector in the high voltage room was triggered, resulting in the spreading of smoke to neighbouring rooms (thus, the fire division did not meet the requirement to prevent the spreading of smoke for at least one hour). The photograph below was taken in the LIR room and shows soot penetration through a small gap in the fire division.

*Figure 16 Soot marks following the spreading of smoke to the neighbouring room (local instrument room) (Source: Havtil)*

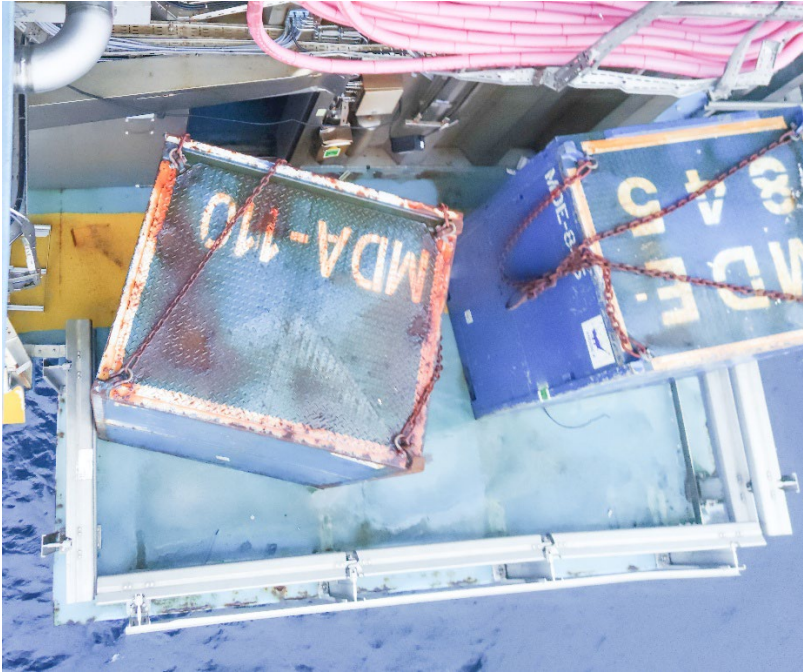
During the inspection on SLB after the incident, we observed that the fire door (pneumatic sliding door in a fire division with fire rating of A-0) was in the open position. The photograph below shows the fire door and two containers pushed in towards the door as a result of water spray from the monitors on adjacent vessels (see Figure 17).

Figure 17 Pneumatic sliding door into the high voltage room. In the photograph, the two containers have been pushed towards the door as a result of being doused with water from water cannons on adjacent vessels (Source: Havtil)

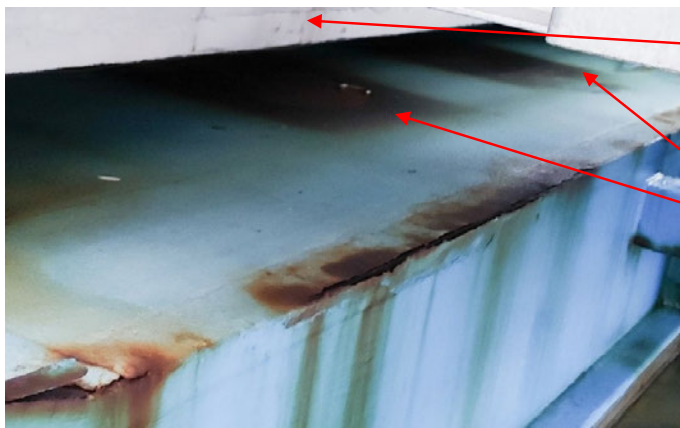
The photograph below shows the roof of the high voltage room/deck above the high voltage room viewed from the outside (just below the back-up generator container). Two marked black areas are apparent which show the effect of heat from the fire in the VSD switchboard.

To markerte svarte  
felter som viser  
varmpåkjeningen fra  
brannen i VSD-tavlen

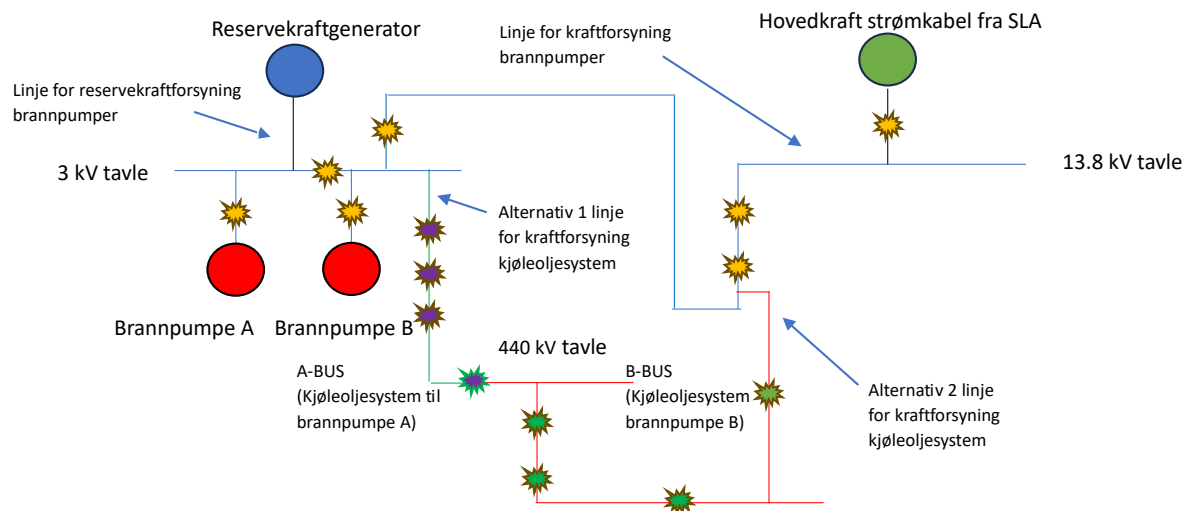
Figure 22 Diagram showing the circuit breakers and transformers that form part of the power supply for the fire pumps on SLB.

The figure shows that the adopted design solution is vulnerable, as dependencies in the system could cause the fire pumps not to start up when needed.

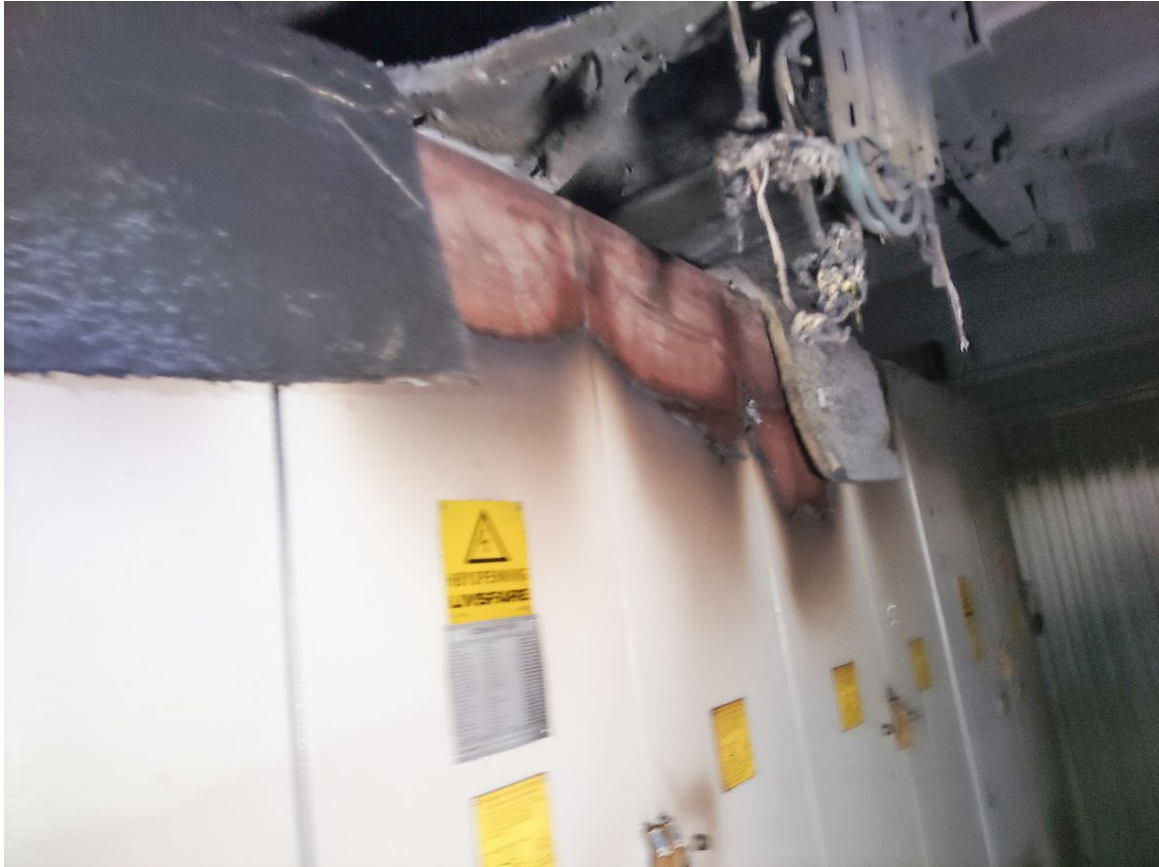
*Figure 24 Thermal insulation in the ceiling above the VSD (1 of 3) (Source: Havtil)*

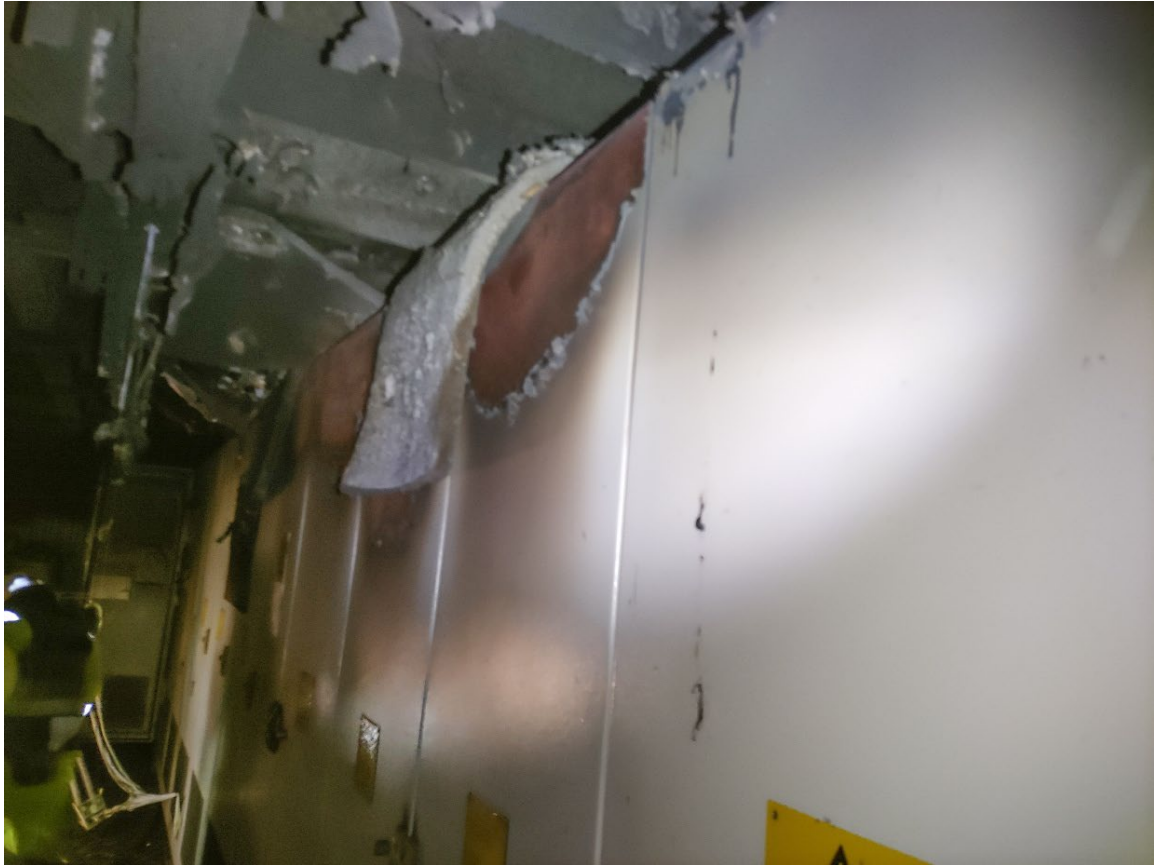
Figure 25 Thermal insulation in the ceiling above the VSD (2 of 3) (Source: Havtil)

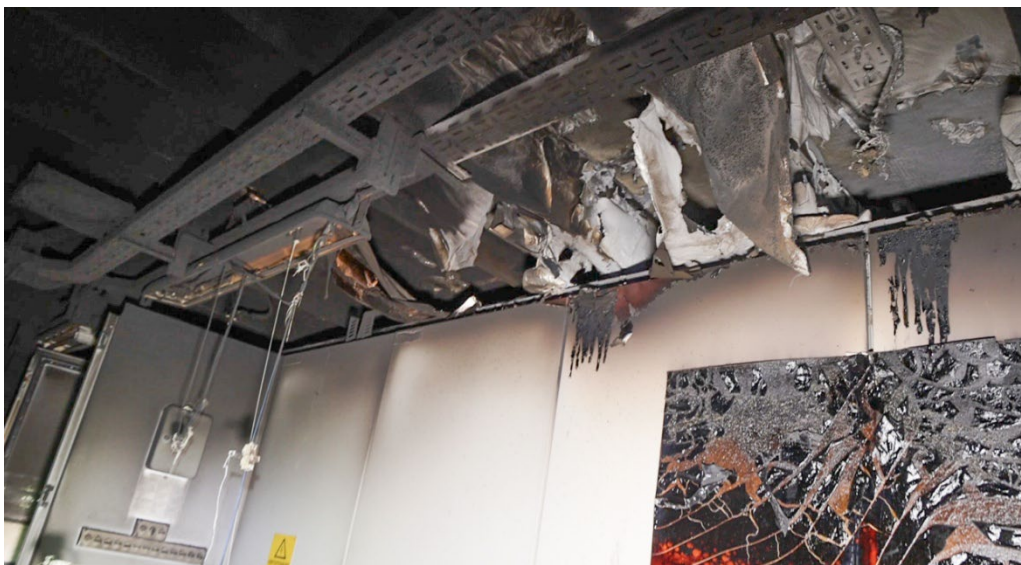
Figure 26 Thermal insulation in the ceiling above the VSD (3 of 3) (Source: Norwegian Police)

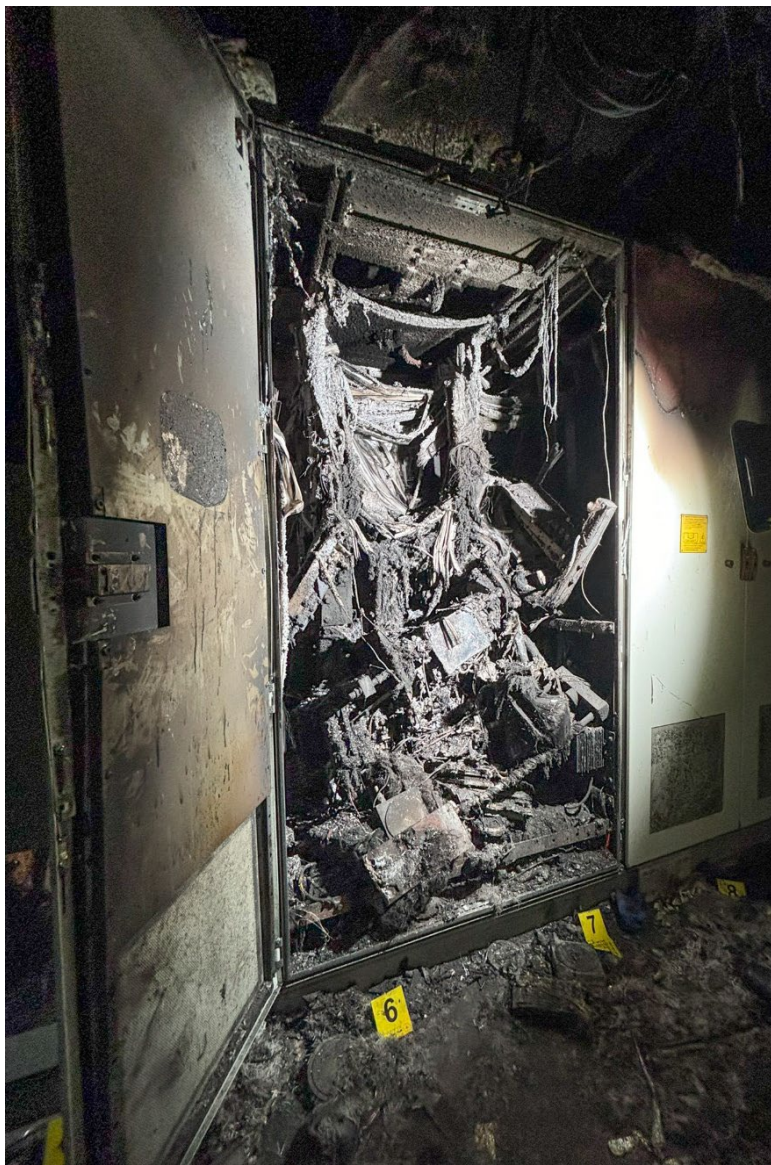
*Figure 27 Fire damage to the inverter part of the VSD (Source: Norwegian Police)*

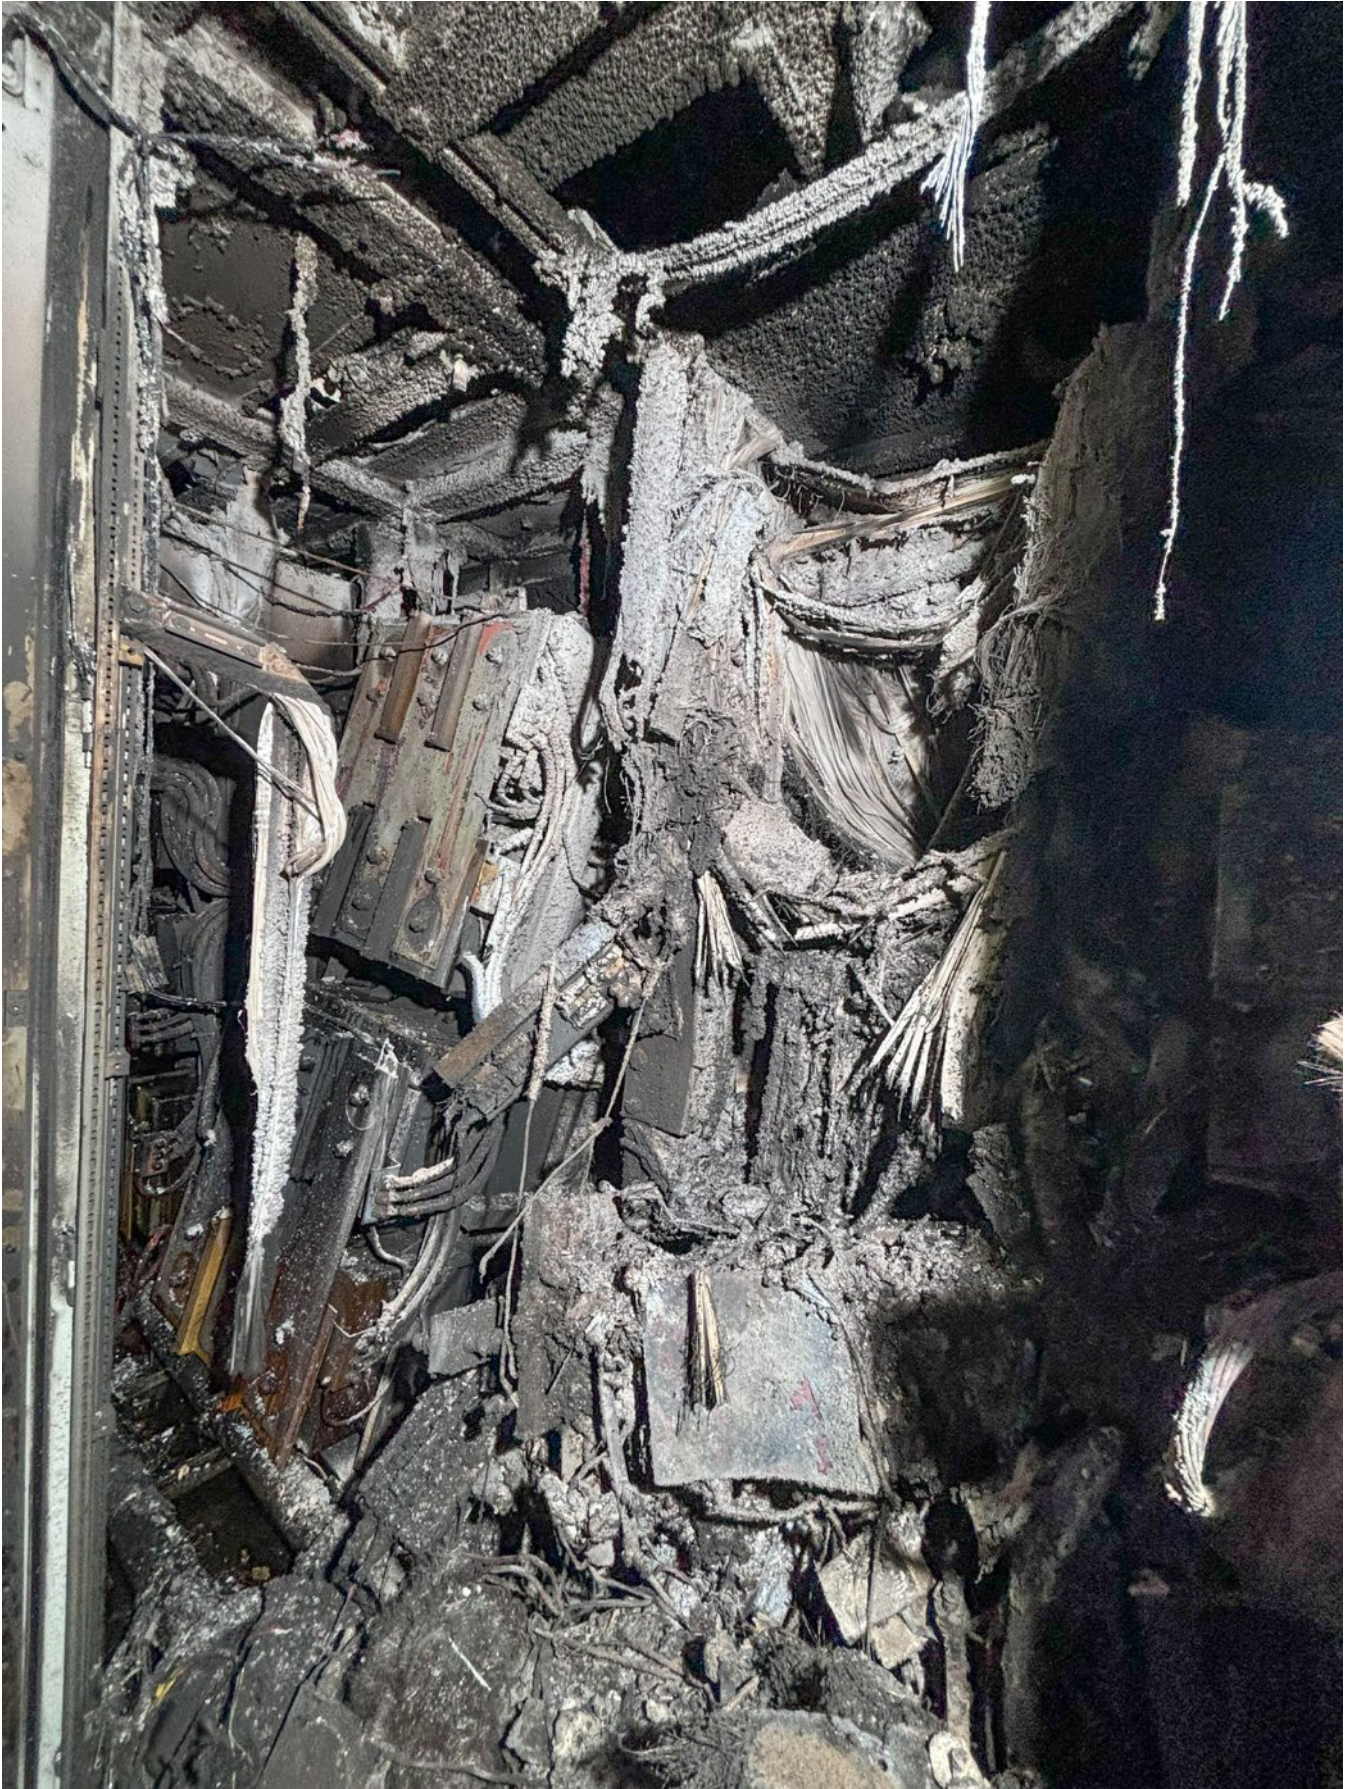
*Figure 28 Fire damage to the VSD viewed from door no. 6 looking towards the DC link (Source: Norwegian Police)*

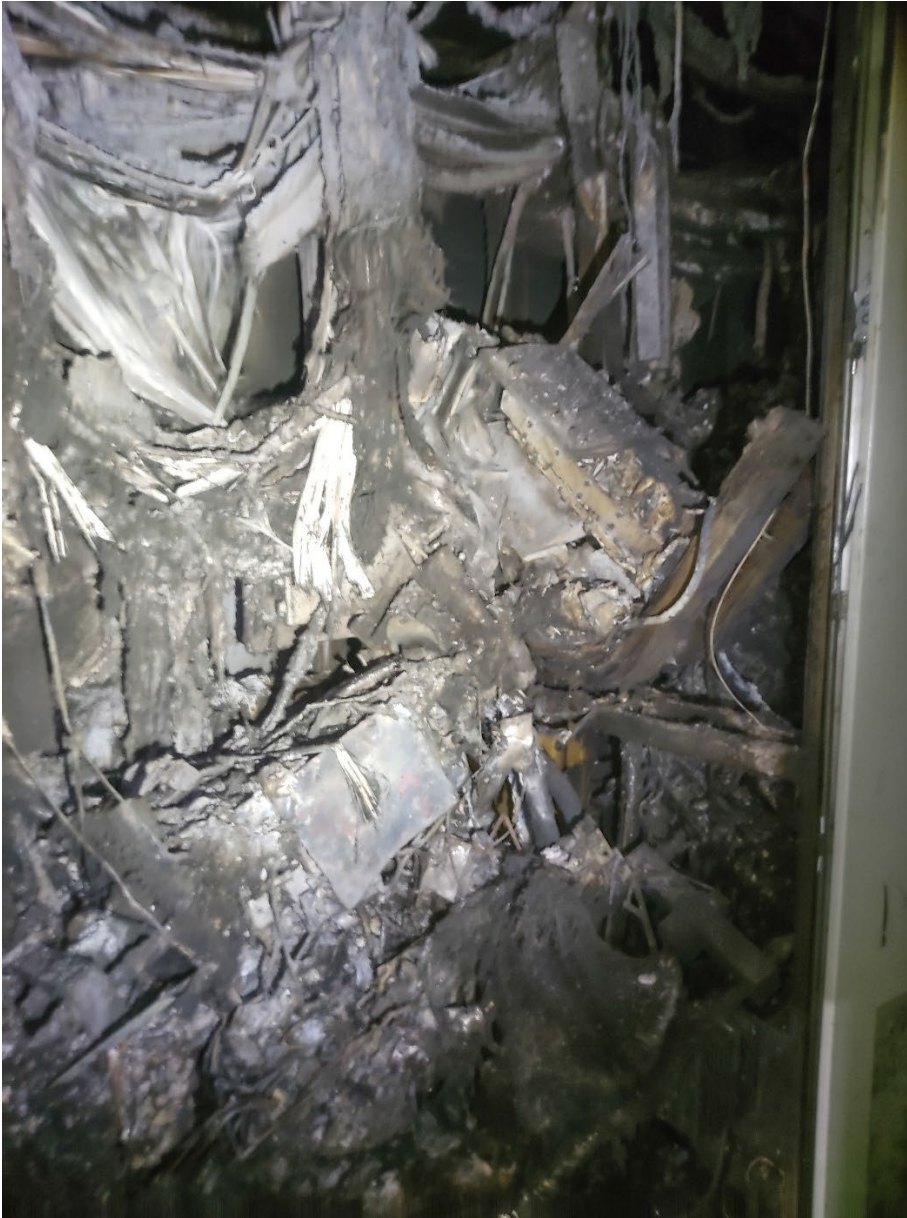
*Figure 29 Fire damage to the VSD viewed from door no. 7 looking towards the output filter (Source: Norwegian Police)*
