Investigation report

Report	
Report title Report on the investigation of a fire in the local equipment room (LER) on <i>Gina Krog</i>	Activity number 001029032
Classification	
<input checked="" type="checkbox"/> Unclassified	<input type="checkbox"/> Exempt from publication
Parties involved	
Team A-1	Approved by / date Kjell M. Auflem / 28 January 2025
Investigation team participants [REDACTED]	Investigation leader [REDACTED]

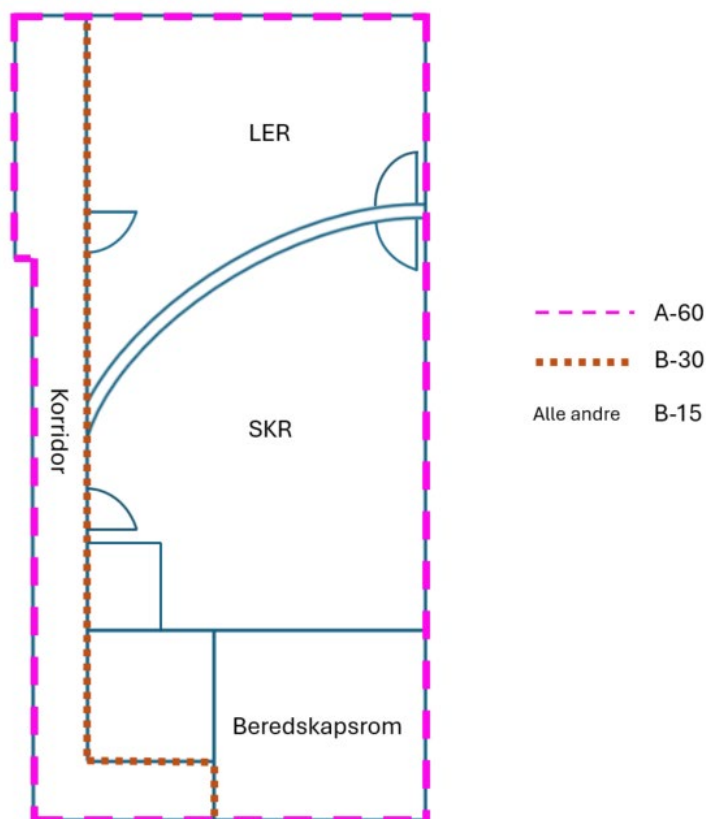
Figure 3 CCR and LER layout and fire divisions

The central control room and LER are separated by a curved wall with large screens located on the CCR side. There is a door from the CCR to the LER, which consists of two separate door leaves that can be opened and closed with space between the door leaves. The emergency preparedness room is connected to the CCR, separated by a sliding glass door. The LER, CCR and the emergency preparedness room as well as the adjacent corridor are separated from their surroundings by an A-60 fire division. LER and SKR are separated from each other by a B-15 fire division.

The sketch below (Figure 3) shows the layout of the LER (above) and CCR (below). The double door between the CCR and LER is visible on the right at the end of the curved wall.

The LER and CCR are not separated from their surroundings by class A fire divisions. The closest class A fire division, which is able prevent the spread of smoke, encircles the LER, CCR and emergency preparedness room as well as adjacent corridors (see Figure 3 in chapter 4.3). If smoke develops in the surroundings of the CCR, it is important to prevent the smoke spreading to the CCR itself, so that personnel do not need to evacuate before the incident has been resolved.

It was not known that the wall between the LER and CRR was not a smoke and gas tight (Class A) fire division.

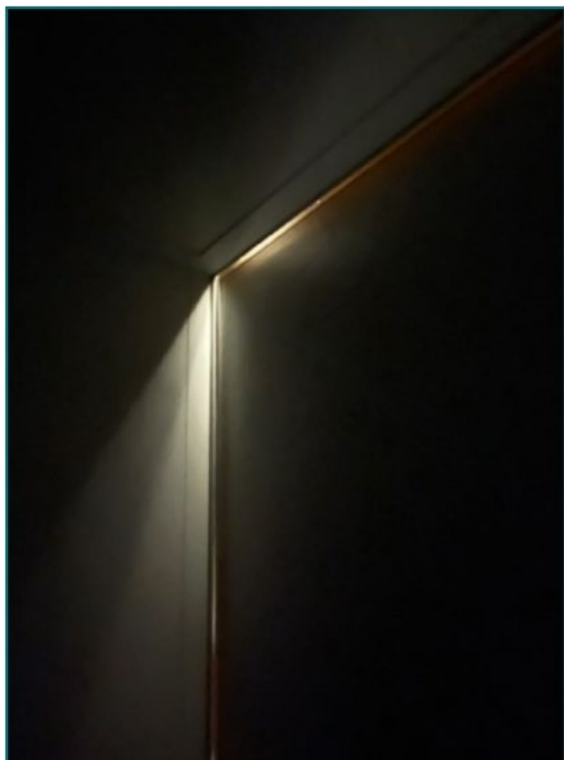
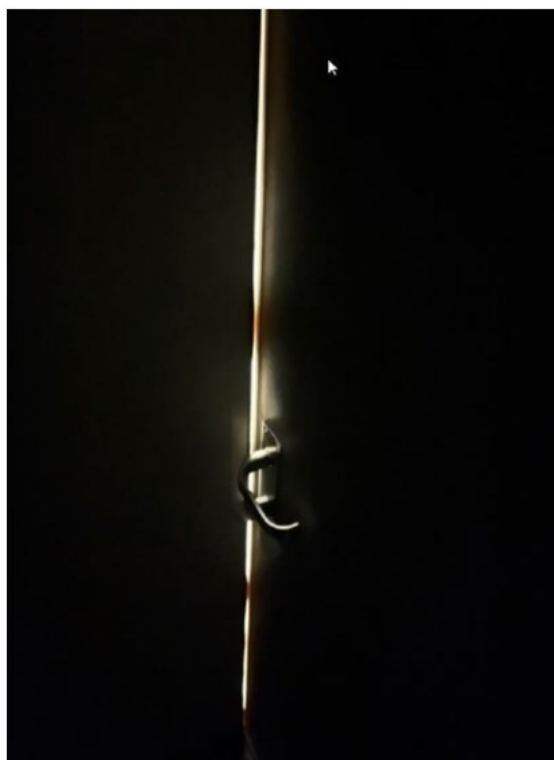
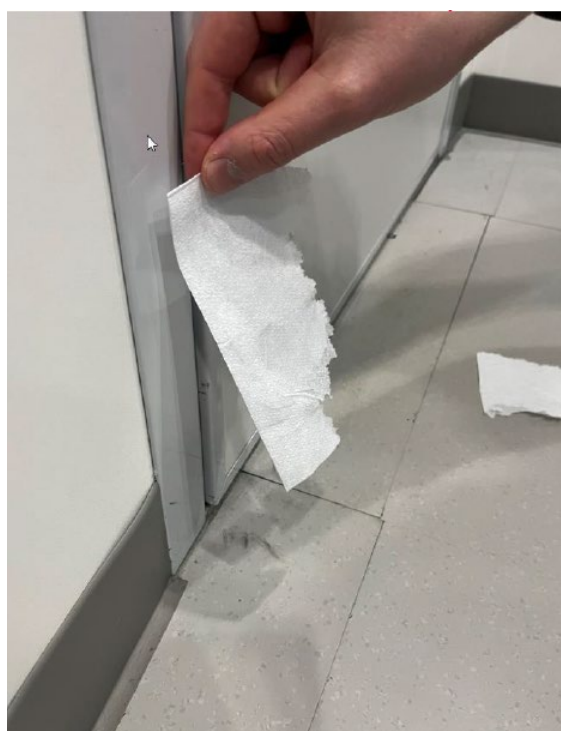
There was a general perception among relevant personnel on board that the division between the CCR and LER was smoke and gas tight. In the aftermath of the incident of the 21 June, it was confirmed that the double door between the CCR and LER was B-15 fire-rated and thus not smoke and gas proof. The fact that smoke leaked in from the LER indicates that the CCR did not have overpressure compared to its surroundings. The image below shows leaky doors and the flow of air between them.

It is unclear how the smoke spread from the LER to the CCR. Based on witness observations, the concentration was highest closest to the wall between the LER and CCR. This may indicate that smoke had spread through walls or doors between the LER and CCR. It has been verified that the double door between the CCR and LER is not sealed (see chapter 4.3).

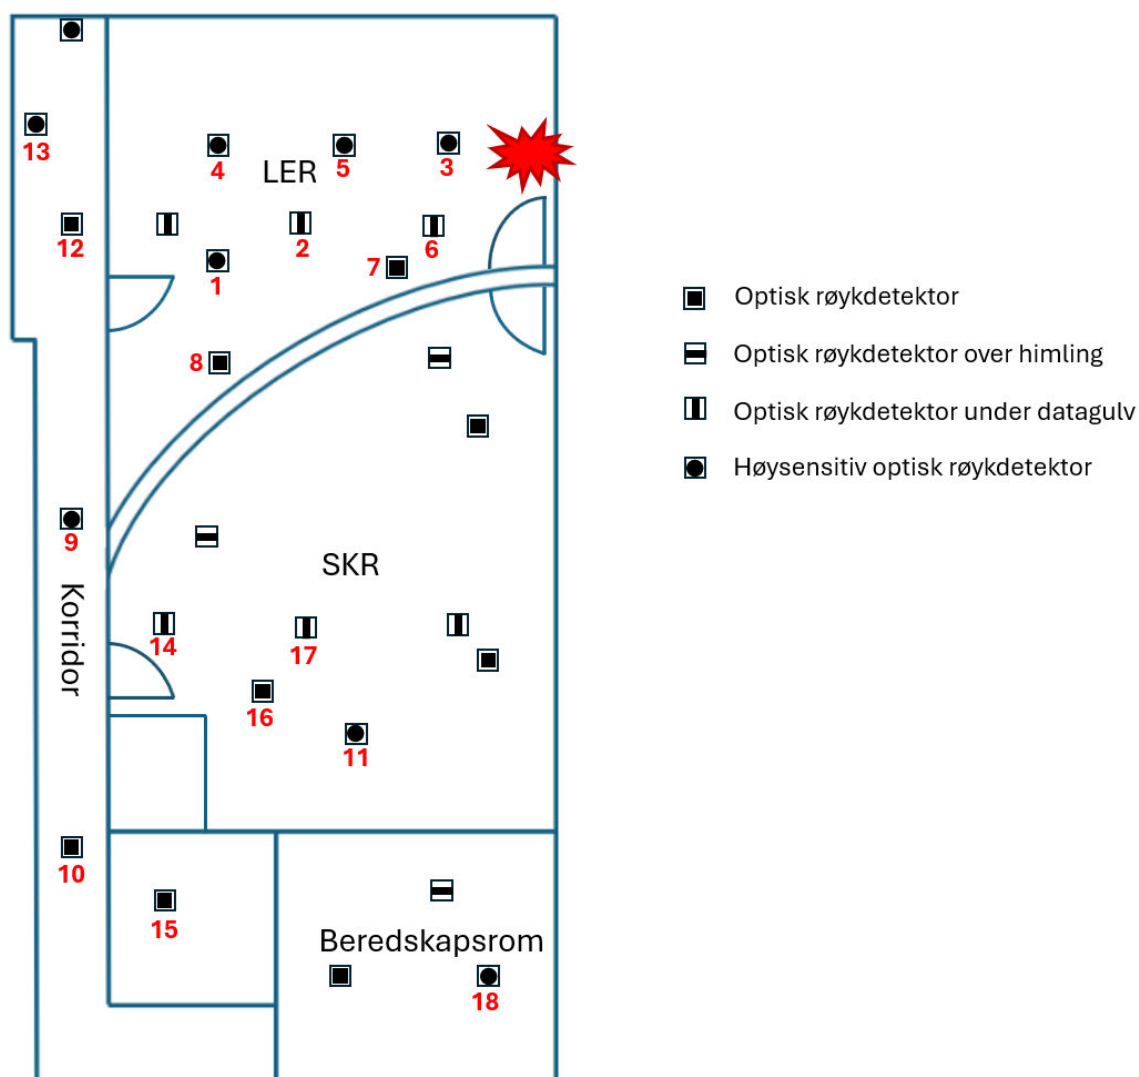
Figure 4 Detector alarm order

The first eight detectors to set off an alarm were located in the LER. The order in which they went off is shown in Figure 4. The red circle indicates the DX unit that was emitting smoke. Smoke detectors 1-4 went off in the space of 32 seconds. Three of the detectors were located in the ceiling and one in the raised floor. The two smoke detectors that confirmed detection were an early detector located in the ceiling of the LER and a detector located in the raised floor of the LER.

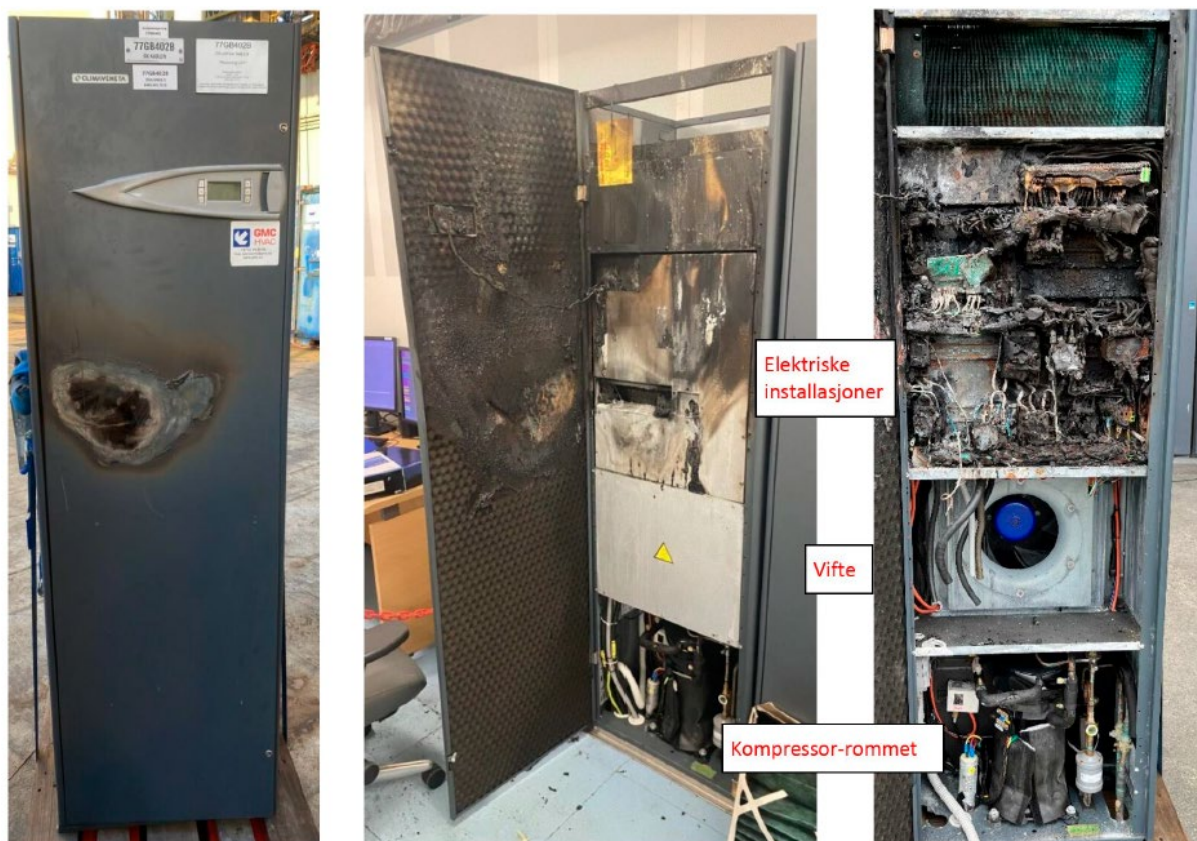
Figure 5 Cooling unit with cabinet door closed (left), open (middle), and after three internal panels/covers were removed (right). (Source: SINTEF Report 2023-01109 Fire in DX unit on the Gina Krog - Rev 1.0 (part 1))

The fire unquestionably occurred in the section of cooling unit ("the DX unit") that contains the vast majority of the electrical components. It is also clear that ignition was caused by electrical energy, most likely supplied through the 230V power supply to the fan and compressor motors. Major damage means that the point of origin of the fire or a detailed chain of events has not been identified, but according to SINTEF's investigations there are two possible hypotheses:

- 1) The cables in two of the terminals (screw clamps) of the circuit breaker through which the entire electrical power is supplied to the DX unit proved to be completely loose. Overheating here – with subsequent ignition of nearby combustible material – may have started the fire.
- 2) Measurements by SINTEF showed that series resonance produces stationary voltages of more than 400V across the motor capacitor of the fan in the external heat exchanger. This reduces the life of the capacitor, and a capacitor failure resulting in a series fault and local heating may have ignited the capacitor itself or nearby components.

The fire occurred in the section of the DX unit that contains the vast majority of the electrical components. Ignition was caused by electrical energy, most likely supplied through the 230V power supply to the fan and compressor motors.

- The cables in two of the terminals (screw clamps) of the circuit breaker through which the entire electrical power is supplied to the DX unit proved to be completely loose. Overheating here – with subsequent ignition of nearby combustible material – may have started the fire.
- Measurements showed that series resonance produces stationary voltages of more than 400V across the motor capacitor of the fan in the external heat exchanger. This reduces the life of the capacitor, and a capacitor failure resulting in a series fault and local heating may have ignited the capacitor itself or nearby components.

- It should be checked that the correct tightening torque is used in the cable terminals for the electrical components in the other DX units on the *Gina Krog*. If there are similar units from the same manufacturer installed at the same time on other platforms, these units should also be checked.
- The motor capacitors on DX units with a similar operating pattern should be replaced with capacitors that have a longer design life.
- An alternative to replacing the motor capacitors may be to rebuild the DX units so that the fan motor is run by a three-phase power supply (i.e., without a motor capacitor), or possibly to even replace entire DX units with three-phase-based units.
