Investigation report

Report	
Report title	Activity number
Hydrocarbon leak on the Ula P facility, 12 September 2012	010019010

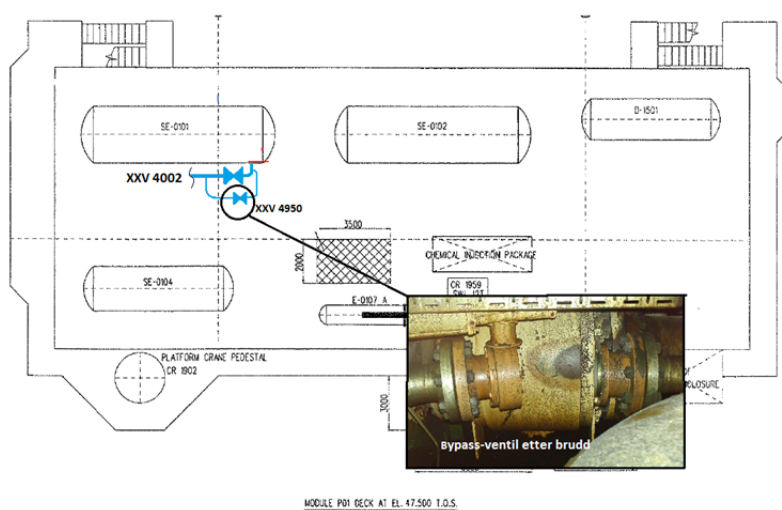
At 07.06.59, a fault caused one of the gas compressors (UGU) to shut down automatically. This meant that the pressure in the HP inlet separator, which delivers gas to the compressor, rose from about 18 barg to roughly 24, which is within the design limit. This was the direct reason why the bolts fractured in the XXV-4950 four-inch bypass valve on the separator's water outlet. Pressure in the line split the valve as shown in Figure 3, and produced water followed by oil and gas flowed at a high rate onto the P01 mezzanine deck.

Figure 3: P01 mezzanine deck, showing the position of the bypass valve in the module, and a photograph of the valve after its failure.

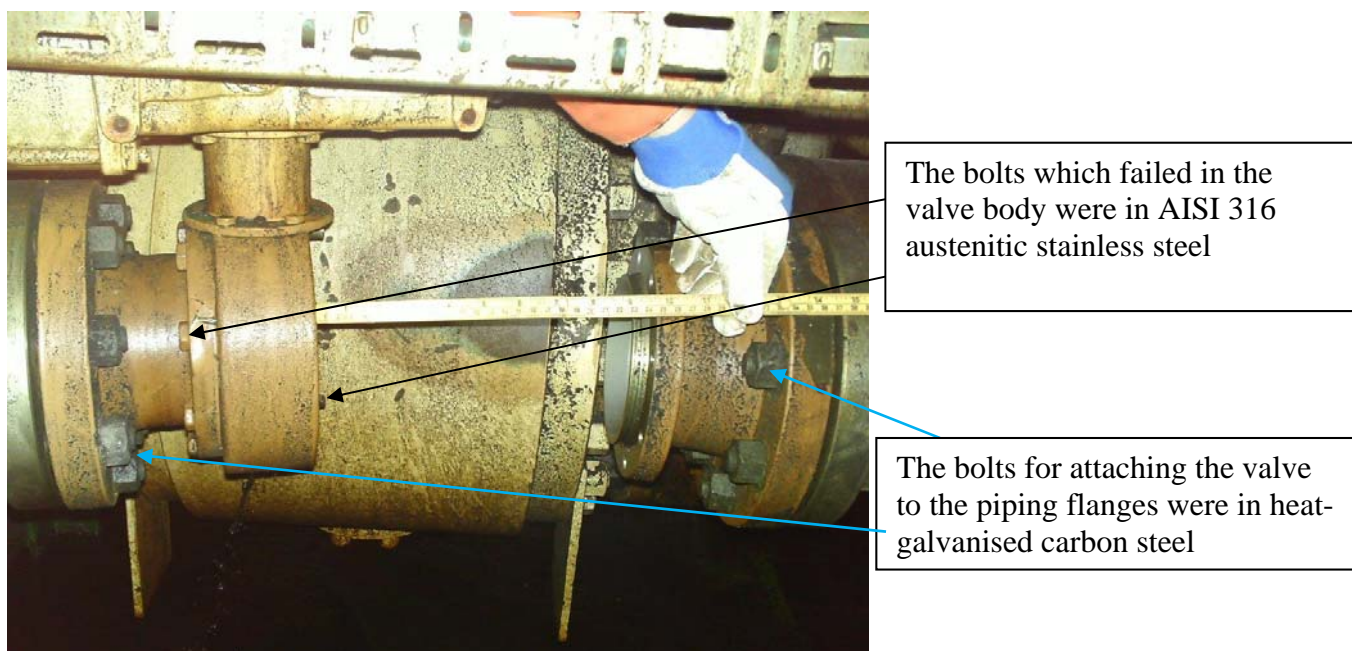
Damage to the bypass valve was analysed by Exova A/S, see /63/. Fracturing of the bolts in the four-inch valve resulted from chloride stress corrosion cracking of austenitic stainless steel, AISI 316 and AISI 304.²

Furthermore, the analysis suggests that the bolts have fractured at different times. The first of them could have broken without causing an external leak. Because a number of the bolts are broken between the valve housing and the flange, the breaks are hard to detect since the bolts

do not fall out, the nuts are covered in paint and the bolt is held in place. When several bolts fail, the strength of the remaining bolts, weakened by corrosion cracking, will ultimately be insufficient.

Photograph 4: shows the valve body bolts in AISI 316 with breaks, and the bolts in heat-galvanised carbon steel for attaching the valve to the piping flanges.
