Kneler A Workover Project

| Skandi Arctic Port Bell Investigation Report | | | | | |
| 3203-S-TKP-U-RA-7006-00-00 | | | | | |

Investigation Report

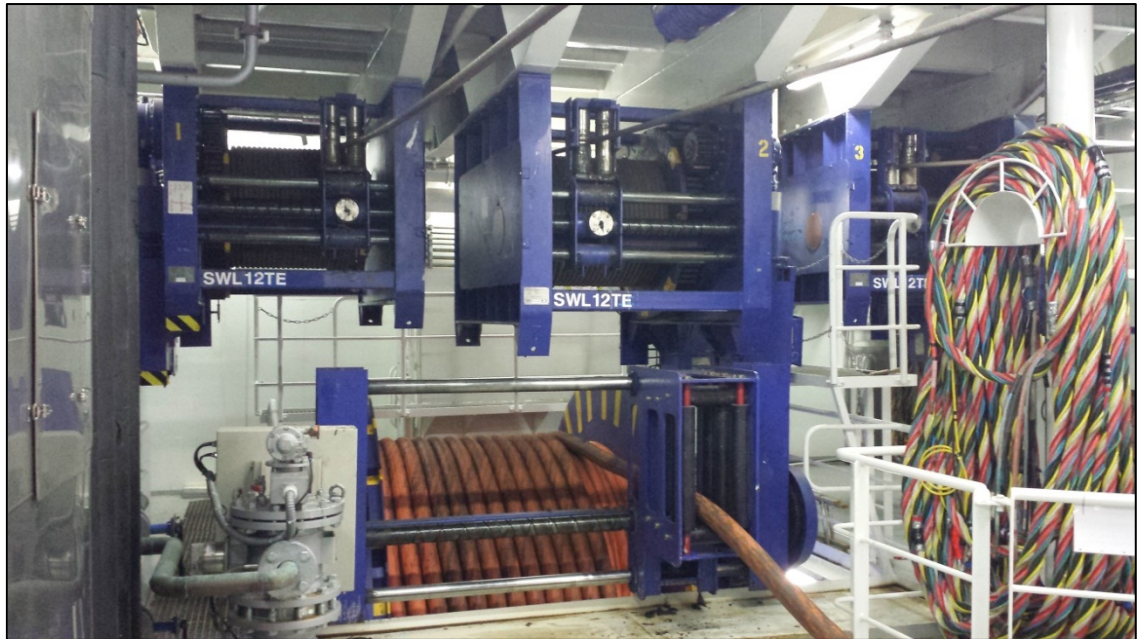
Figure 0-4: PICTURE 1 - 3 x wire winches and 1 x umbilical winch (port side)

The bell descended at much higher than normal speeds during the uncontrolled descents. The umbilical winch motors are significantly less powerful than the wire winch motors as they are designed to manage a much smaller load. It is probable that as the umbilical winch has a much larger rotational inertia compared to the wire winches, combined with the significantly less powerful motors it was not able to pay out the umbilical fast enough and maintain the nominal 0.5 Te tension. Consequently the maximum design load was exceeded leading to failure of the chinese finger and main umbilical connections.

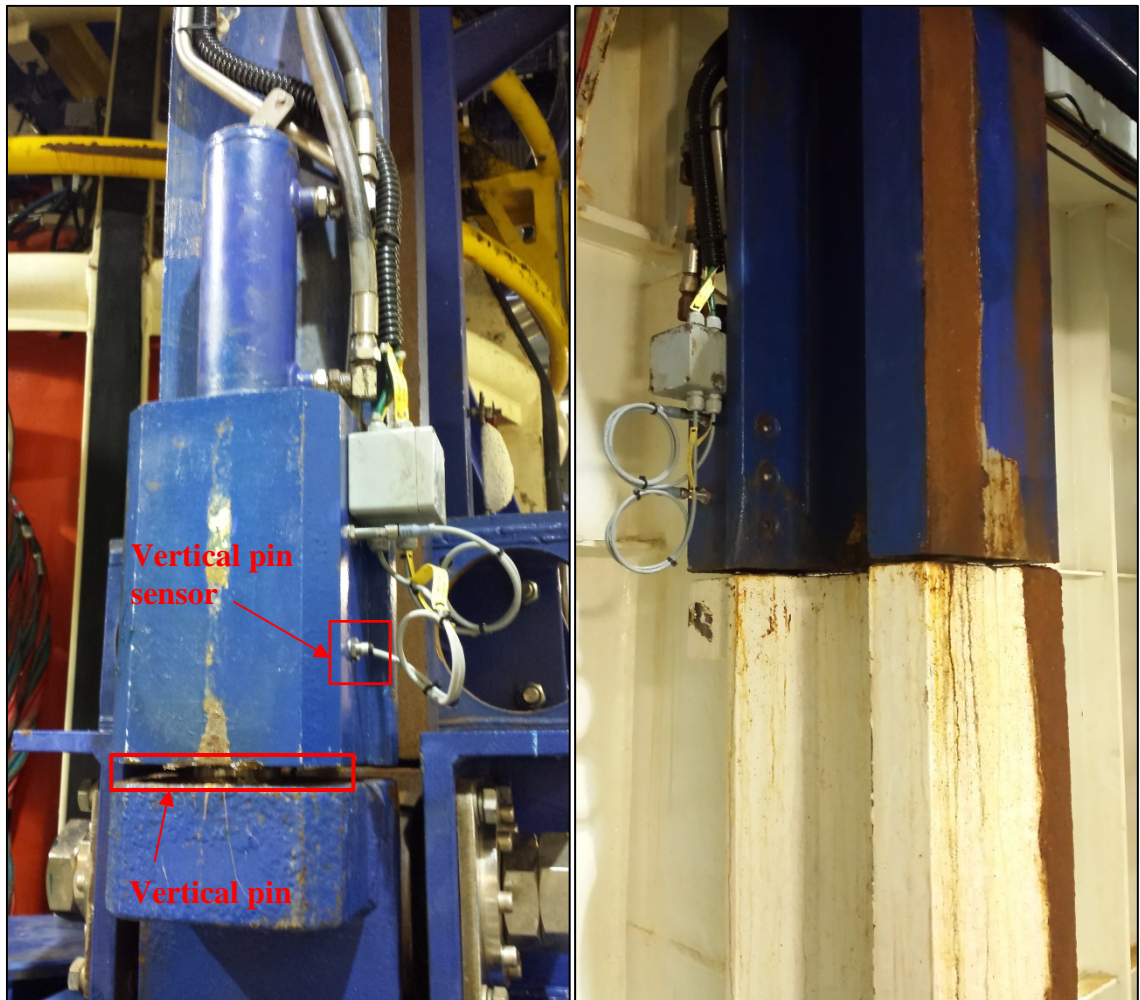
Figure 0-5: PICTURE 2 - Vertical locking pin sensor (left) and guiding rails (right)

NOTE: The reliability of the proximity sensors (See 11.2.3) has been poor from commissioning with some 50 sensors within the system suffering from a variety of problems such as too small an activation range (3mm) or corrosion of the connections leading to premature failure. There are two vertical locking pin sensors of which only the lower one became faulty. The upper one was fully operational throughout the incident. Though the fault with this sensor was the trigger for incident it played no further part in the proceedings.

Figure 0-5 shows the vertical locking pin 1 lock sensor which reported inconsistent (faulty) and led to the automatic soft stop of the system during initial lowering of the bell through the moonpool. From build, these sensors have a history of faulty operation and have almost all been swapped out for more reliable and robust ones with a greater activation range. In the case if this sensor it was an excessive build-up of grease that led to the faulty operation.

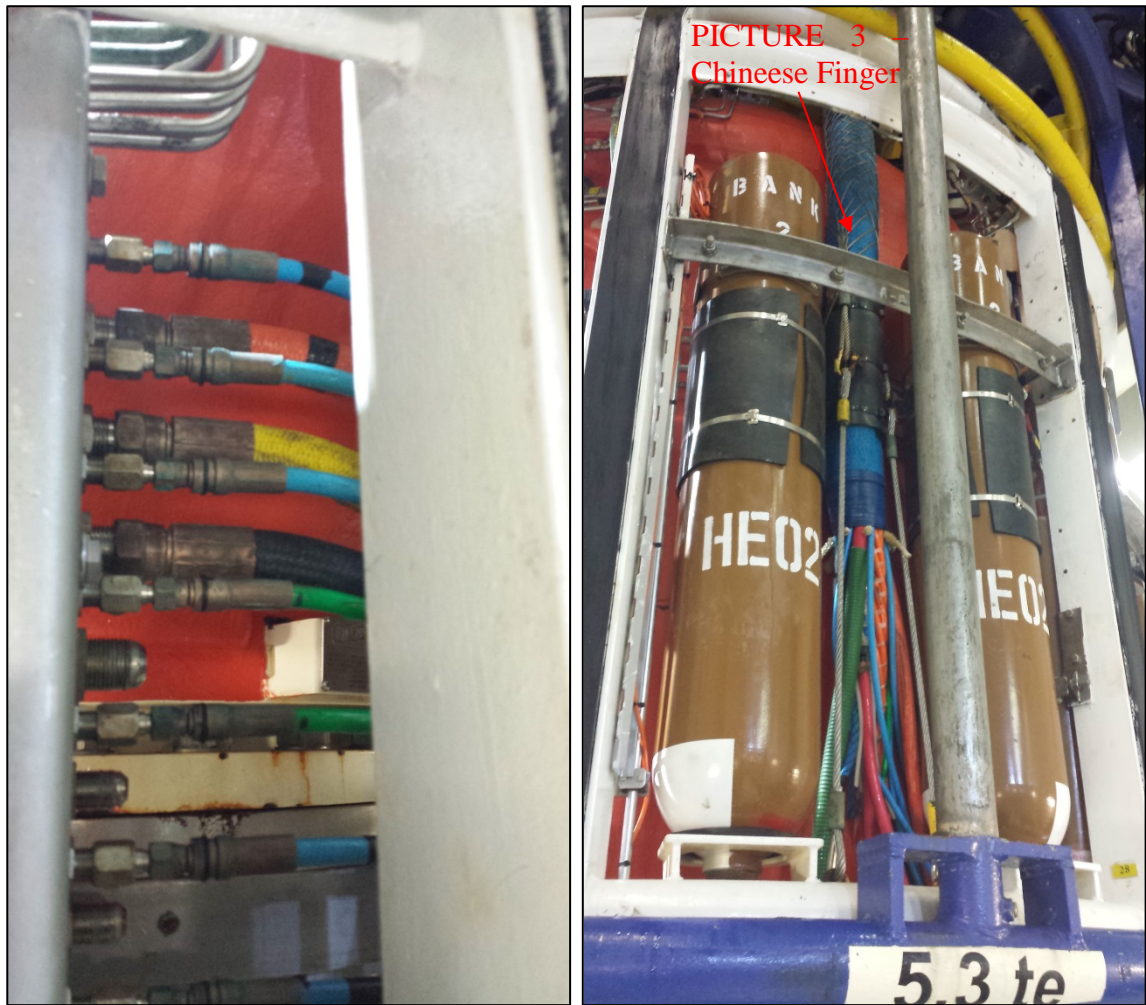
Figure 0-6: PICTURE 3 - Umbilical termination plate (left) and standard umbilical entry / termination (right)

The umbilical termination plate and fittings on the bell hull were damaged. All connection points, gas, water, electrical and signal cables need thorough inspection, testing and repairs.

already fully collapsed and alarms were sent to the port LARS control panel. Umbilical load warnings were also sent to the port LARS control panel. The umbilical was over tensioned resulting in breaking of the chinese finger securing system which was intended to take a normal load of 0.5 Te and a maximum design load of 1.5 Te. Once the chinese finger had failed, gas connections at the umbilical termination plate were ripped off. A hot water supply hose was also broken off at its bell hull penetration point. The bell began to lose pressure through the open ended connections. The second uncontrolled descent of the bell stopped after 6 seconds with a movement of approximately 4 meters. Once again the bell accelerated to at least 3 times the normal speed when descending through the moonpool.

Figure 0-6 shows the chinese finger used to secure the main umbilical to the bell frame via wire stropps and shackles. This system has been manufactured for a maximum design load of 1.5 Te and normal working load of 0.5 Te.

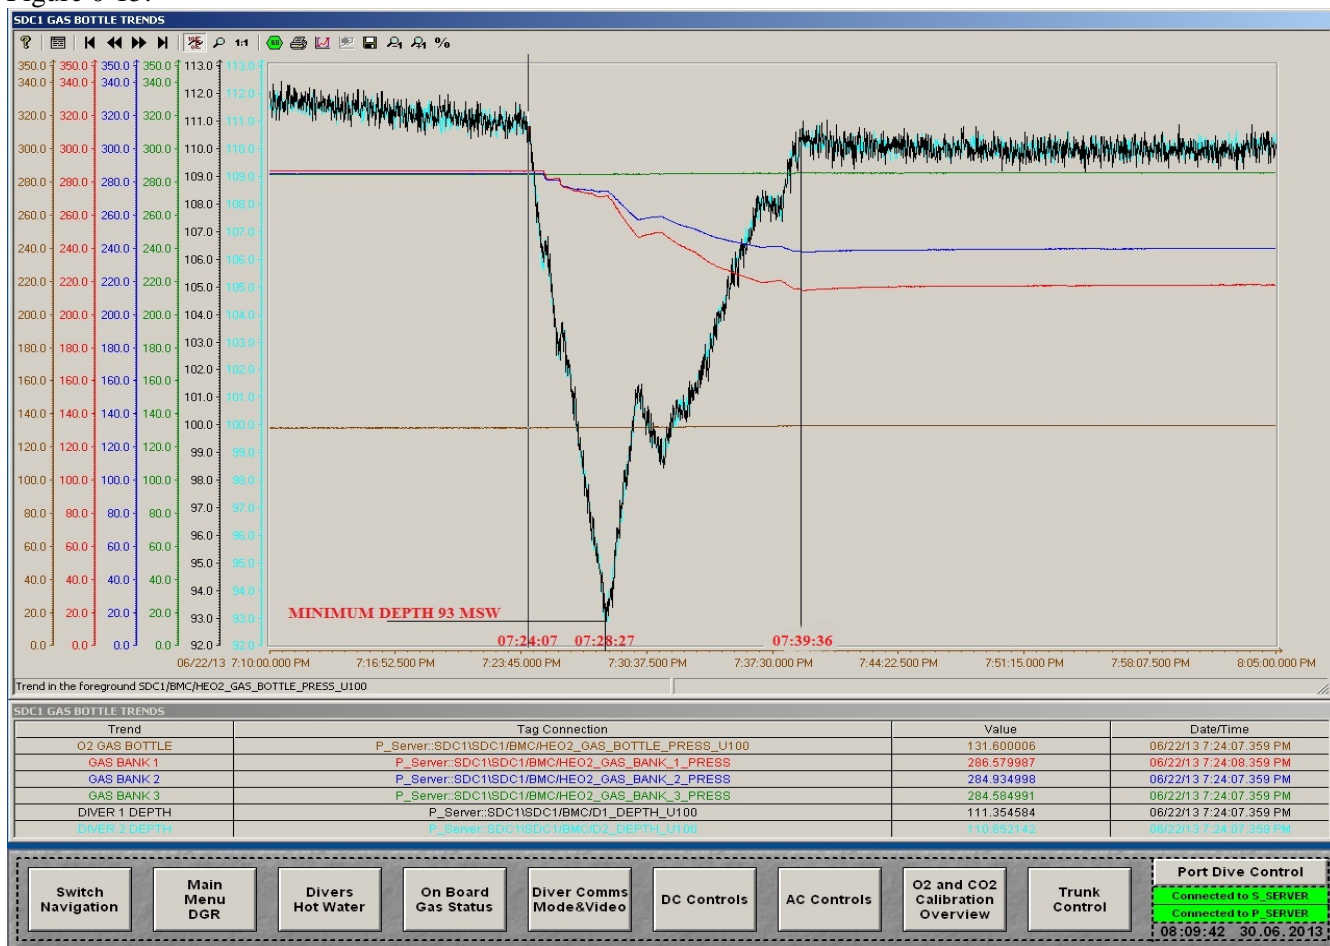
Figure 0-11 Port LARS bell internal depth and on-board gas bank pressures with key times

The bell internal pressure dropped from 111 msw to 93 msw in a time span of 4 minutes and 15 seconds. The leak rate (volume) was approx. 2960 l/min, the average pressure loss (decreases with decreasing differential pressure), expressed in msw, was 4.24 msw/min. At this point in time, the divers in the bell had closed most of the leaking valves and had started to regain the internal depth of the bell through pressurizing by means of the on-board bell gas reserves.

The last leak was stopped 11 minutes and 19 seconds after the initial leaks occurred. Living depth of 110 msw was regained 15 minutes and 29 seconds after the leaks started.

14,2 % of the available on-board gas (10/90) was used to compensate for leaks and to regain living depth in the bell. This means that, at the actual usage rate, there was still gas left for another 95 minutes of compensating for the leaks.

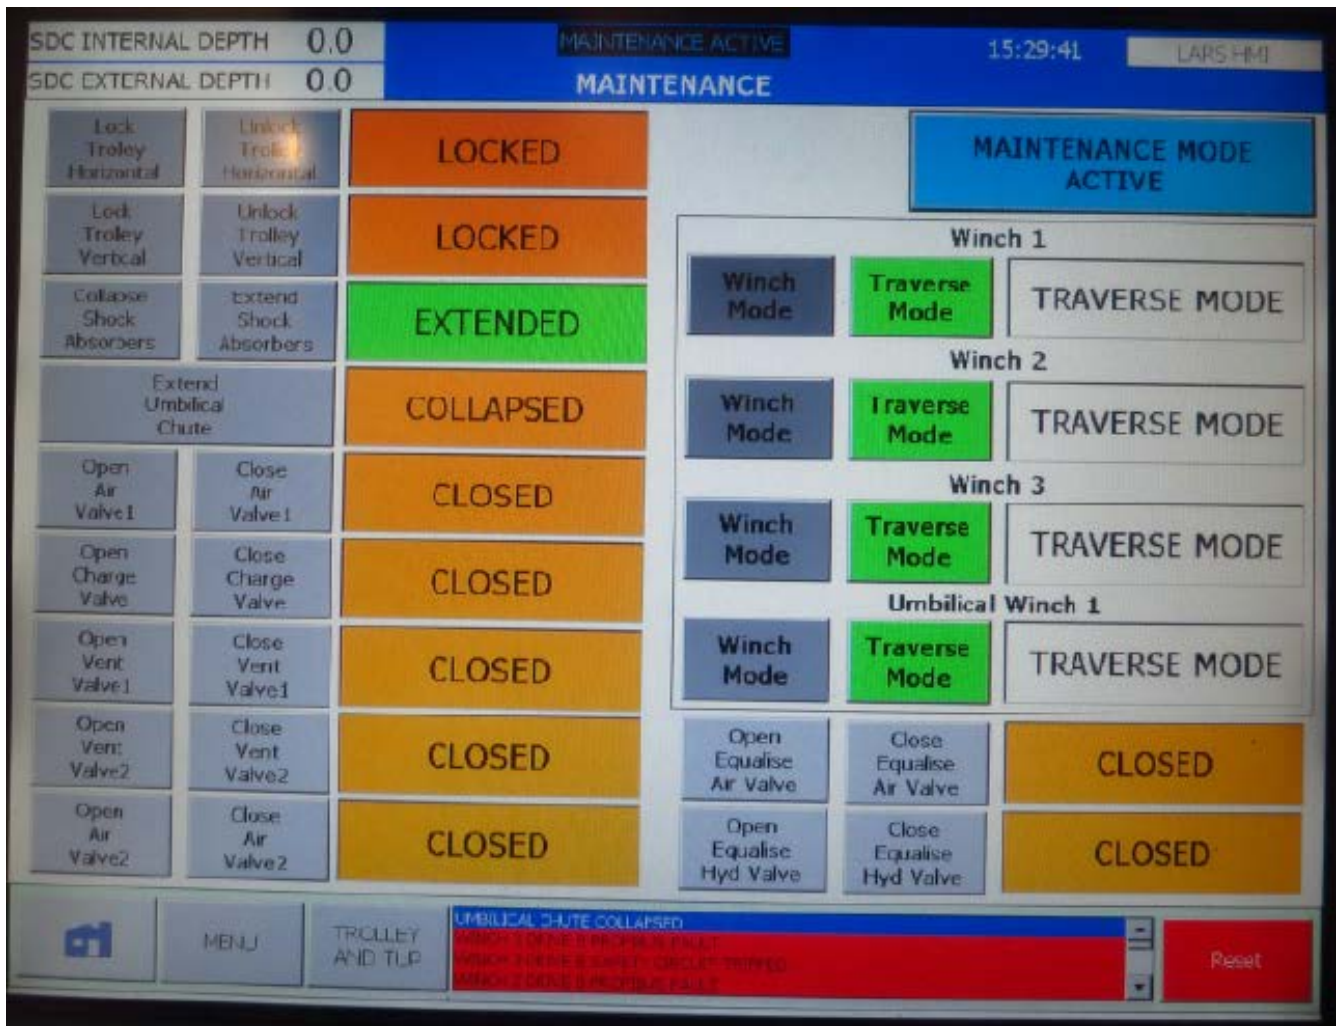
Fig F-2 Maintenance screen on operational system

| Barrier | Status during incident | Comment |
|---|---|--|
| LARS HMI password protected to prevent maintenance mode access. | Failed | Technician has the password and it is the same as for activating an override which is what he intended to do. |

At section 2.24 the password philosophy details two user levels where the upper level only is password protected. However verbal statements from the Control Systems Superintendent and PLC Technician suggest that historically separate passwords existed for access to maintenance mode and override functions. There currently exists only one password that is common to all protected modes or functions.
