Investigation report

Report	
Report title Report of the investigation of the well control incident in well 31/2-G-4 BY1H/BY2H on the Troll field with the <i>Songa Endurance</i> drilling unit	Activity numbers 001054029 001054030

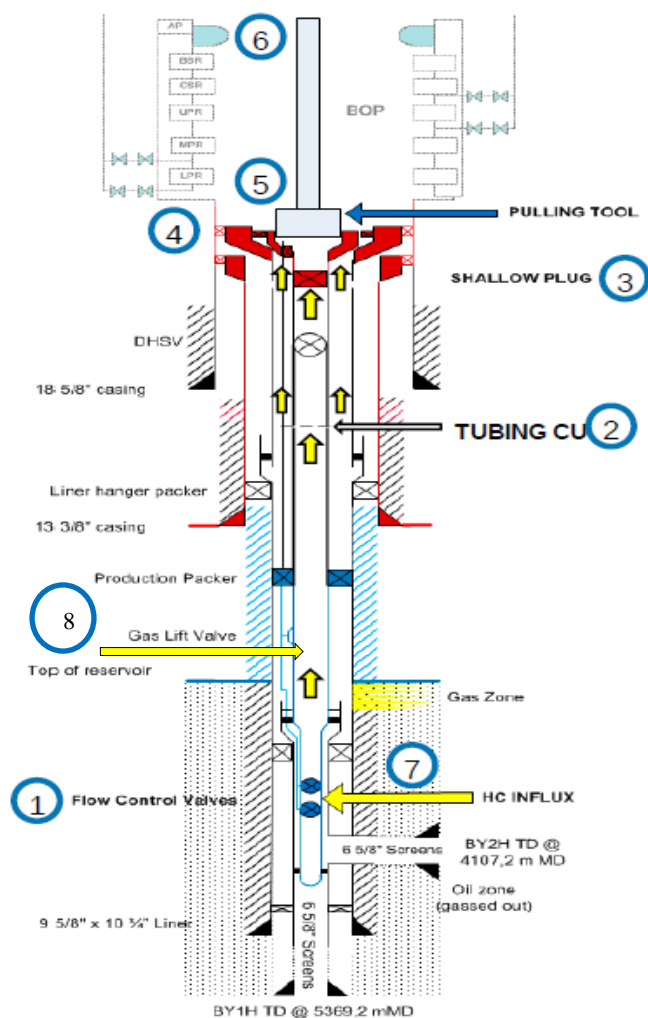
- (1) FCV
- (2) Tubing cut
- (3) Shallow-set plug
- (4) Wellhead
- (5) Pulling tool
- (6) AP
- (7) Influx from reservoir through FCV
- (8) Influx from reservoir through GLV

Figure 1 Schematic illustration of the well.

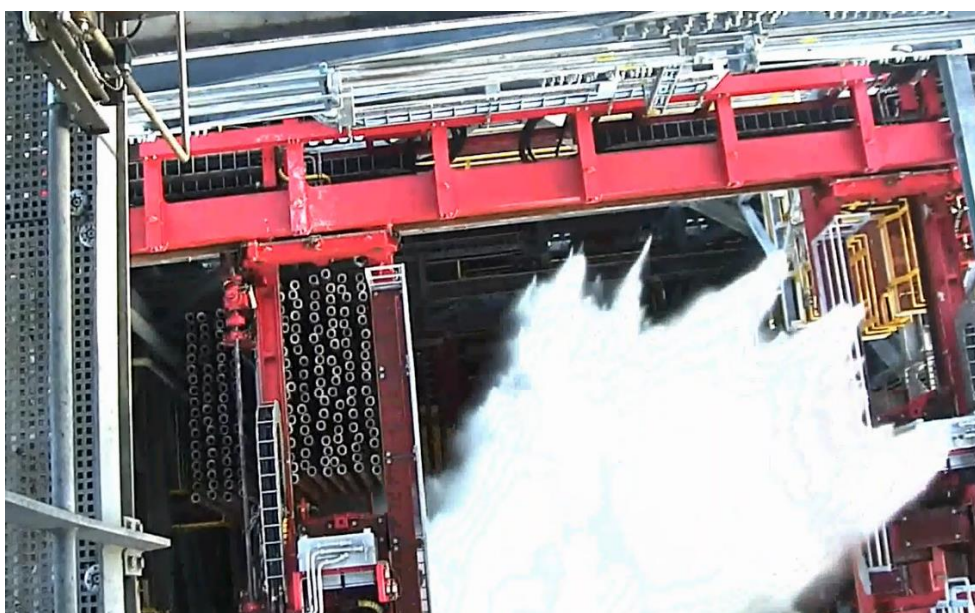
Figure 2 Flow on Songa Endurance on 15 October 2016 seen from the top of the derrick. (Source: Songa Offshore)

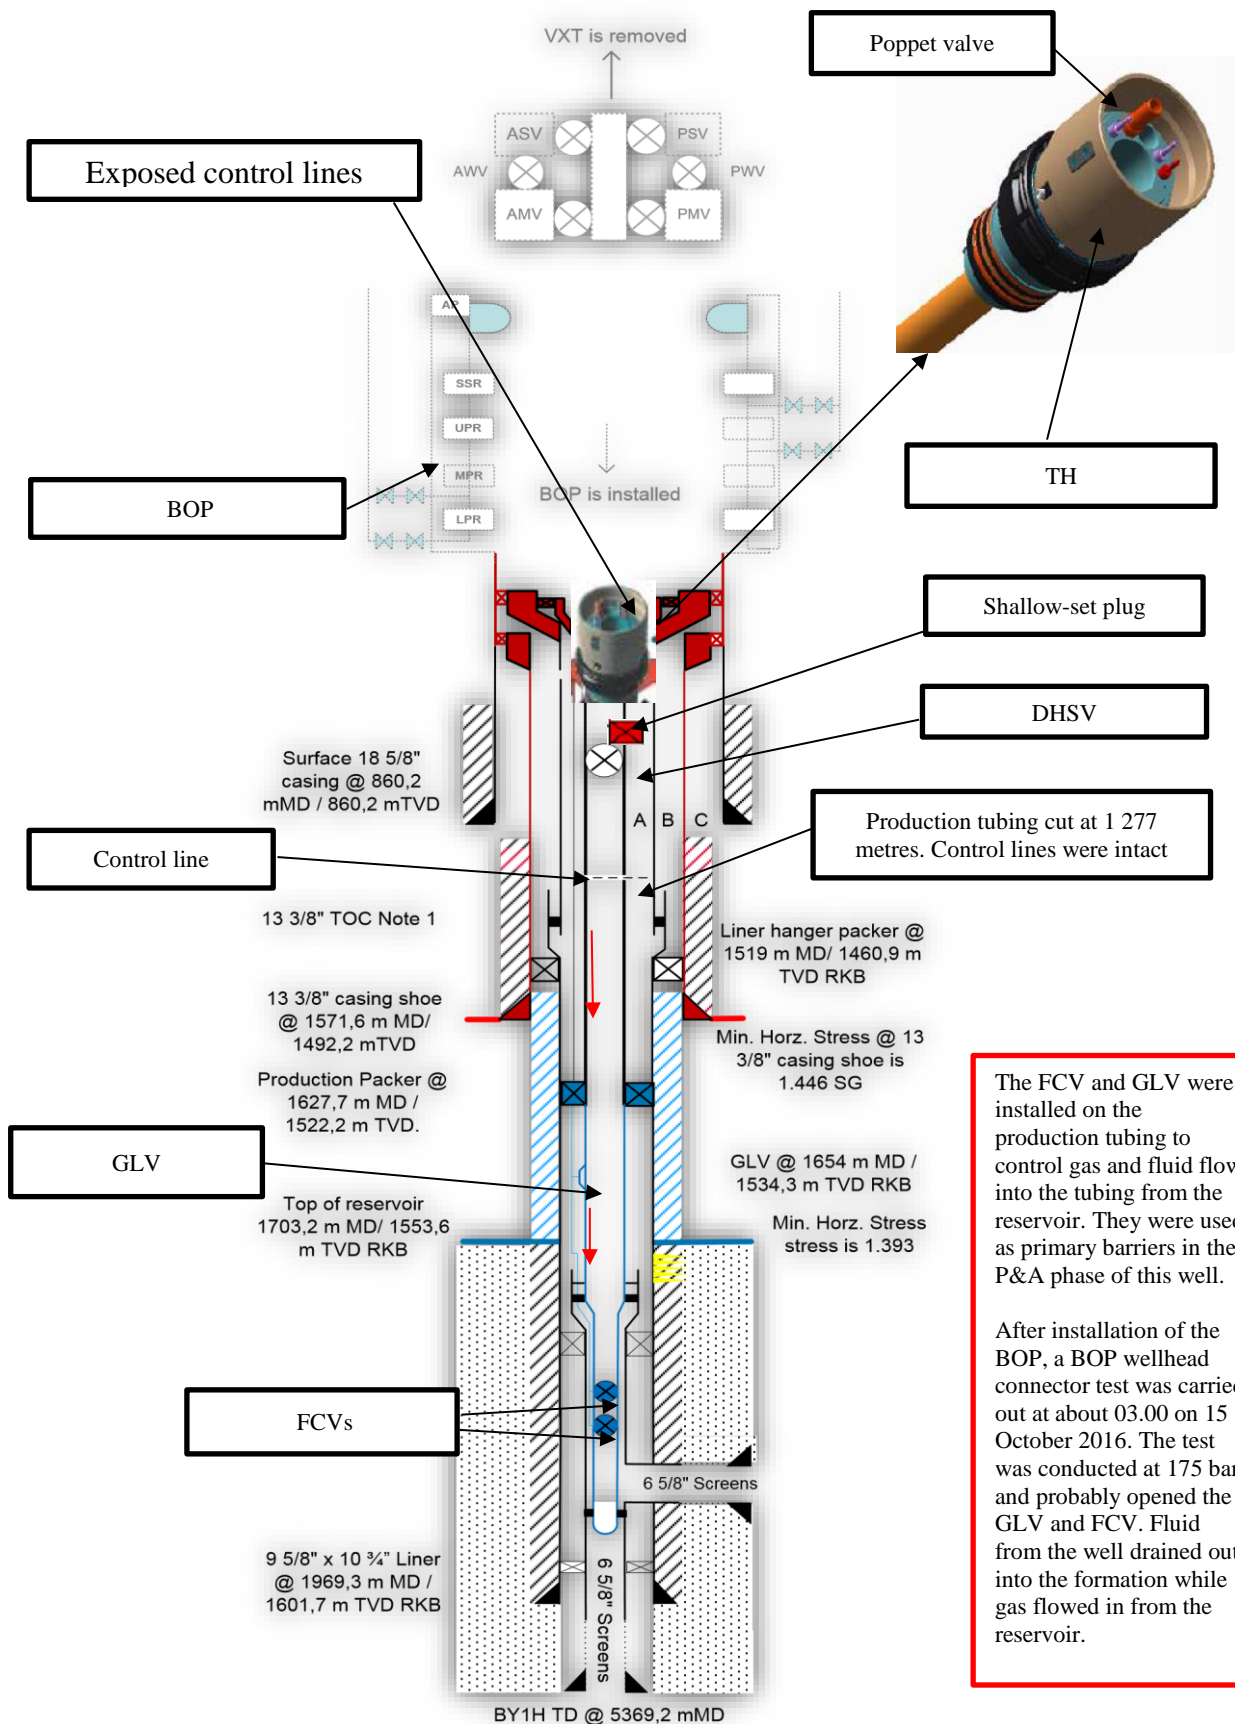
These poppet valves can be opened by pressure from above but not from below. Hydraulic control of the valves from the surface is provided via the Xmas tree. The FCVs and GLVs are controlled from the surface after the installation of the VXT. When the latter is removed, the poppet valves are exposed to pressure from above and unprotected. They can be opened or closed (cycled) by the application of hydraulic pressure through control lines of 28-138 bar.

Figure 14 Control lines with poppet valves on the TH after removal of the VXT and installation of the BOP.

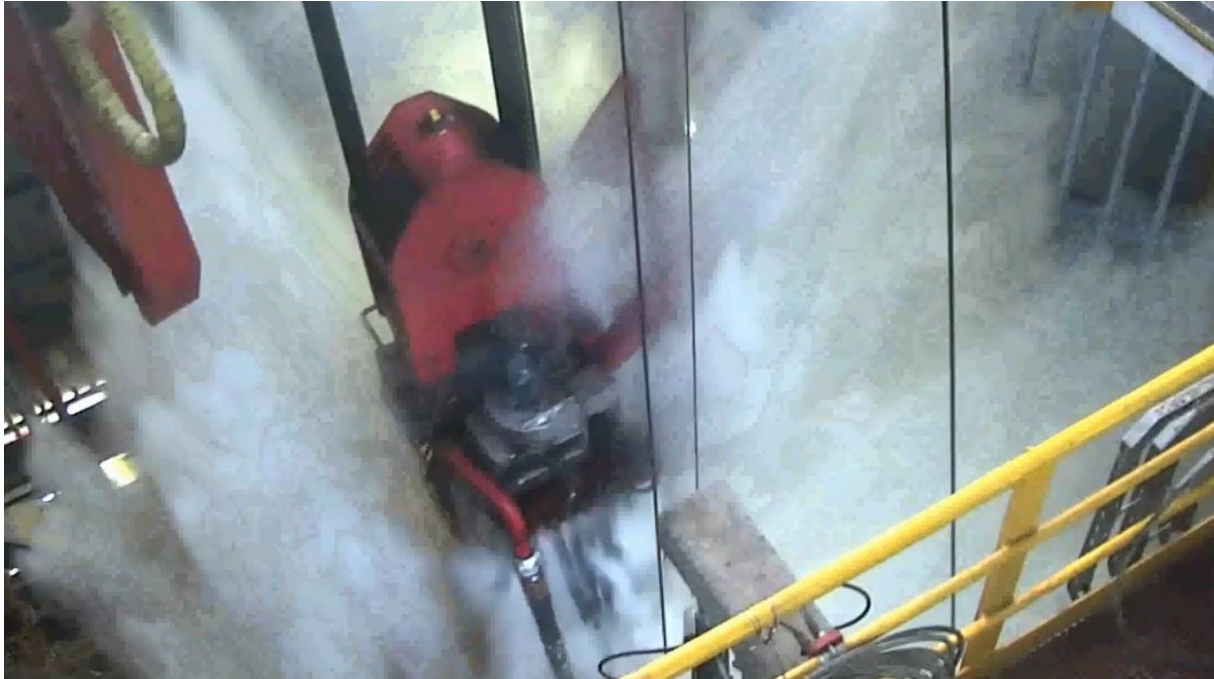
15.10.2016	09.33	When the overpull reached 13 tonnes, the top drive with the THSRT and the completion string was suddenly raised six metres. After a few seconds, large quantities of fluid and gas flowed out of control up through the rotary table.	Nobody was out on the drill floor in the red zone (marked area on the floor subject to movement restrictions).

Figure 15 Outflow of gas and fluid at the fingerboard level. (Source: Songa Offshore)

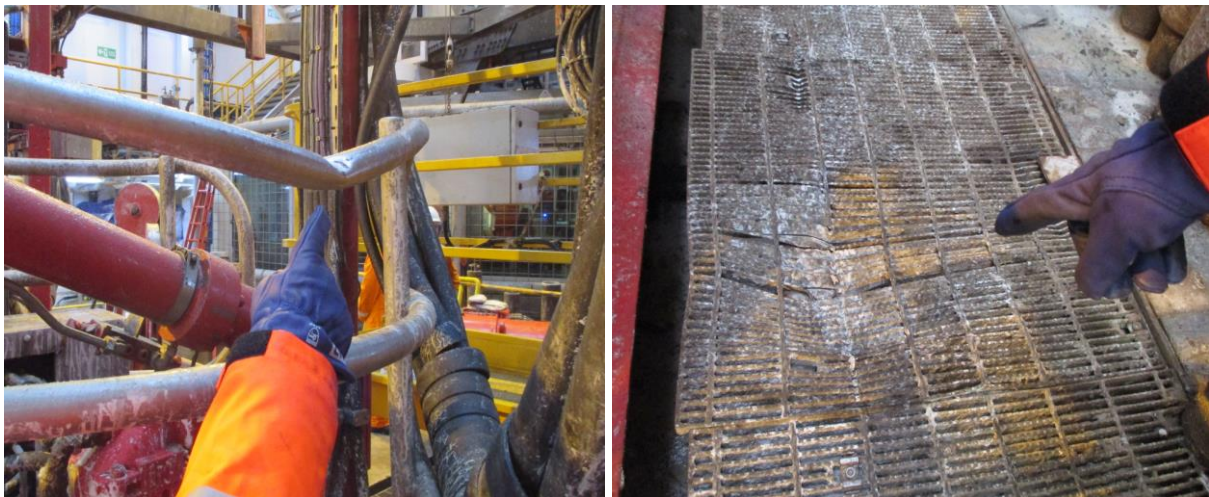
This flow lifted both the 2.5-tonne PS-21 hydraulic slips and some two tonnes of bushings, shifting the latter several metres across the drill floor. The fluid column reached right to the top of the derrick, about 50 metres above the drill floor. Large quantities of fluid/gas prevented personnel in the driller's cabin seeing what was going on outside. Figure 17 shows where the bushings landed. One length of bushing hit and damaged the railing on the work basket before landing on the deck grating alongside the drillpipe store (figure 16).

Figure 16 Damaged railing and deck grating.

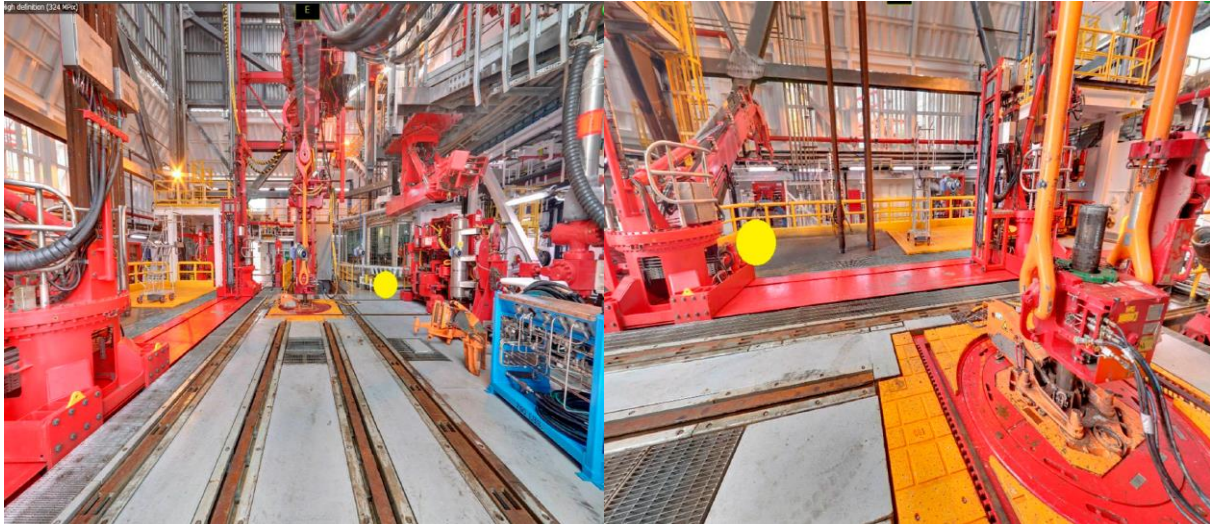
Figure 17 Position of bushings after the incident on the drill floor (marked with yellow circle).

Had the bushings from the rotary table hit the driller's cabin, serious personal injuries could have been caused and rapid shut-in of the well prevented. The investigation has not assessed the ability of the cabin to withstand this load.

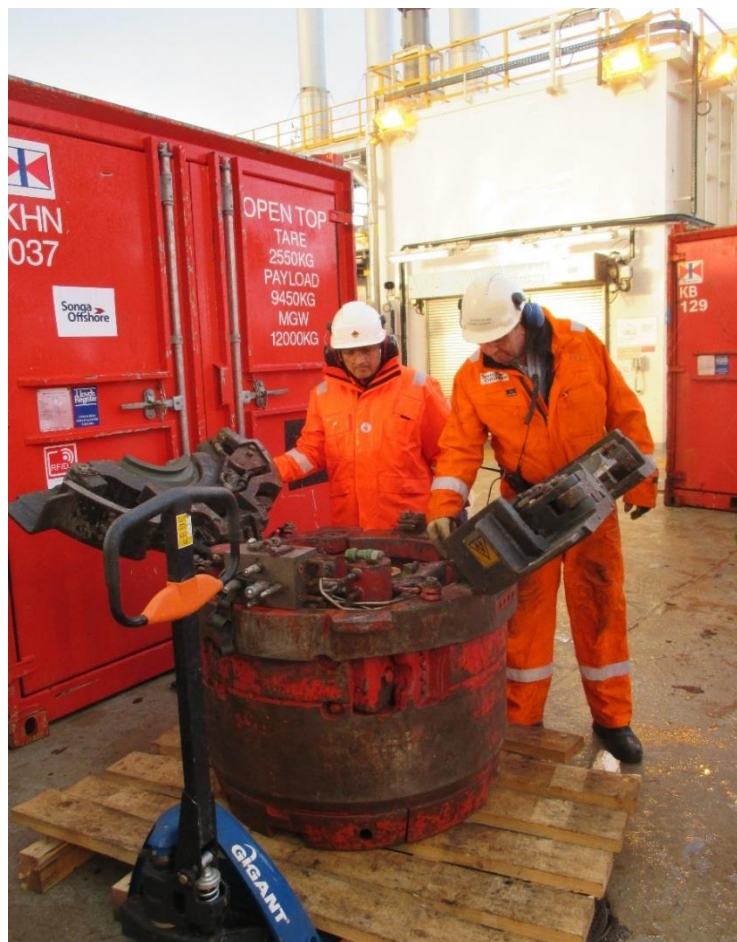
When the flow of fluid and gas decreased, the PS-21 hydraulic slips landed under the rotary table and on top of the diverter.

Figure 18 The PS-21 slips.

After normalisation, repairs were carried out to damaged equipment on the drill floor, including the electric motor on the top drive and the PS-21 hydraulic slips.

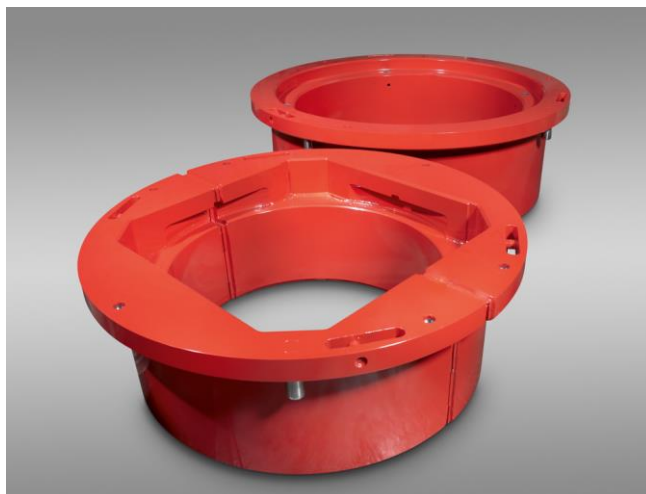
Figure 19 Bushings.

Gas from Troll consist largely of methane (94 per cent). Large quantities of gas filled the space above the drill floor during the incident. The 2.5-tonne slips and two bushings of one tonne each were thrown up from the rotary table. The bushings landed five-six metres from the rotary table and the slips followed the string down and landed on the diverter. This could have generated sparks and potentially led to ignition. The latter could have caused an explosion and potentially fatal conditions for the personnel in the driller's cabin.

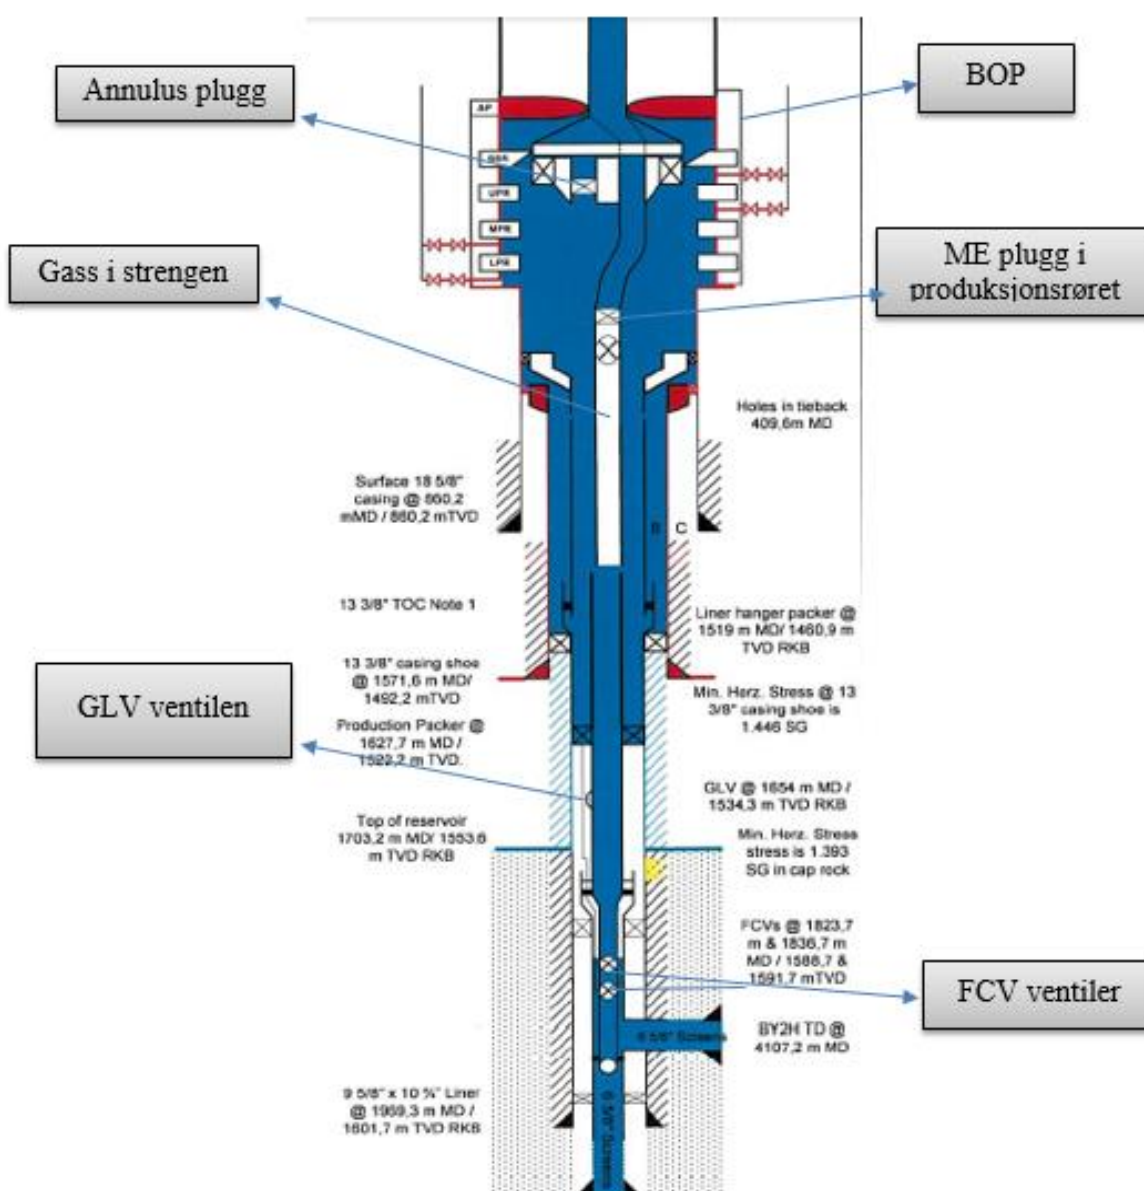
Figure 20 Well diagram after establishing the primary barrier in the annulus. Dark blue indicates intrusion of kill fluid.
Key: Annulus plug, Gas in string, ME plug in production tubing.

The combination of the leak and the ME plug in the string hindered pumping of kill fluid down the string. This meant the string above the cut point remained standing with gas inside. The leak in the string arose because the retrieval tool for the TH was not screwed fully tight during connection before the incident occurred. The kill operation was therefore challenging.
