Investigation report

Report	
Report title Investigation report on a steam leak at Mongstad on 8 November 2012	Activity number 001902023

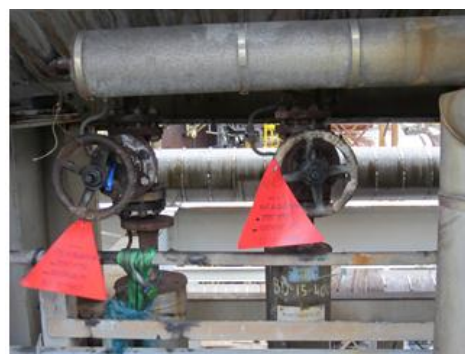
The valve on the left was shut and the leak ceased.

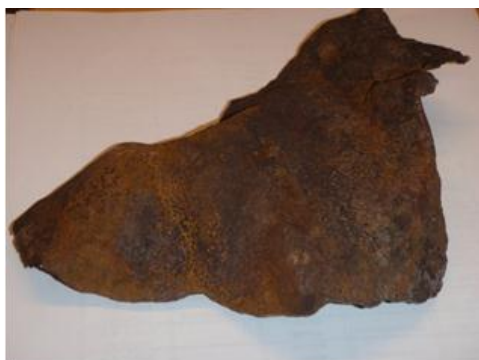
The water leak which had been attributed to the steam tracing pipe could also have come from the actual steam pipe. Small holes in the latter were visible close to the fracture zone. It is nevertheless impossible to be certain about that. The holes in the steam pipe could have arisen during the incident. This type of fracture in steam pipes as a result of corrosion is infrequent. Corrosion normally weakens the material and small holes occur which gradually get bigger. Leaks are therefore usually discovered before they get large. In this case, heavy corrosion must have been concentrated in a small area around the whole diameter of the pipe. All the same, the leak has probably started in a small area and spread immediately because of reduced material thickness, and the final section has ruptured because of a big outflow and powerful movements.

This bit of pipe was ripped off and shows heavy corrosion.

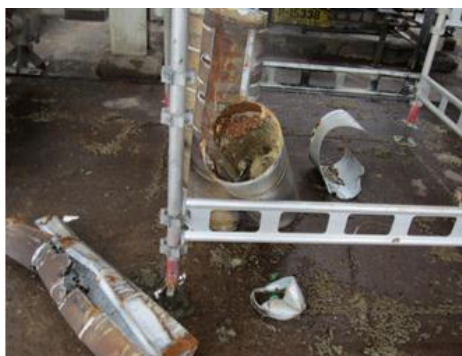
Remains of the mantling were thrown off the pipe.
