Investigation report

Report	
Report title Report of the investigation into a gas leak at Hammerfest LNG on 31 May 2023	Activity number 001901051

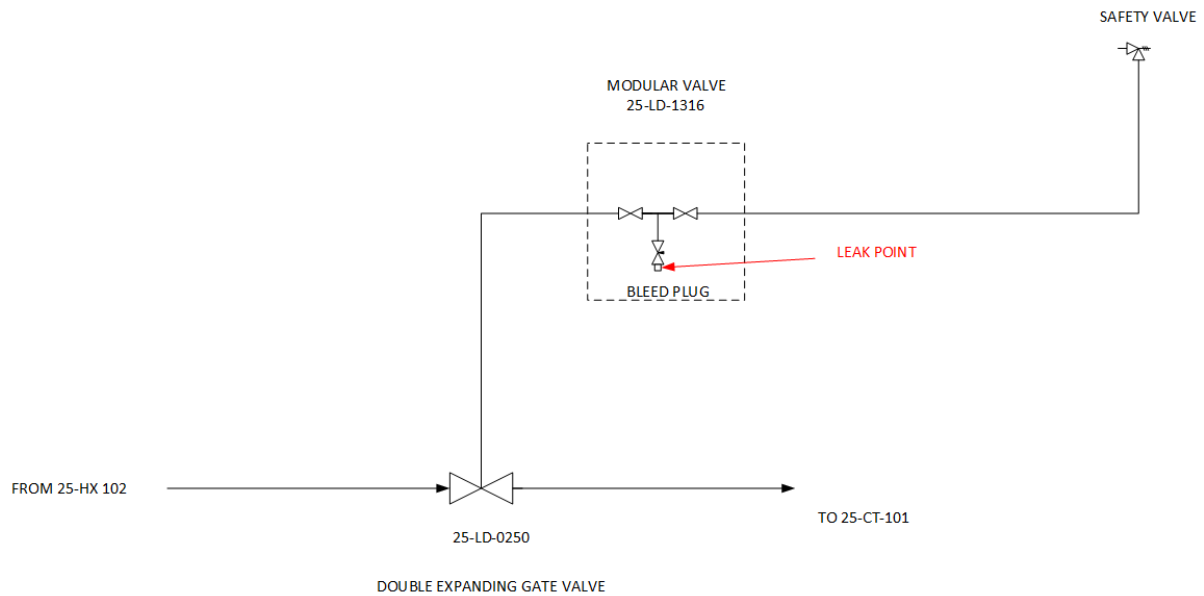
Figure 3 Simplified diagram of the safety valve and upstream valve arrangement.

The piping segment upstream of the safety valve was modified in 2017 because of challenges with a screwed connection. Preparatory work for this job began in 2014.

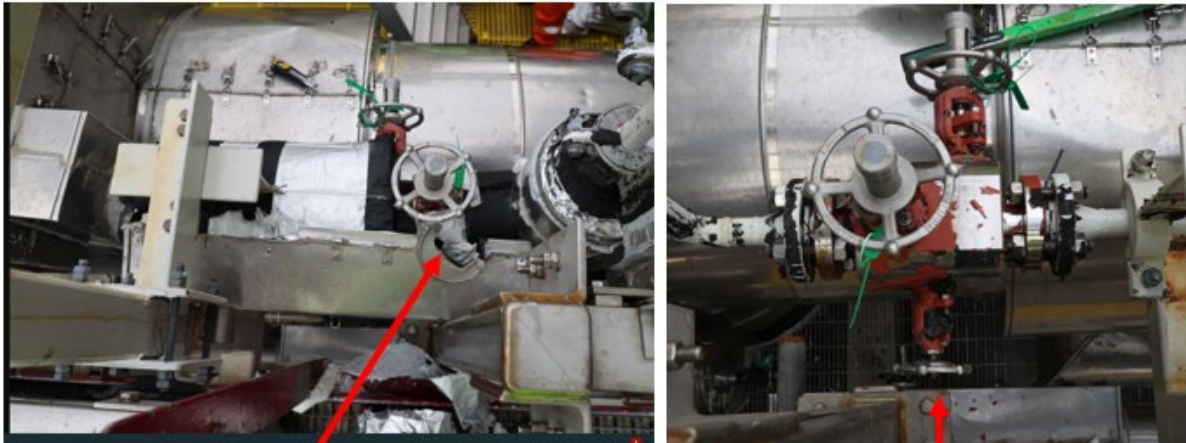
The piping upstream of the safety valve is insulated and the valves, with the exception of their wheels, are enclosed in this insulation. That includes the bleed plug. Stripping insulation from the piping upstream of the safety valve was under way when the leak was discovered. After the incident, the bleed plug was found to be in the open position. The needle valve upstream of the plug has probably been moved somewhat in connection with insulation removal. See chapter 11. Operating conditions in the cooling medium at the leak point were about 43 barg and -151°C , with the medium in the liquid phase at this point.

Needle valve enclosed by the insulation which was removed during the ongoing job. The needle valve itself is not visible in the photo. The area around the insulation box which was going to be removed was very restricted.

Needle valve without insulation box.

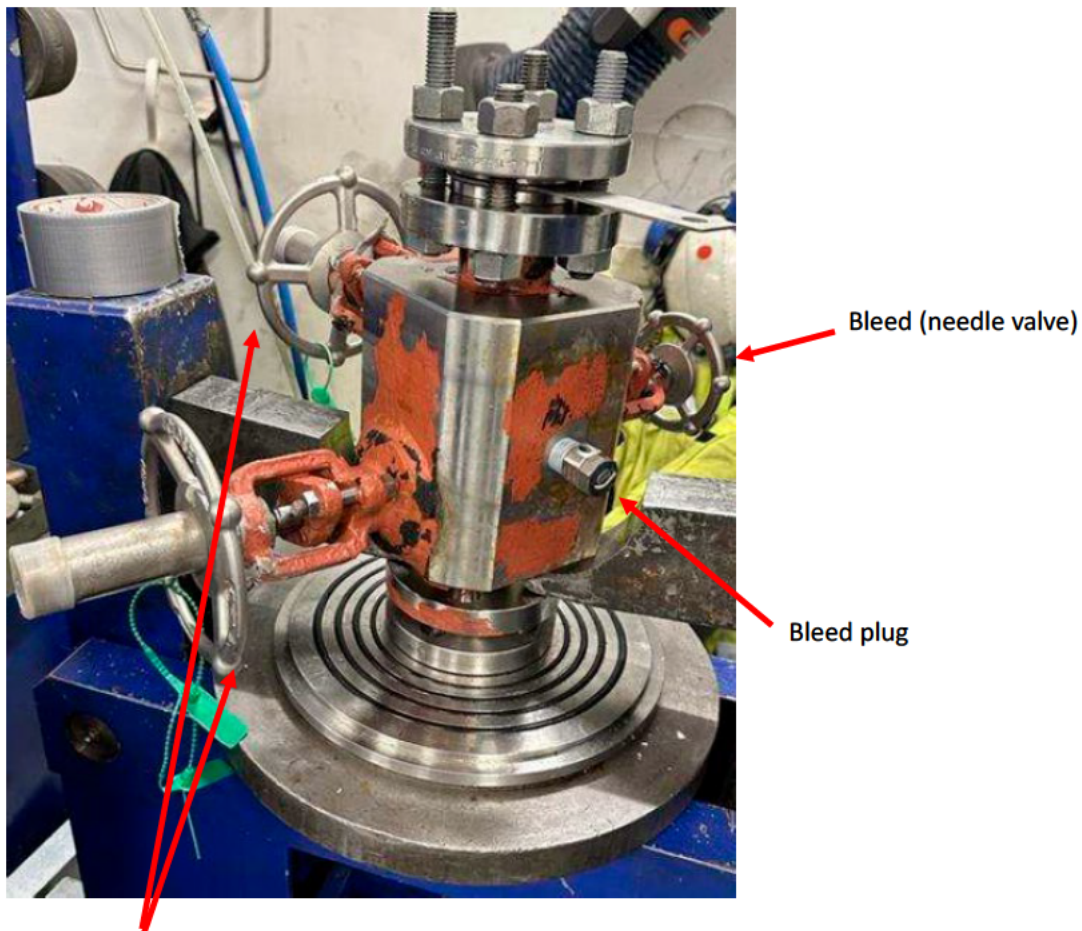
Figure 5 Modular valve upstream of the safety valve. Source: Equinor.

A modular valve (compact DB&B with a needle type as the bleed valve) is installed on the line upstream of the safety valve. A bleed plug is installed in the bleed line. This is an anti-blowout type and left-hand threaded.

In normal operation, the isolation valve upstream of the safety valve is secured in the open position and will only be used in connection with recalibration or maintenance of the safety valve. The bleed (needle) valve and the bleed plug in the compact valve will normally be in the closed position. The bleed system is used to ensure the system has been depressurised before valve removal.

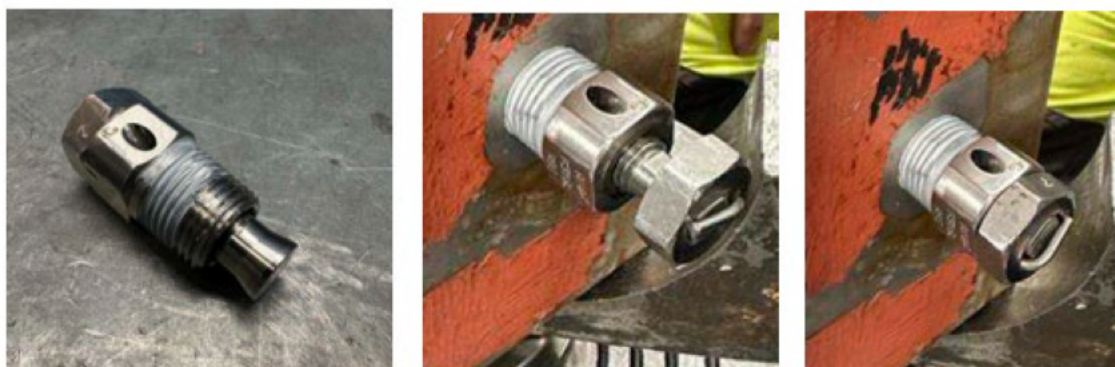
Figure 6 Left: The type of bleed plug used. Centre: The bleed plug in closed position. Right: the bleed plug in open position. Source: Equinor Synergi 2531047 external HC leak in area G.

The direct cause of the leak was that the bleed plug on the bleed line in the modular valve stood in the open position at the same time as the actual bleed valve was a little open. The latter had probably been moved a little during the insulation removal process.

The bleed plug (anti-blowout type) involved in the incident is left-hand threaded. That differs from the plug type normally found at the plant and has to be screwed out to close.

The bleed plug involved in the incident was an anti-blowout type and left-hand threaded. This kind of plug must be screwed out to close it.

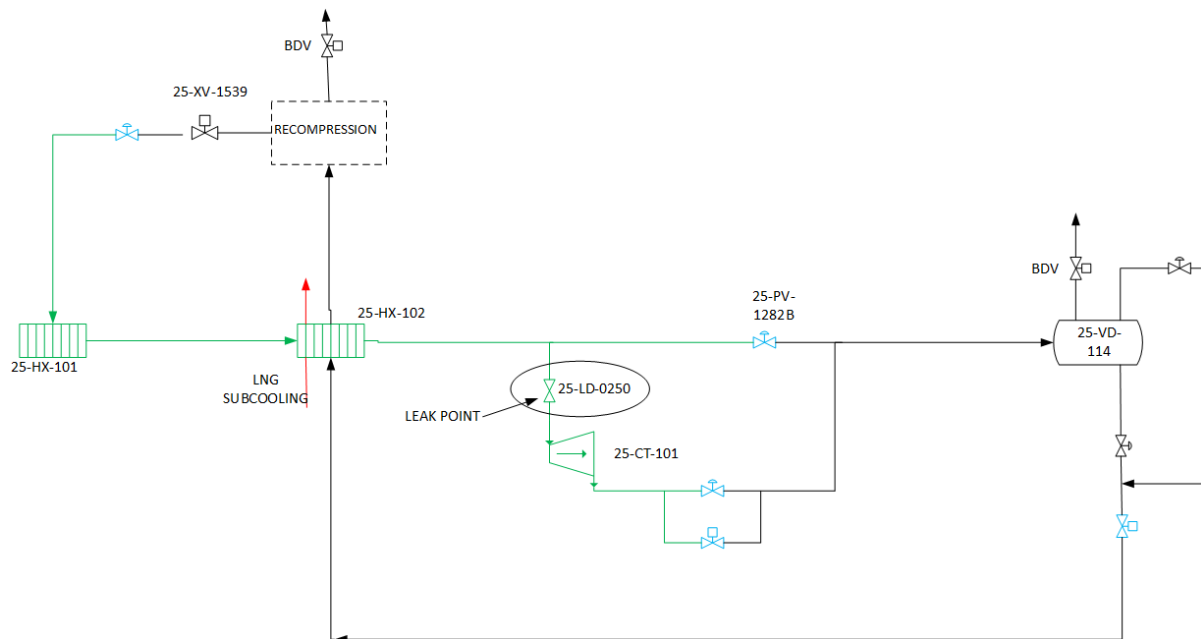
Figure 7 Diagram showing interventions in the event of ESD/blowdown of the cooling circuit.

Earlier studies have revealed that some segments will be left pressurised after ESD with subsequent blowdown. A memorandum was produced for the response management in the autumn of 2022 to highlight which segments are involved.

The actual leak point is in a segment which will remain pressurised after ESD with subsequent blowdown.

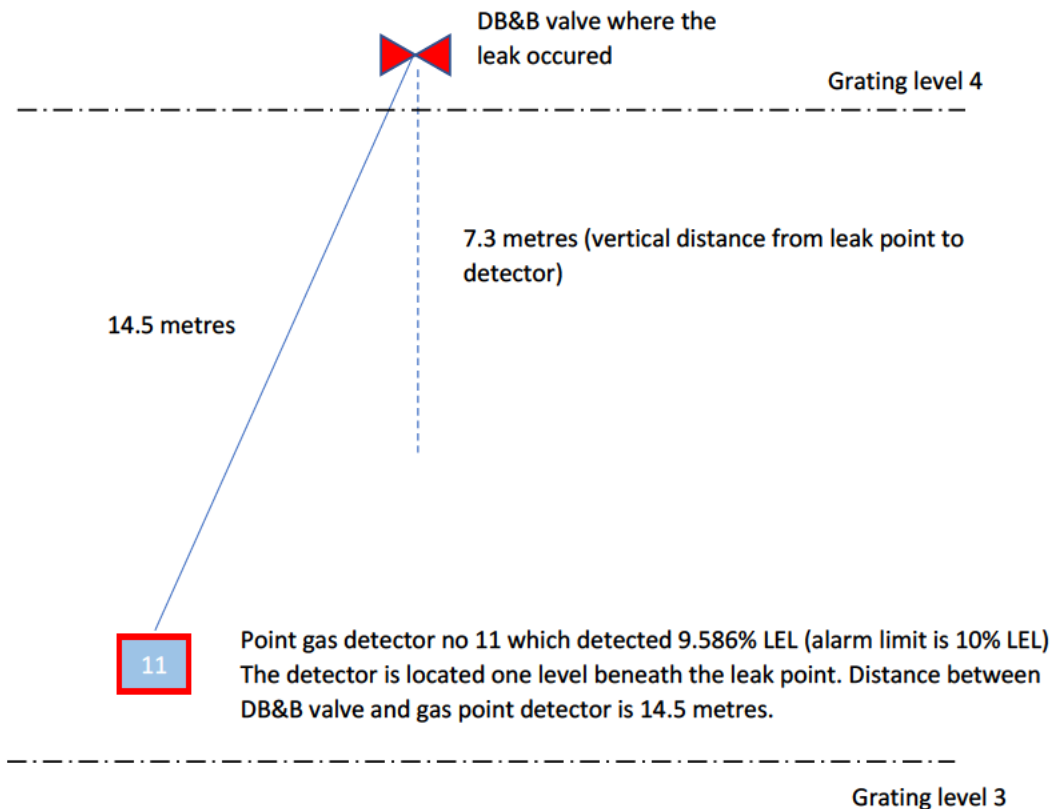
Figure 10 Overview of distance from the leak point to the point gas detector with a reading of 9.586% LEL on the level below. The alarm limit for initiating automatic actions with point gas detectors is 10% LEL.

Point gas detector no 11 (on the level below the leak point) had the highest reading during the incident. It is located 14.5 metres (diagonally) from the leak point, as shown in the diagram below.

When the incident occurred and throughout its course, no detectors initiated an alarm. Detection was confined to personal gas detectors – two on insulation workers one and two, and one carried by one of the three area technicians called to the site. This form of detection resulted in the CCR operator initiating manual actions. The CCR has a button for manual ignition-source disconnection of non-critical sources. Disconnection was activated manually when personal detectors confirmed a gas leak. If the detection system had received a single reading of 10% LEL or 1.0 LELm, non-critical ignition sources would have been disconnected automatically.
