Investigation report

| Report title Personal injuries from H ₂ S exposure at Sture on 12 October 2016 | Activity number 001903018 |

| Main group T-Land-based plants | Approved by/date Kjell Arild Anfinsen/10 February 2017 |

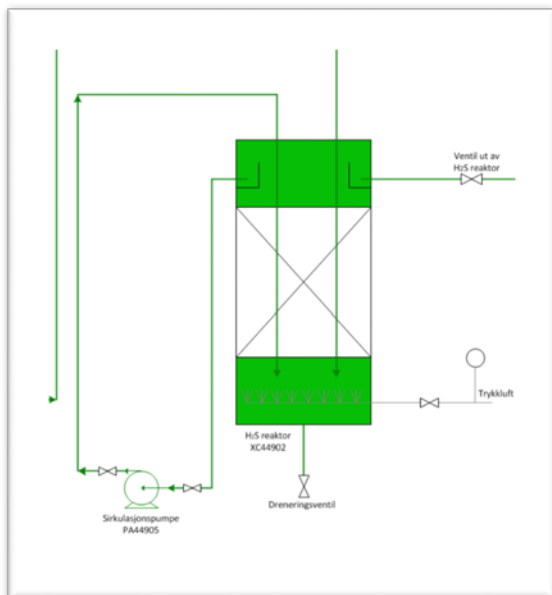
Fig 1. Diagram (source: Statoil)

The H₂S reactor is a 14-metre-high concrete cylinder with a diameter of five metres. Water is pumped in over the top and conducted to the bottom of the reactor, which is filled with packing material in the form of pots to create the largest possible contact surface between water and bacteria. The water rises through the reactor while bacteria convert the H₂S to sulphate. After treatment, the water overflows into the collection chamber at the top of the reactor before flowing on to the next stage in the treatment plant.

A recirculation pump takes water from the collection chamber and feeds it back to the reactor in order to ensure adequate water circulation.

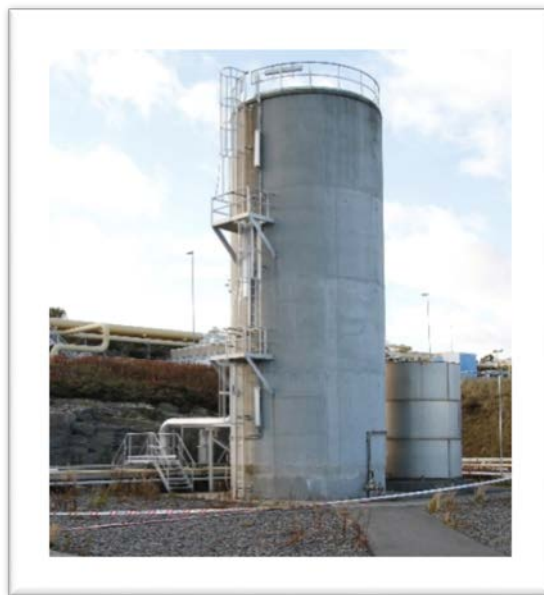
Fig 2. H₂S reactor (source: police)

Signs in the area stated that the control room should be contacted concerning H₂S, but this was not able to determine the concentration in the area. No H₂S detectors were permanently installed in the treatment plant. The stairs up to the top of the H₂S reactor had no barrier.
