Investigation report

Report	
Report title Incident with a fall from scaffolding involving personal injury and a steam escape at Mongstad on 27 June 2020	Activity number 001902053

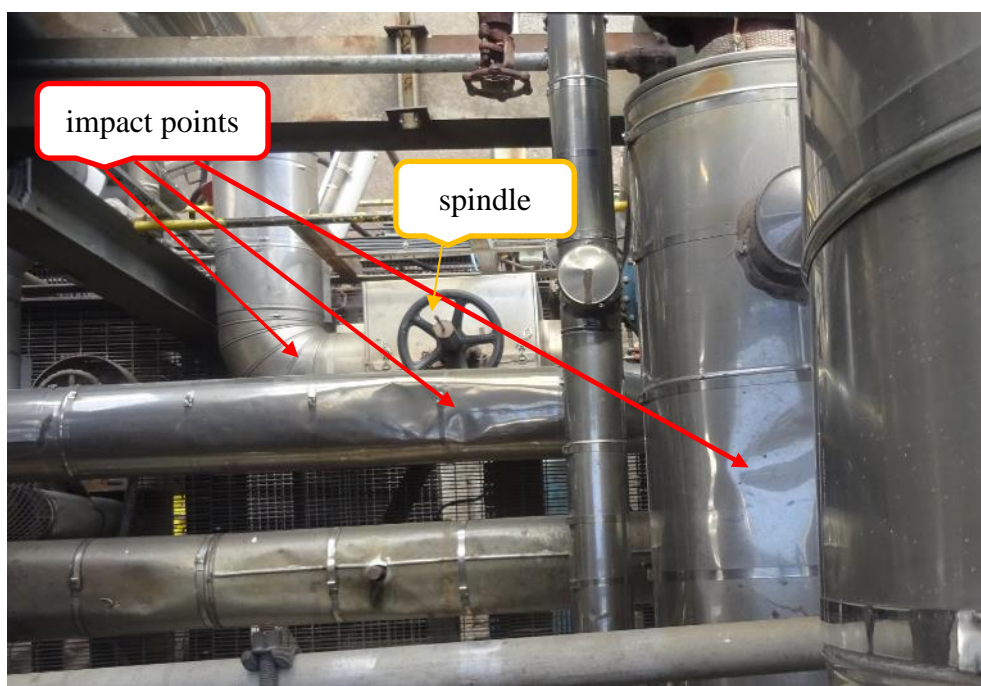
Operator 2 fell/slid without a hard hat to a lower level on the walkway below. Fall height: four-five metres. He had zero vision and took an arbitrary route from the accident site. A valve with spindle was located immediately alongside his descent. Had the operator hit that, he could have suffered serious injury or been killed.

Photograph 1 Where operator 2 fell, with impact points and spindle. The view is from above down to the walkway below the scaffolding. Photo: Equinor Mongstad

The direct cause of the incident was that operator 2 fell/slid between piping and down to the level below (about four-five metres) as he attempted to escape from the area with steam.

The original evacuation route became unavailable to operator 2 when he lost vision because of the large quantities of steam coming from the hose. At that point, the hose had become attached to the scaffolding, and its jet was pointing at the evacuation route.

Operator 2 had to get under the piping to obtain more torque for opening the valve. Access was difficult and the workplace constricted. When the plug loosened, operator 2 was lying under the piping and crawling towards the edge of the scaffolding was his only evacuation option.
