Investigation report

Report	
Report title Report of the investigation into a naphtha leak at Slagentangen on 24 August 2020. Rev 2	Activity number 007931030

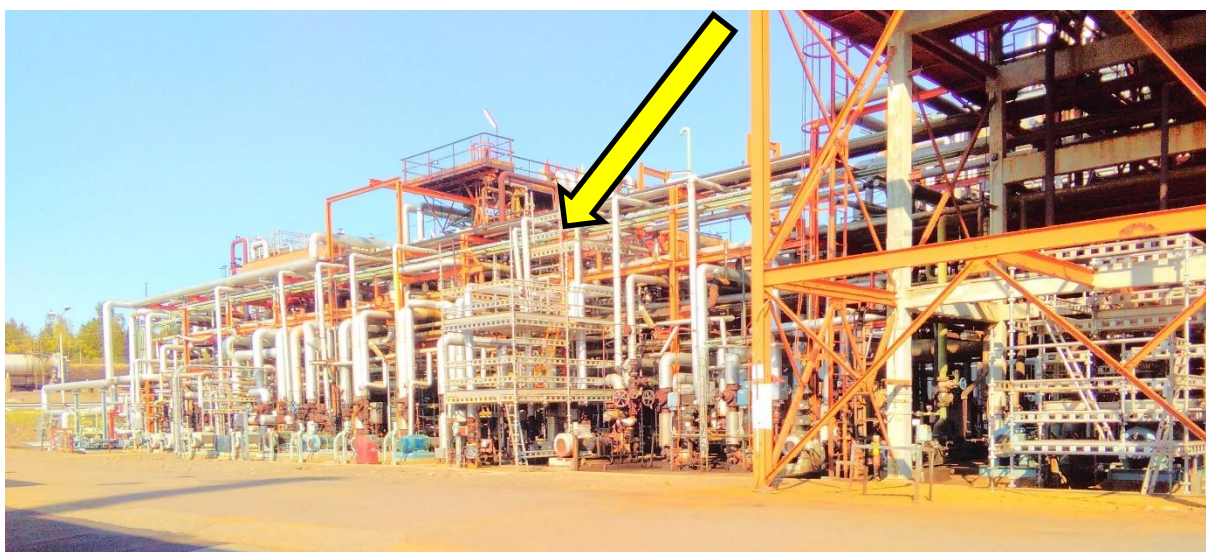
Figure 5: The pipestill, with the arrow pointing to the leak site.

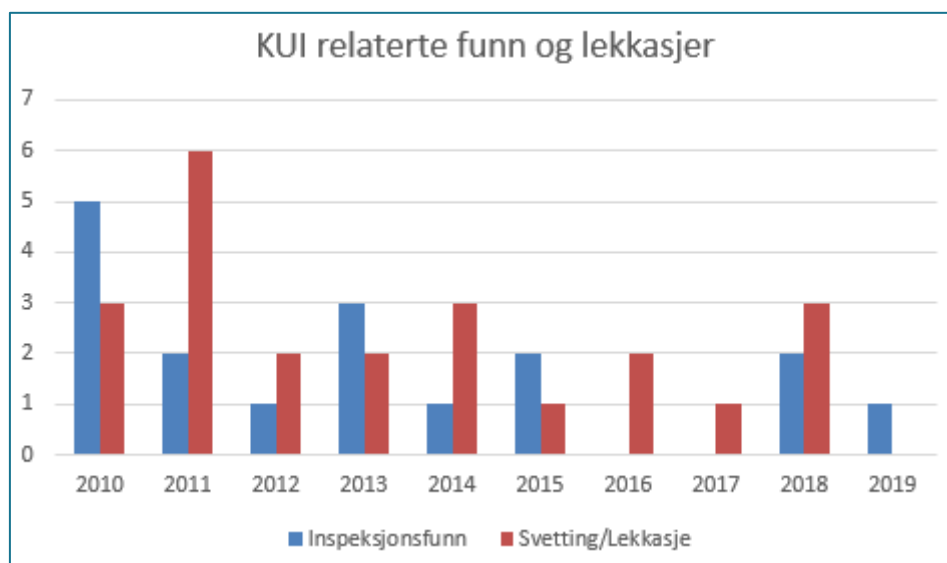
Esso registers sweating and leaks caused by CUI. Based on information from the company, these findings and observations are presented in Figure 7. This shows that the annual number of incidents has declined since 2011.

Figure 7: Number of findings and observations during operation and inspections.
Key: CUI-related discoveries and leaks; Inspection findings; Sweating/leaks.

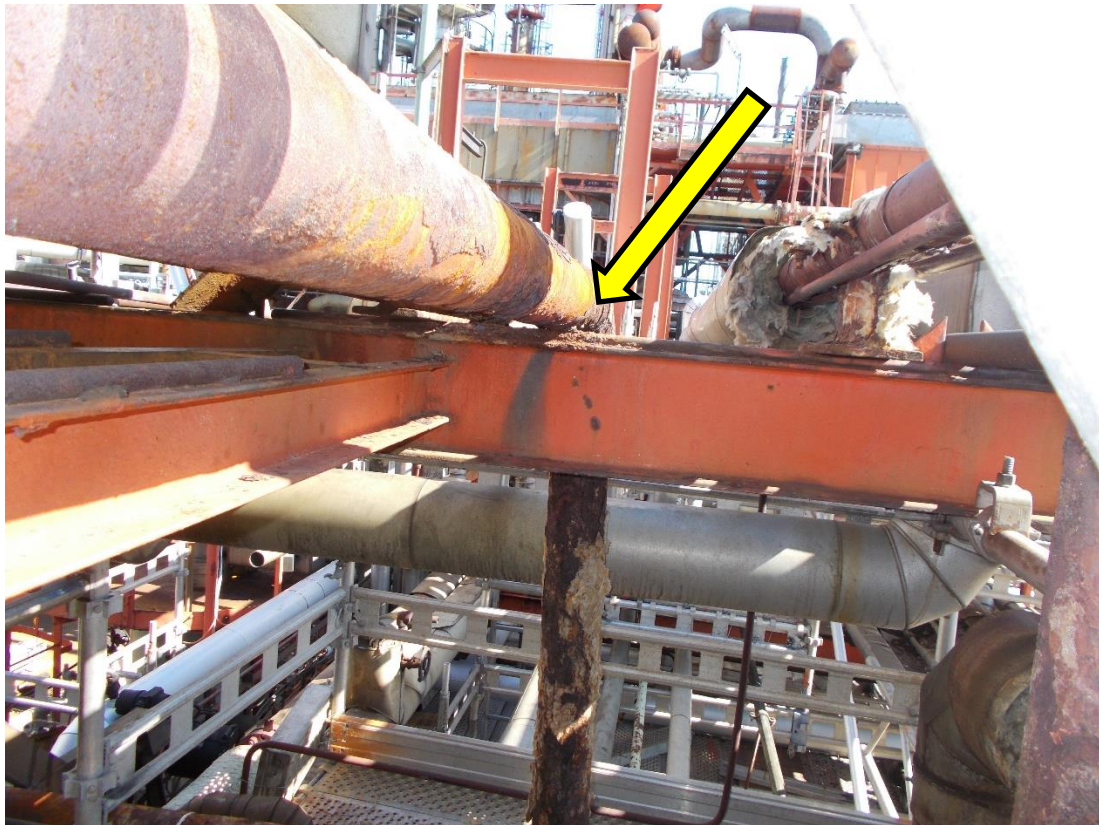
The leak has occurred after substantial external corrosion owing to CUI. See Figure 8 and Figure 9. Whether internal corrosion has also contributed to wall thinning has not been investigated. This is considered unlikely, given that virgin naphtha is not corrosive and there was no sign of internal corrosion when the pipe was cut and blinded after the leak. The pipe rests directly on a small plate on the steel beam which provides its support, and the insulation has not covered it entirely. That has given easy access for water. The insulation jacket has not been inspected for leakage, but it has been reported that jacket condition is the same on surrounding pipes. See Figure 10. Together with the pipe's condition, this indicates that CUI is likely.

Figure 8: The naphtha pipe after removal of its insulation. The assumed leak point is at the end of the horizontal stretch indicated by the arrow.

The direct cause of the leak was external corrosion of a four-inch pipe taking naphtha from pump P-111 to cooler E-136. Lack of inspection and repair meant that the corrosion had continued long enough for a hole to form in the pipe.

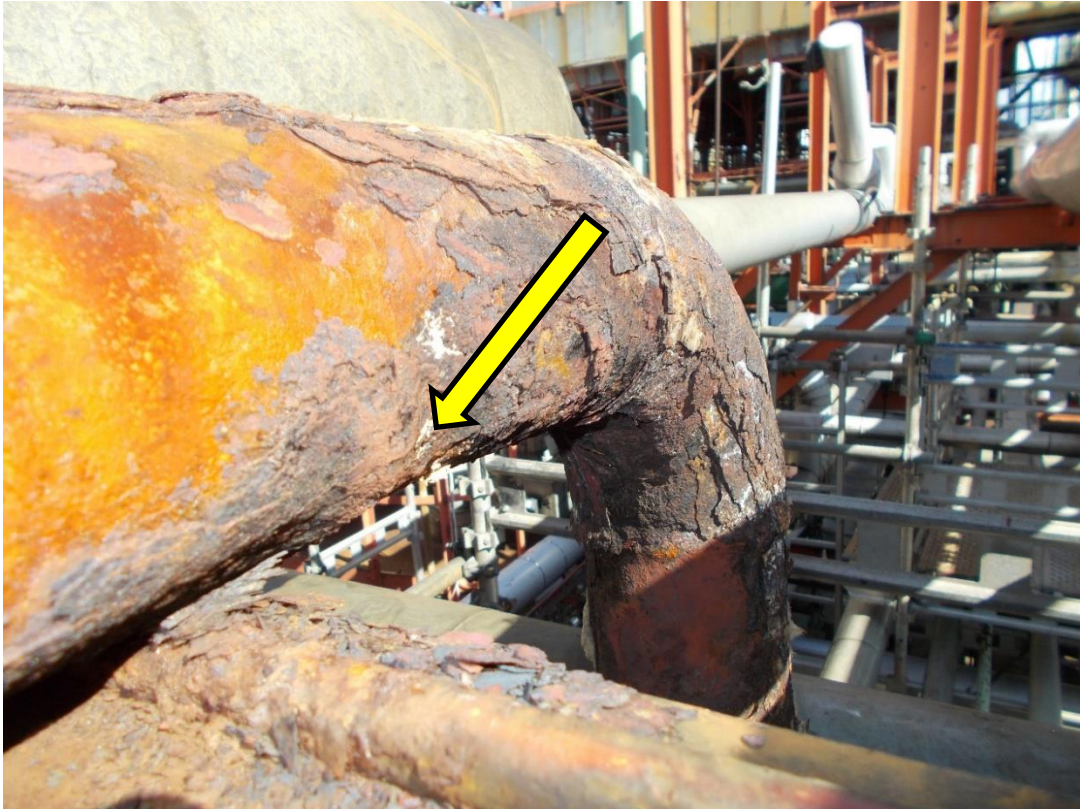
Figure 9: The naphtha pipe after removal of its insulation. Arrow indicates the assumed leak point.

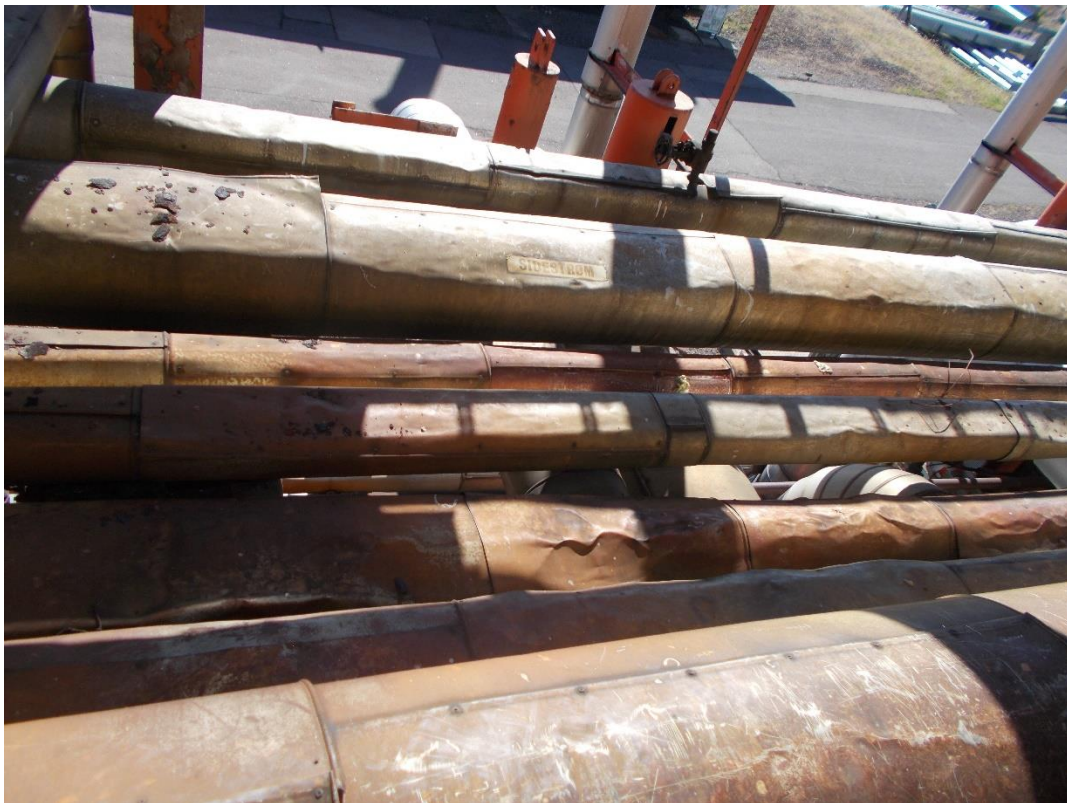
Figure 10: Condition of insulation jackets on surrounding pipes close to the leak.
