# Investigation report

Report title Report of the investigation into a fire in the inlet separator on Snorre B	Activity number 001057042
--	------------------------------

Team T1-Equinor	Approved by/date Kjell M Auflem/15 August 2019
Members of the investigation team Liv Ranveig Nilsen Rundell, Eva Hølmebakk, Aina Eltervåg, Jorun Bjørvik	Investigation leader Jorun Bjørvik

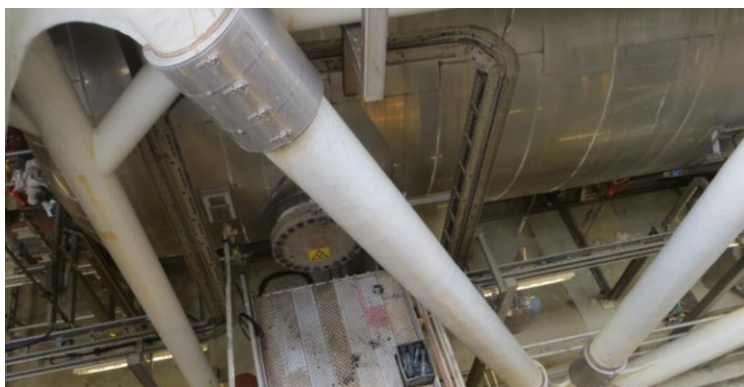
During the incident, the smoke was observed to change colour several times from white to grey-white.

Figure 2 The inlet separator with manway cover closed. Photo PSA

The direct cause of the fire was spontaneous combustion of iron sulphide which came into contact with oxygen during the venting process after primary cleaning of the separator had been completed. This led in turn to ignition of remaining oil residues in the separator.
