Investigation report

Report	
Report title Report of an investigation – Equinor Mongstad – Person fallen from scaffolding	Activity number 001902065 Case 2023/116

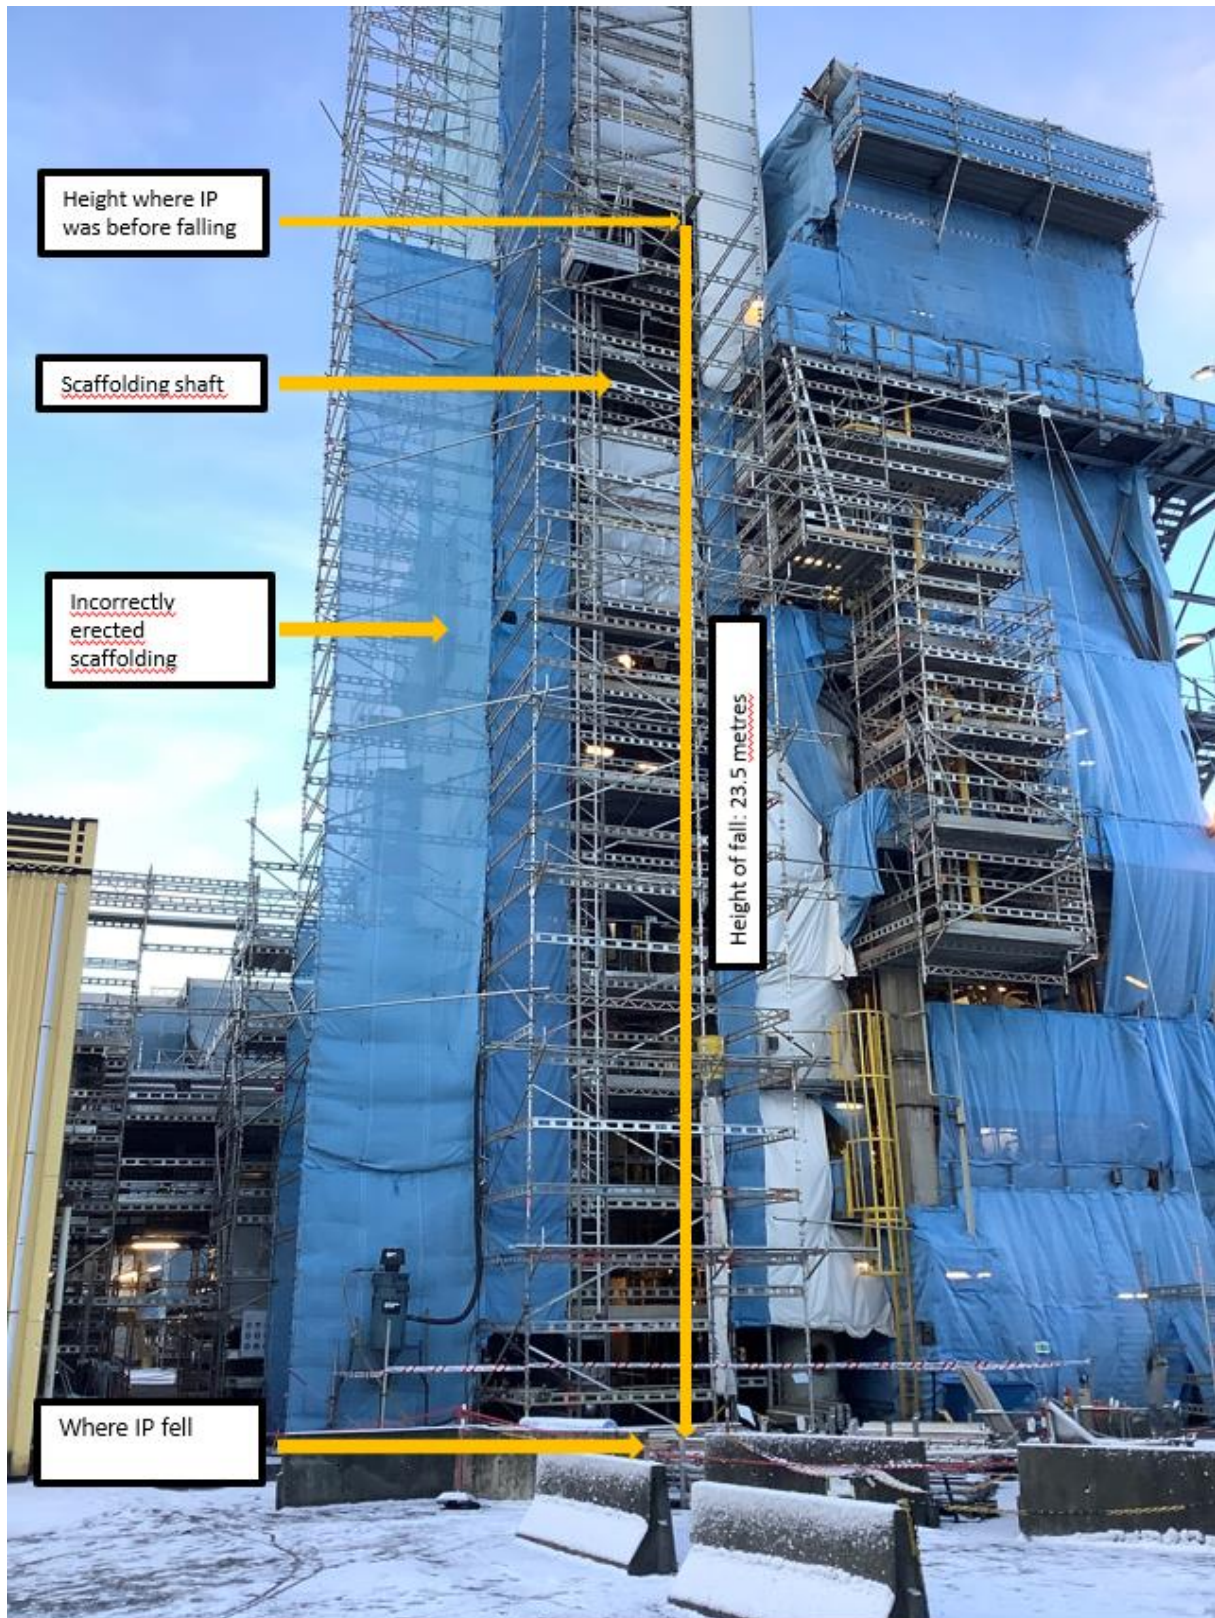
Figure 9. Scaffolding and injury site

<p>Wednesday 18 Jan 2023, 13.34</p>	<p>According to the ganger, the IP lost their balance while trying to install a ledger at the next level, and fell from 23.5 metres inside the scaffolding. The ledger to which both fall-arrest harnesses were attached fell down together with the IP. The IP and ledger hit scaffolding components when falling.</p>	<p>The safety latch at one end of the ledger must at some point have opened unintentionally, since the latch on the relevant ledger was very loose and was easy to flip up at the slightest touch during the technical investigation of the scaffolding materials after the incident.</p>
<p>Wednesday 18 Jan 2023 After the fall</p>	<p>The scaffolding team immediately reported the incident by radio. The fire station was alerted at once about a fall from height in the process plant. Mongstad's response organisation was activated along with BBS's response organisation, which comprised the local management and the next level at the BBS head office in Kokstad.</p>	<p>The IP, who was seriously injured but had a pulse and was partly conscious, was immediately dealt with by personnel present and eventually by response personnel. They were transported to Bergen's Haukeland Hospital with life-threatening injuries. Next of kin were notified. Equinor halted all scaffolding activity at Mongstad, and all work at height ceased. A town hall meeting was held with all ISS personnel at Mongstad. A similar meeting was held with all contractors on 19 January 2023.</p>

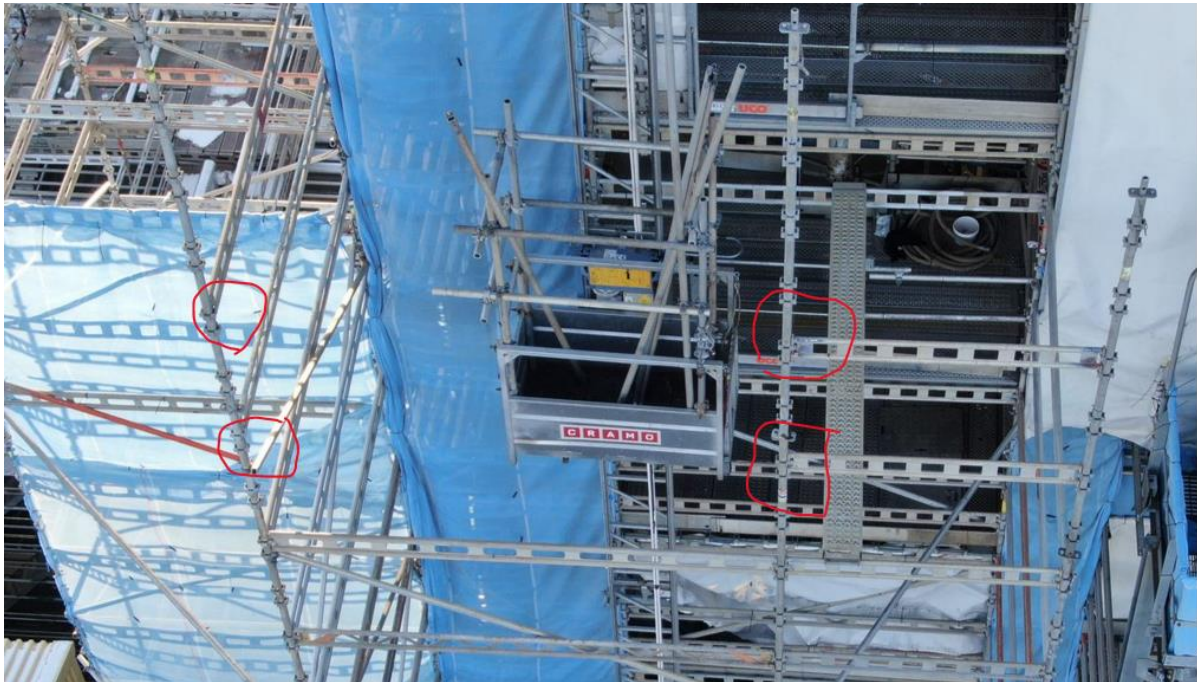
Figure 11. Ledger attachment site marked by red circle.

suffered a fracture in the lower hook where the lanyard was attached. The upper locking collar on the standard fractured.

The IP came into contact with another ledger during their fall, which probably slowed the fall. Clear signs of damage to this ledger could be seen. The ledger was bent from contact with the falling IP, and suffered fractures and cracking in a total of five bracings towards the one end.

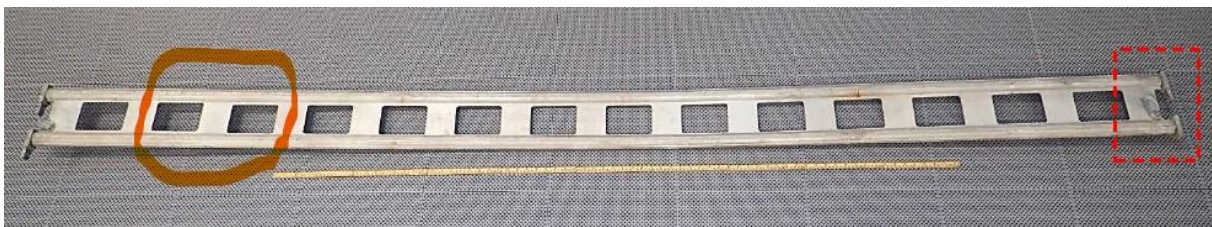
Figure 12. Source: Equinor report MAT-2023021.

"Fractures in the standard locking collar and ledger hook on the scaffolding components involved in the accidental fall at Mongstad during January 2023 were caused by ductile overloading. This overloading occurred because the ledger at the time of the fall was only attached to one standard, so that collar and hook were subjected to a substantial bending moment.

The hooks on the fall-arrest equipment were attached to ledger holes two and three from the one end, marked in red in figure 12. When the ledger is only attached to the standard at one end, marked by a rectangle with dashed lines in figure 12, a load of about 100 kilograms can cause the standard's locking collar to fracture. In the event of a fall, the load can then cause fractures in the collar and ledger hook.

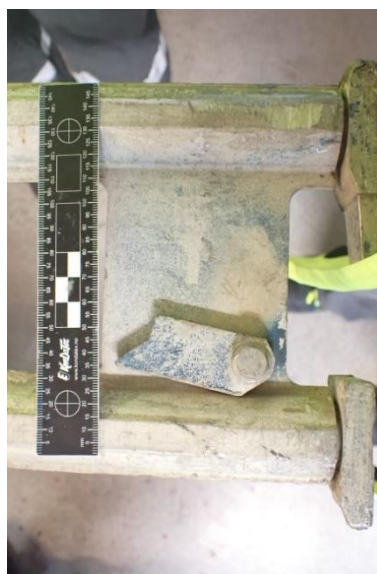
The direct cause of the incident was that one end of the ledger came loose from the standard and the IP lost their balance on the ledger they were standing on, causing them to fall backwards, and the ledger hook at the other end was bent out of the collar and detached.

Figure 14. Ledger with fracture in lower hook.
