Investigation report

Re	Report												
Rep	port title	Activity number											
Re	Report of the investigation into the engine-room fire on <i>Scarabeo</i> 5 401001006												
Se	curity grading												
\checkmark	Public		Restricted		Strictly confidential								
	Not publicly available		Confidential

PETROLEUMSTILSYNET

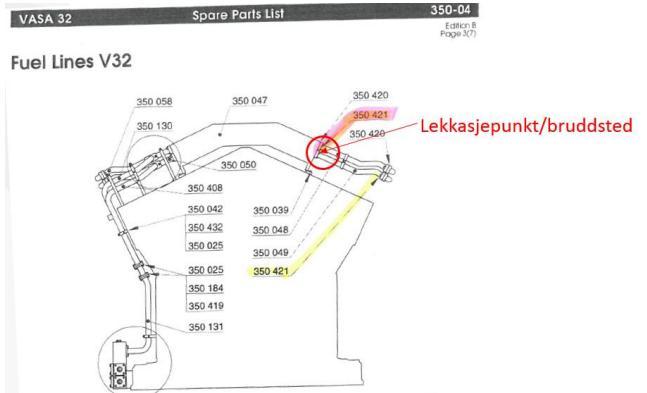
The diesel oil line where the leak occurred is a pipe with an external diameter of 35mm and 3mm of wall thickness. The leak occurred at the transition between this line to the bridge pipe (see figure 1).

Figure 1. Diesel oil supply on the Vasa 32 engine. Source: Wärtsilä/Saipem. Text in red: Leak point/fracture site.

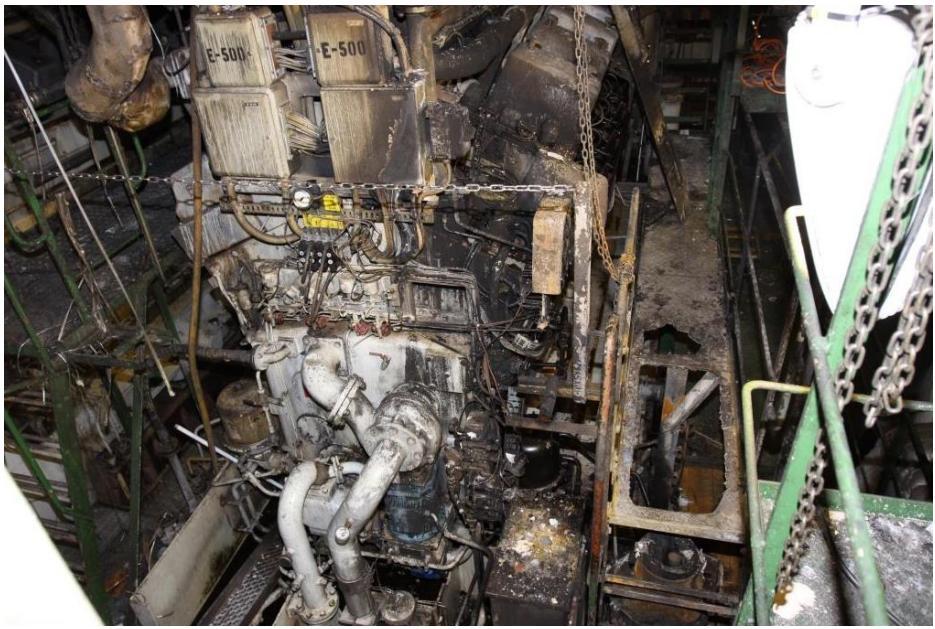
Scarabeo 5 suffered damage to DG7, ventilation channels, fire insulation, high-voltage cabling and other equipment in the engine room. In the investigation team's view, the consequences of the incident could have been reduced if the Novec extinguishing system was activated earlier.

Figure 2 Photograph of DG7 after the fire. Taken by the police.

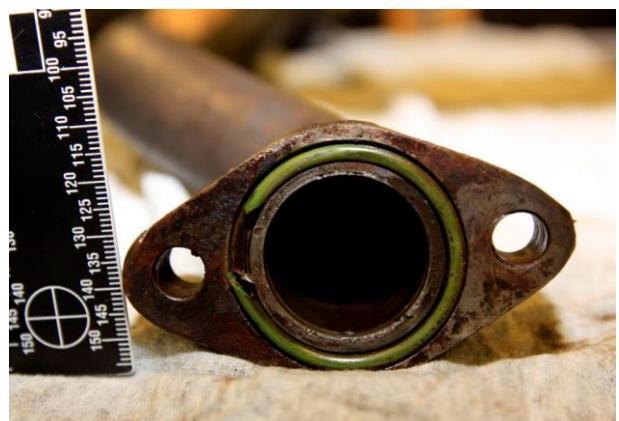
The leak occurred in a low-pressure diesel oil pipe supplying DG7. It arose in a flange held with two bolts and sealed with an O-ring. The investigation revealed that the fracturing of one of these bolts caused the leak. According to DNV GL, the most likely cause of the fracture was fatigue. Bolts fracturing after a certain time in use is not unusual.

Figure 3 Diesel oil pipeline with flange and O-ring. Taken by the police.
