Investigation report

Re	port						
Rep	ort title				Activity number		
Investigation of an incident with fatal consequences on					418005005		
CC	COSLInnovator, 30 December 2015						
Sec	curity grading						
\checkmark	Public		Restricted		Strictly confidential		
	Not publicly available		Confidential				
e	mmary

Mobile drilling unit *COSLInnovator* was struck by a wave at 16.38 on 30 December 2015. The impact occurred forward on the port side, and the unit suffered extensive damage. One person died and four were injured. The damage was confined to part of the living quarters.

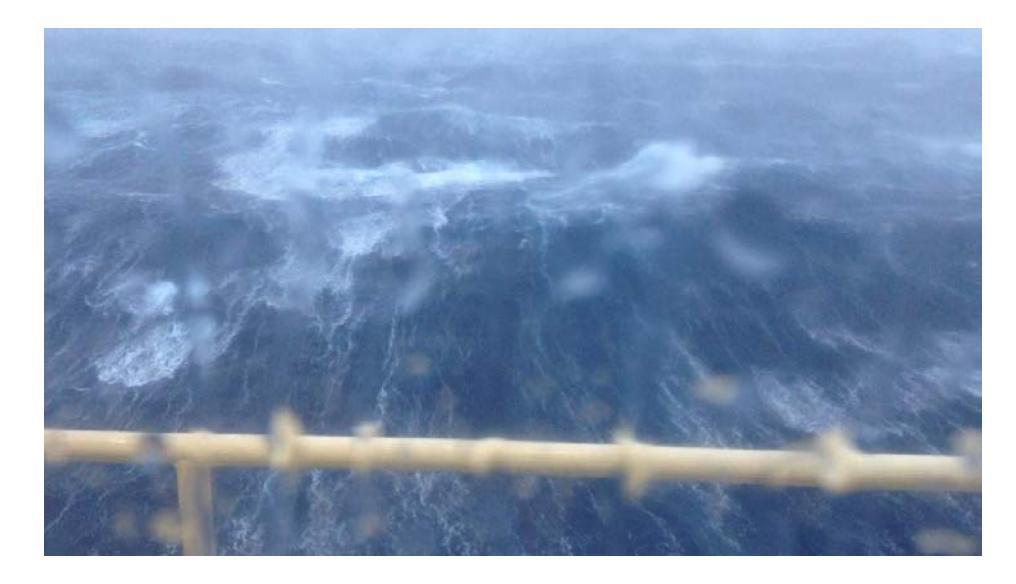
The NMI¹² notes that the sea state on the incident day has a return period of four years if wave direction is ignored. Including direction, the return period is 25 years. Figure 2 presents a view of the sea taken earlier on the incident day at a lower sea state.

Figure 2 Image captured from a video shot from CI at 14.24 on the incident day, 30 December 2015 (shot by safety officer).

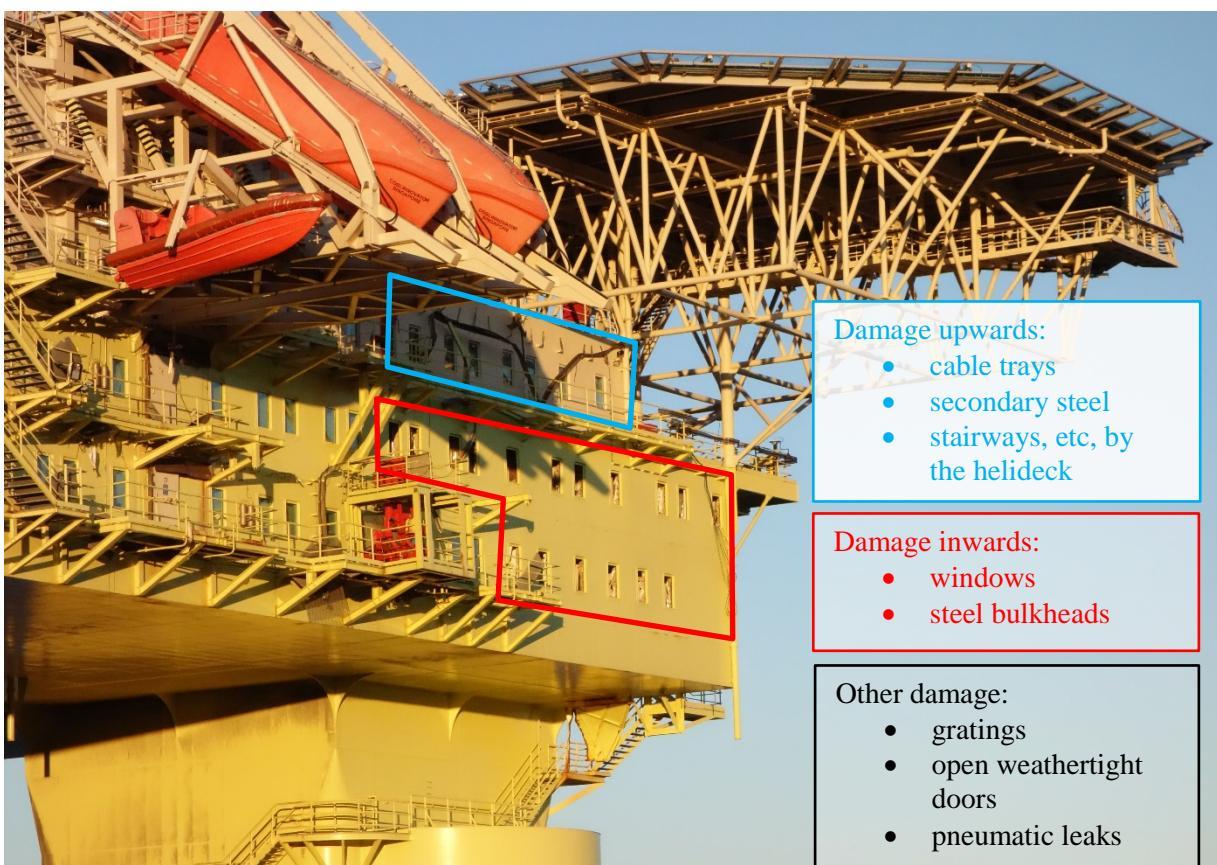
CI suffered extensive damage to a total of 17 cabins as well as corridors on two decks forward on the port side. Six windows on the lower deck and 11 on the mezzanine deck were driven in. See Figure 3.

Figure 3 Forward bulkhead of the CI berthed at CCB after the incident. The scale of the damage can be seen from the broken windows and fastening brackets for cable trays.

- Below the main deck level, damage to windows and steel bulkheads was directed inwards, with some displacement of grating panels. No structures (gangways and the like) were present immediately forward of and below damaged windows on the outside of the bulkhead.
- Above the main deck level, damage to grating panels, cable trays and secondary structures was directed upwards.
- Towards the centre of the box girder's forward face and above A deck level, damage to glass, grating panels, weathertight doors, cable trays, equipment cabinets and so forth was on a smaller scale and oriented in various directions both inwards at the midships doors and upwards in the helideck area.

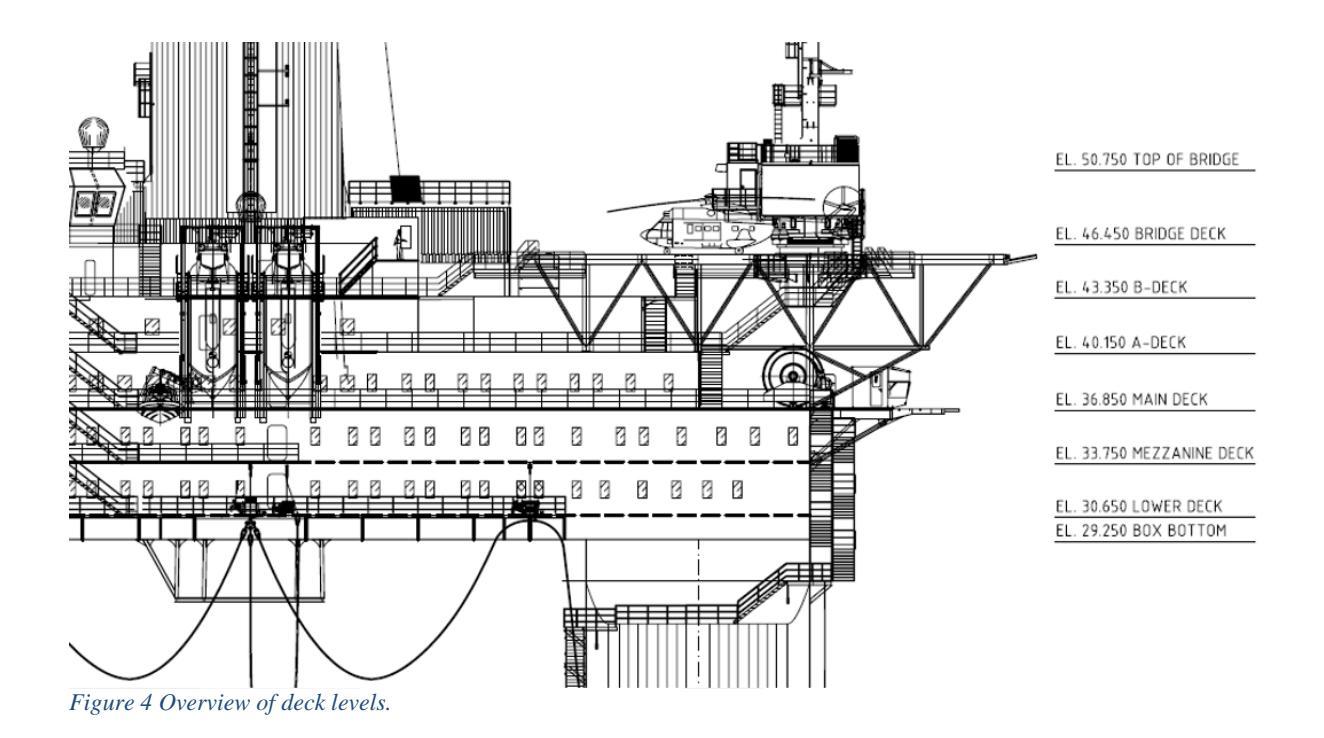
The PSA noted the following main features of the damage.
