Investigation report

Report		
Report titleActivity numberInvestigation of incident on 31 January 2024 involving a cabin001094054window on Åsgard A being forced in by green water		Activity number 001094054
Classification		
⊠ Unclassified	Exempt from p	publication
Parties involved		
Team	Approved by / date	
A-1	Elin S. Witsø / 28 M	May 2025
Investigation team participants	Investigation leader

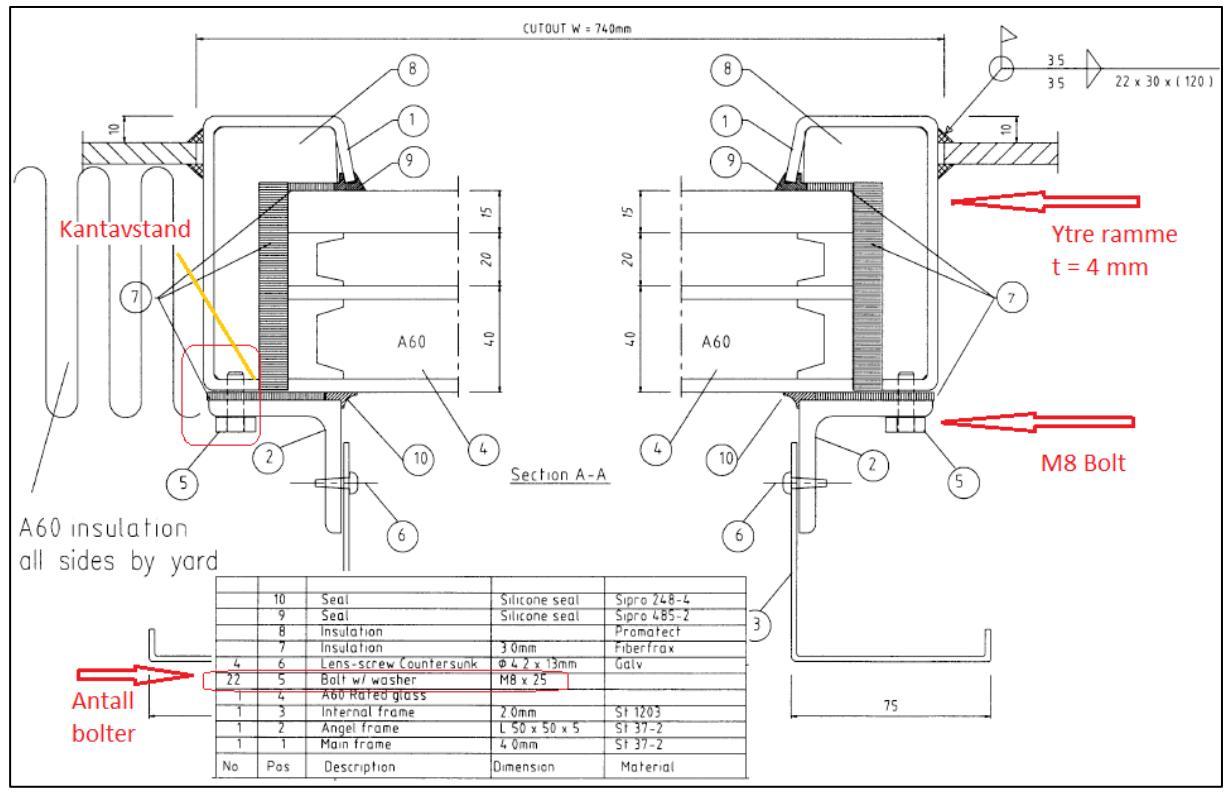
Figure 6: Extract from drawing C055-HX-C-XF-7550-07, rev. 01F (source: Equinor)

The window of cabin 812 is of type W1, as shown in Figure 6 Window plan, with A60 fire resistance and a 670x1050mm glass area (W x H). The external dimensions of the window including the frame are 735x1110mm. The glazing consists of tempered outer glass, a gas layer and laminated tempered glass consisting of two glass panels and a flexible polymer panel with fire-resistant properties.

The type W1 windows are mounted using 8mm bolts screwed into threaded holes through the outer frame. The outer frame is a prefabricated, 4mm-thick profile made of 37-2 grade steel with a yield strength of 235 MPa and a tensile strength of approx. 370 MPa. The frame itself is welded using a 3.5mm fillet weld on the outside and inside of the bulkhead.

Equinor's investigation report shows that 26 bolts are used to secure the window, based on the photographs taken after the incident. However, 22 bolts are shown on drawing C055-HX-C-XF-7550-07. It is uncertain whether this difference is due to a typographical error or later revision of the drawing.

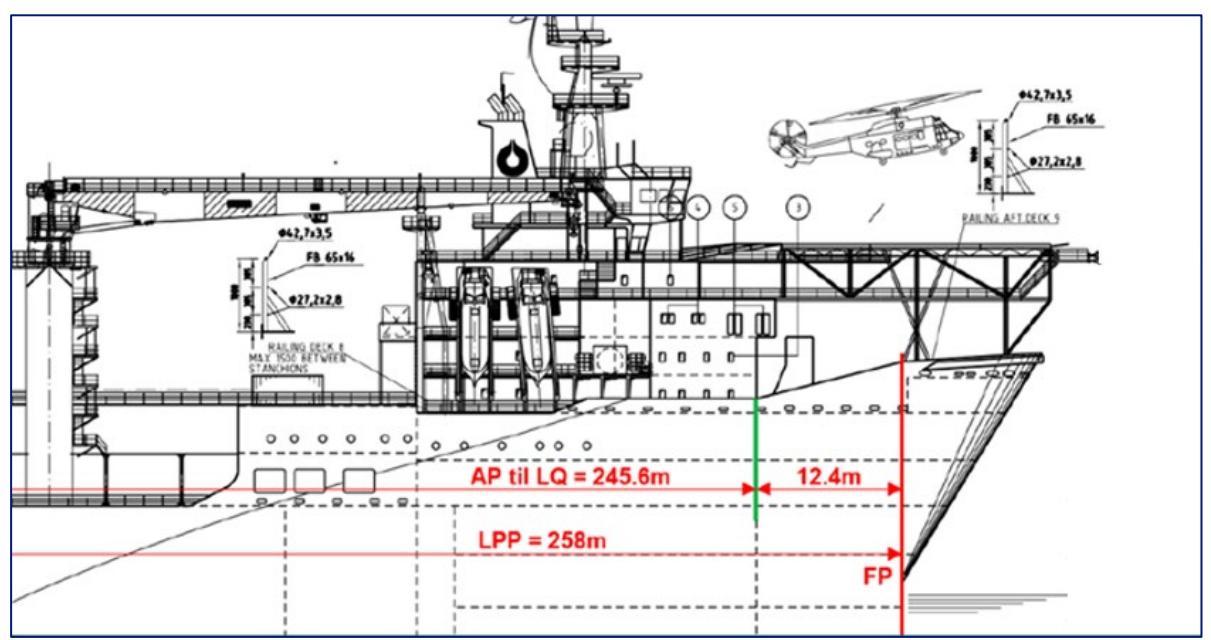
Figure 7: Deck elevations for description of freeboard above still water level to LQ and FP. Illustration for Åsgard A. (Source: Equinor)

According to Equinor's investigation report, at the time of the incident, Åsgard A had a draught measured amidships of 18,455m with an aft trim of 3,493m (0.7758 degrees). This gives a freeboard above still water level of 22.8m on the forward perpendicular (FP), and 18.9m at the bulkhead towards the bow (front wall of living quarters). This means that, during the incident, Åsgard A had approximately 0.5m less freeboard above still water level at the living quarters than Norne FPSO is able to operate with when in winter condition. Equinor also states that the freeboard on the FP was 3.2m higher on Åsgard A than the minimum for Norne FPSO in winter condition.

Within the operating criteria for Åsgard A, the freeboard in line with the living quarters may be less than the equivalent on Norne FPSO. This is because, during the winter months, Norne FPSO has introduced loading condition with a higher freeboard.

Equinor considers it likely that this incident was caused by a wave coming from the starboard side rather than over the bow. We have no reason to doubt this conclusion.

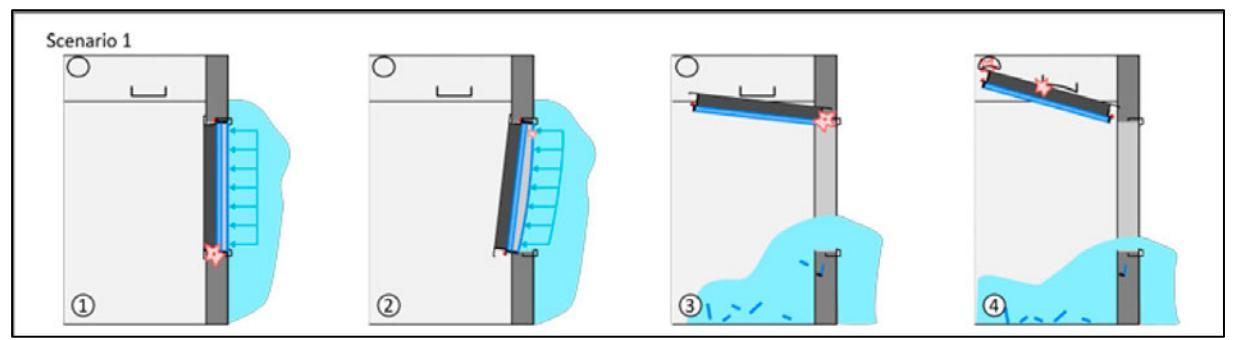
Figure 8: Most likely sequence of events (Source: Equinor)

Equinor's investigation report assumes that the most likely sequence of events is that the window frame and window came loose at the bottom and were pushed up through the ceiling by the water that was forced into the cabin and then landed on the floor. The glass most likely broke due to stresses in the frame as the window was forced in. Equinor has used an external party to assess the likely sequence of events.

The bolts along the top edge of the window were the last to become detached and acted as hinges before being wrenched out of their fixings. Finally, the window and frame landed on the floor.

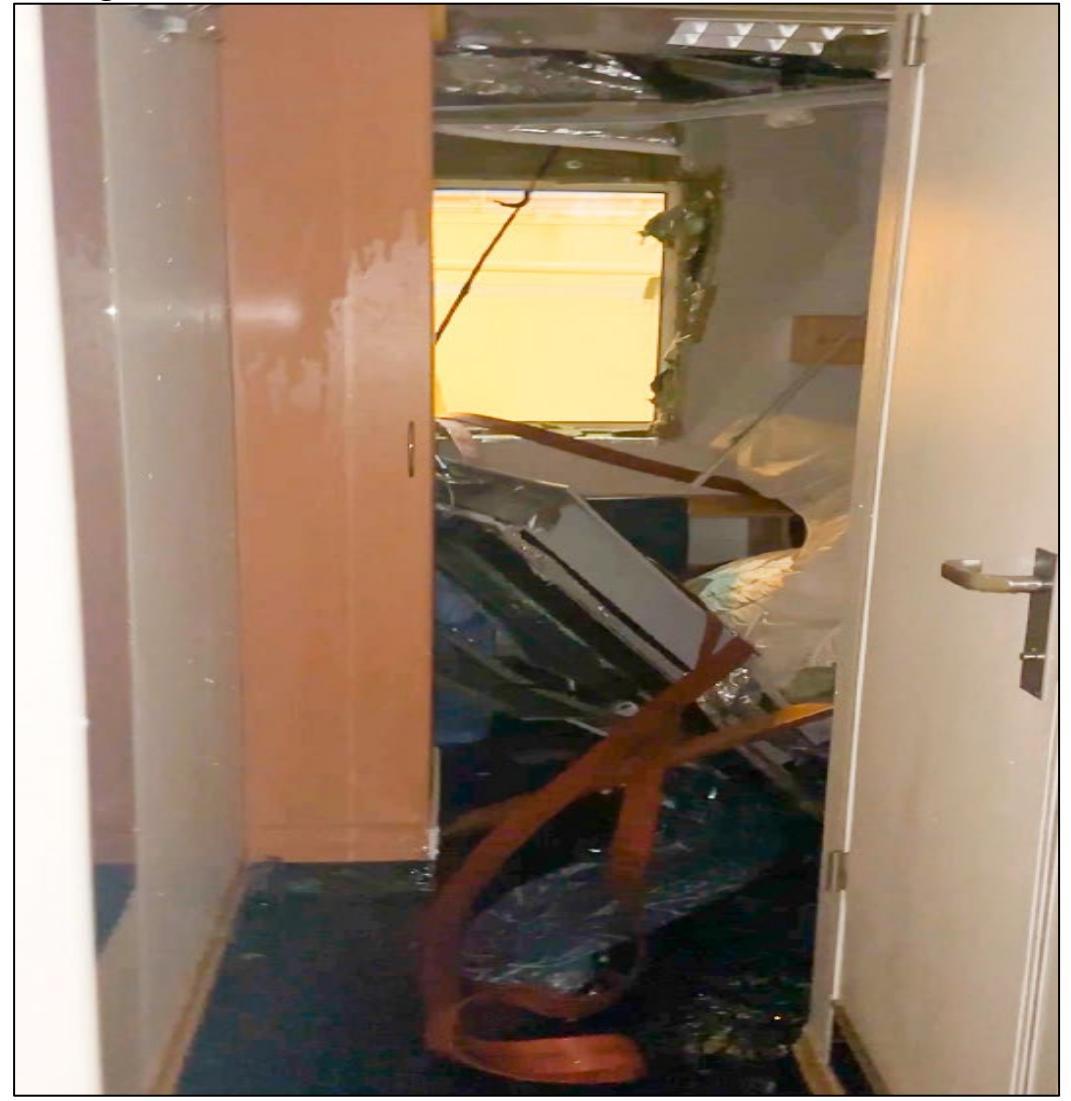
The incident caused material damage where the window and frame of cabin 812 were broken. The window's outer and inner glass layers were smashed into lots of small round fragments. Seawater was washed into the living quarters on deck 8 and down the elevator shaft and stairs to the stairway on deck 7. Water got under the cabin's ceiling panel and flowed from there into the adjacent cabins 810, 811 and 813. Water penetrated deck 7 and the ceiling of the medical facility. Ventilation pipes and cable trays in the ceiling of cabin 812 were damaged. External cable trays and lighting fixtures were damaged during the incident. The fire-protection box on the front deck came loose and parts of the box and fire hose were found inside cabin 812.

Damage to cabin 812

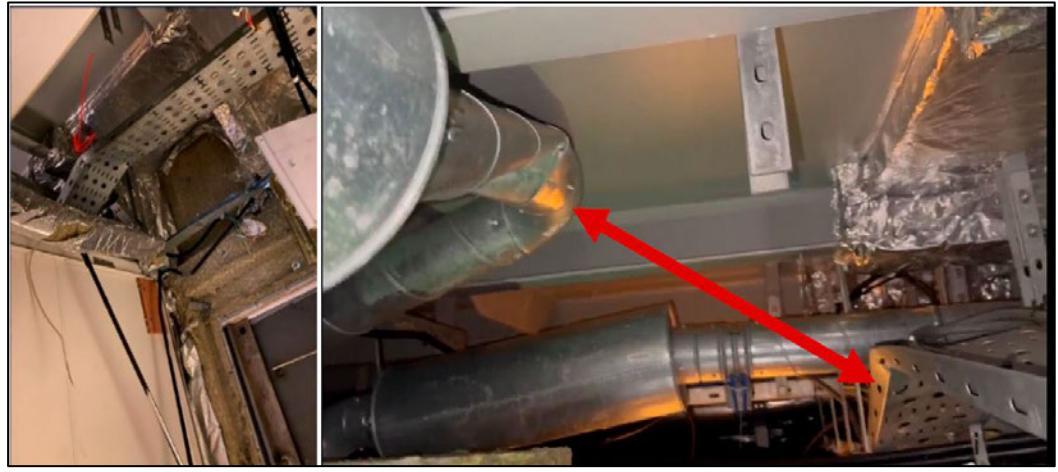
Damage to ventilation duct and cable trays in cabin 812

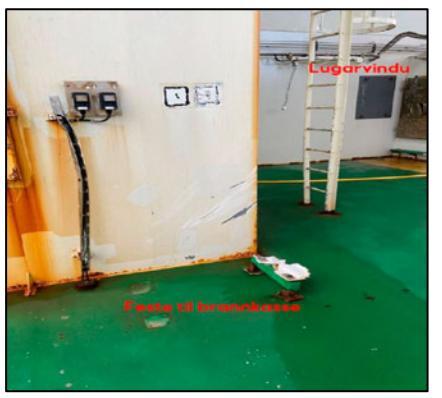
Fire-protection box attachment torn-off

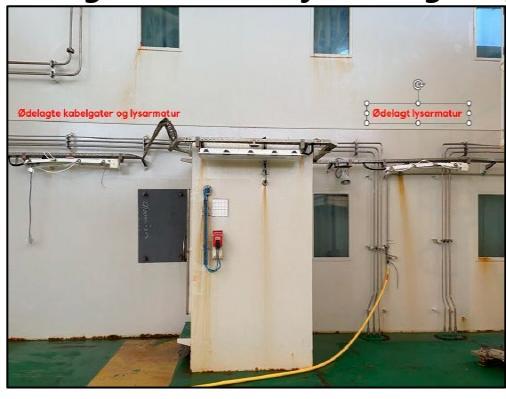
Damage to cable trays and lighting fixtures
